SPECIAL REPORT  
ON  
SPARE CRDM WELD  
REFURBISHMENTS

Public Service Electric & Gas  
Salem Generating Station  
September 1988

CRDM LEAK REPAIR/REFURBISHMENT REPORT  
SALEM - 1

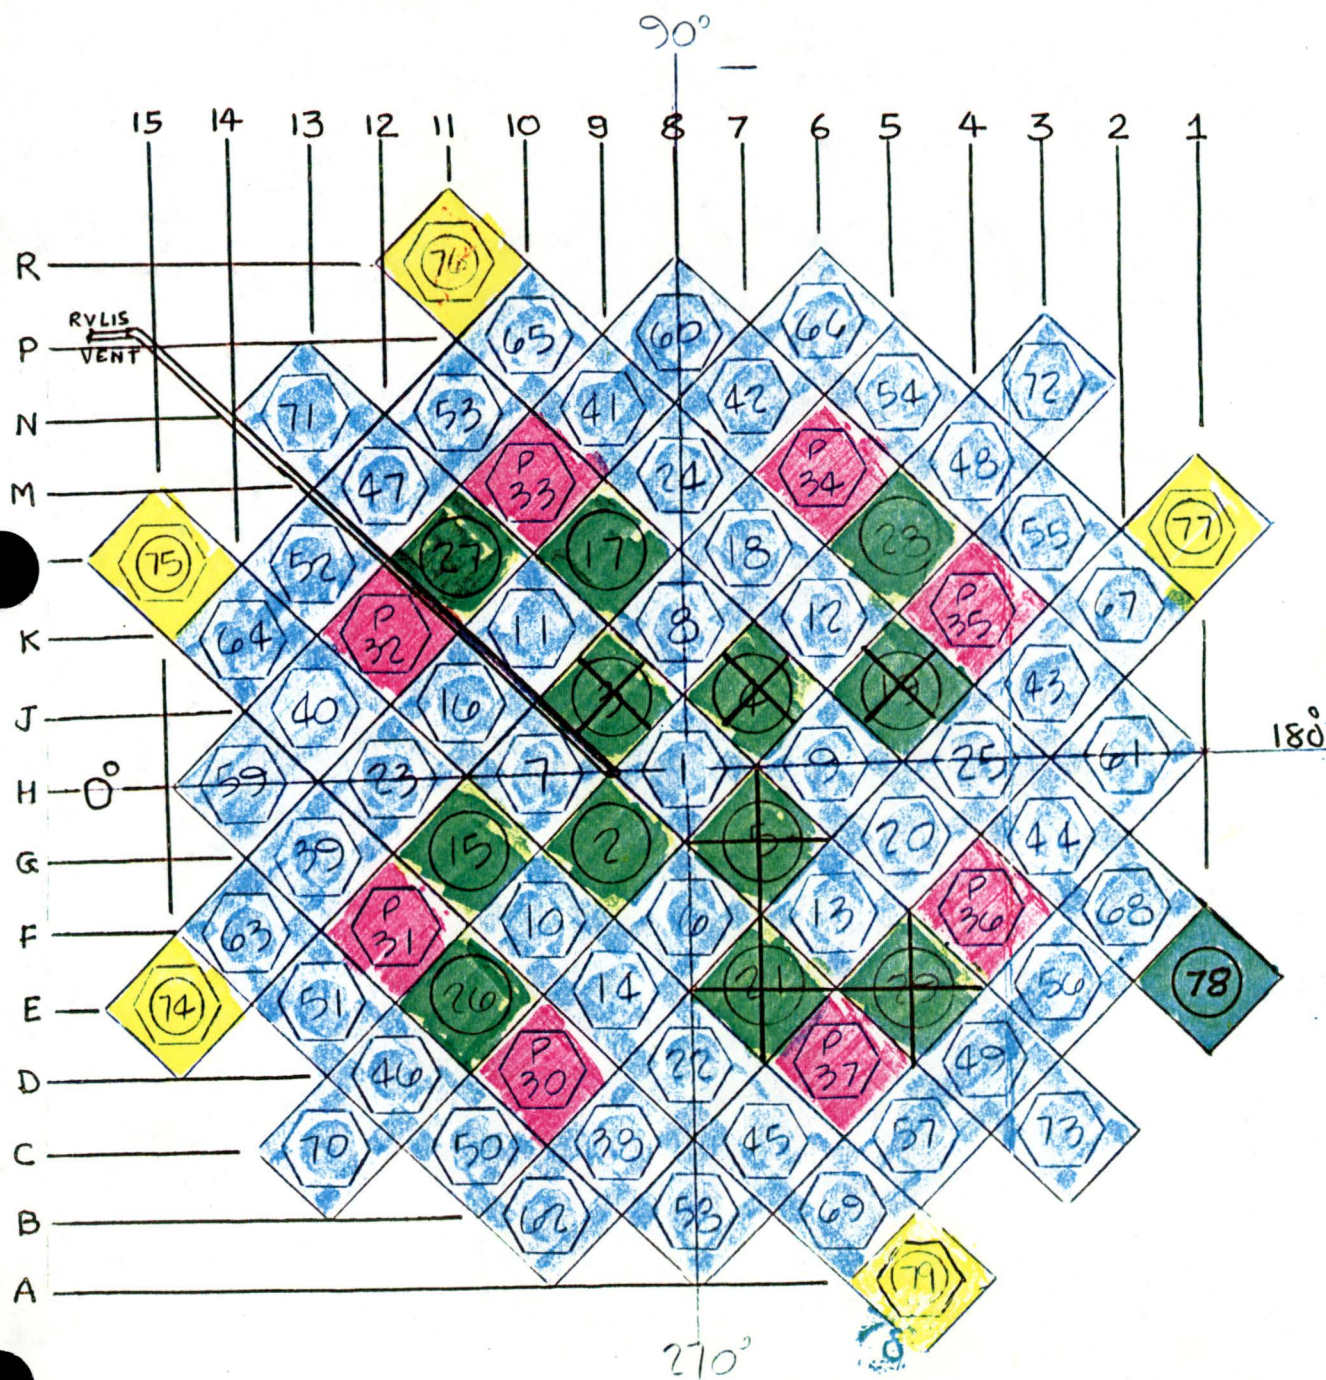
ATTACHMENT 2

On January 7, 1988, Salem Unit 1 was being returned to service after its seventh refueling outage. RCS inservice hydrostatic testing was being conducted at 2300 psi with the Unit in Mode 3 (heatup) as a part of the recently installed bottom mounted instrumentation design modification. Reactor head area inspection through the lower shroud inspection doors revealed the presence of pin hole leaks on three canopy weld locations of spares or the reactor vessel head adapters. The leaks were characterized by fine sprays of steam/water from the pinholes on the head penetrations E5, E7 and G7 (Attachment 2).

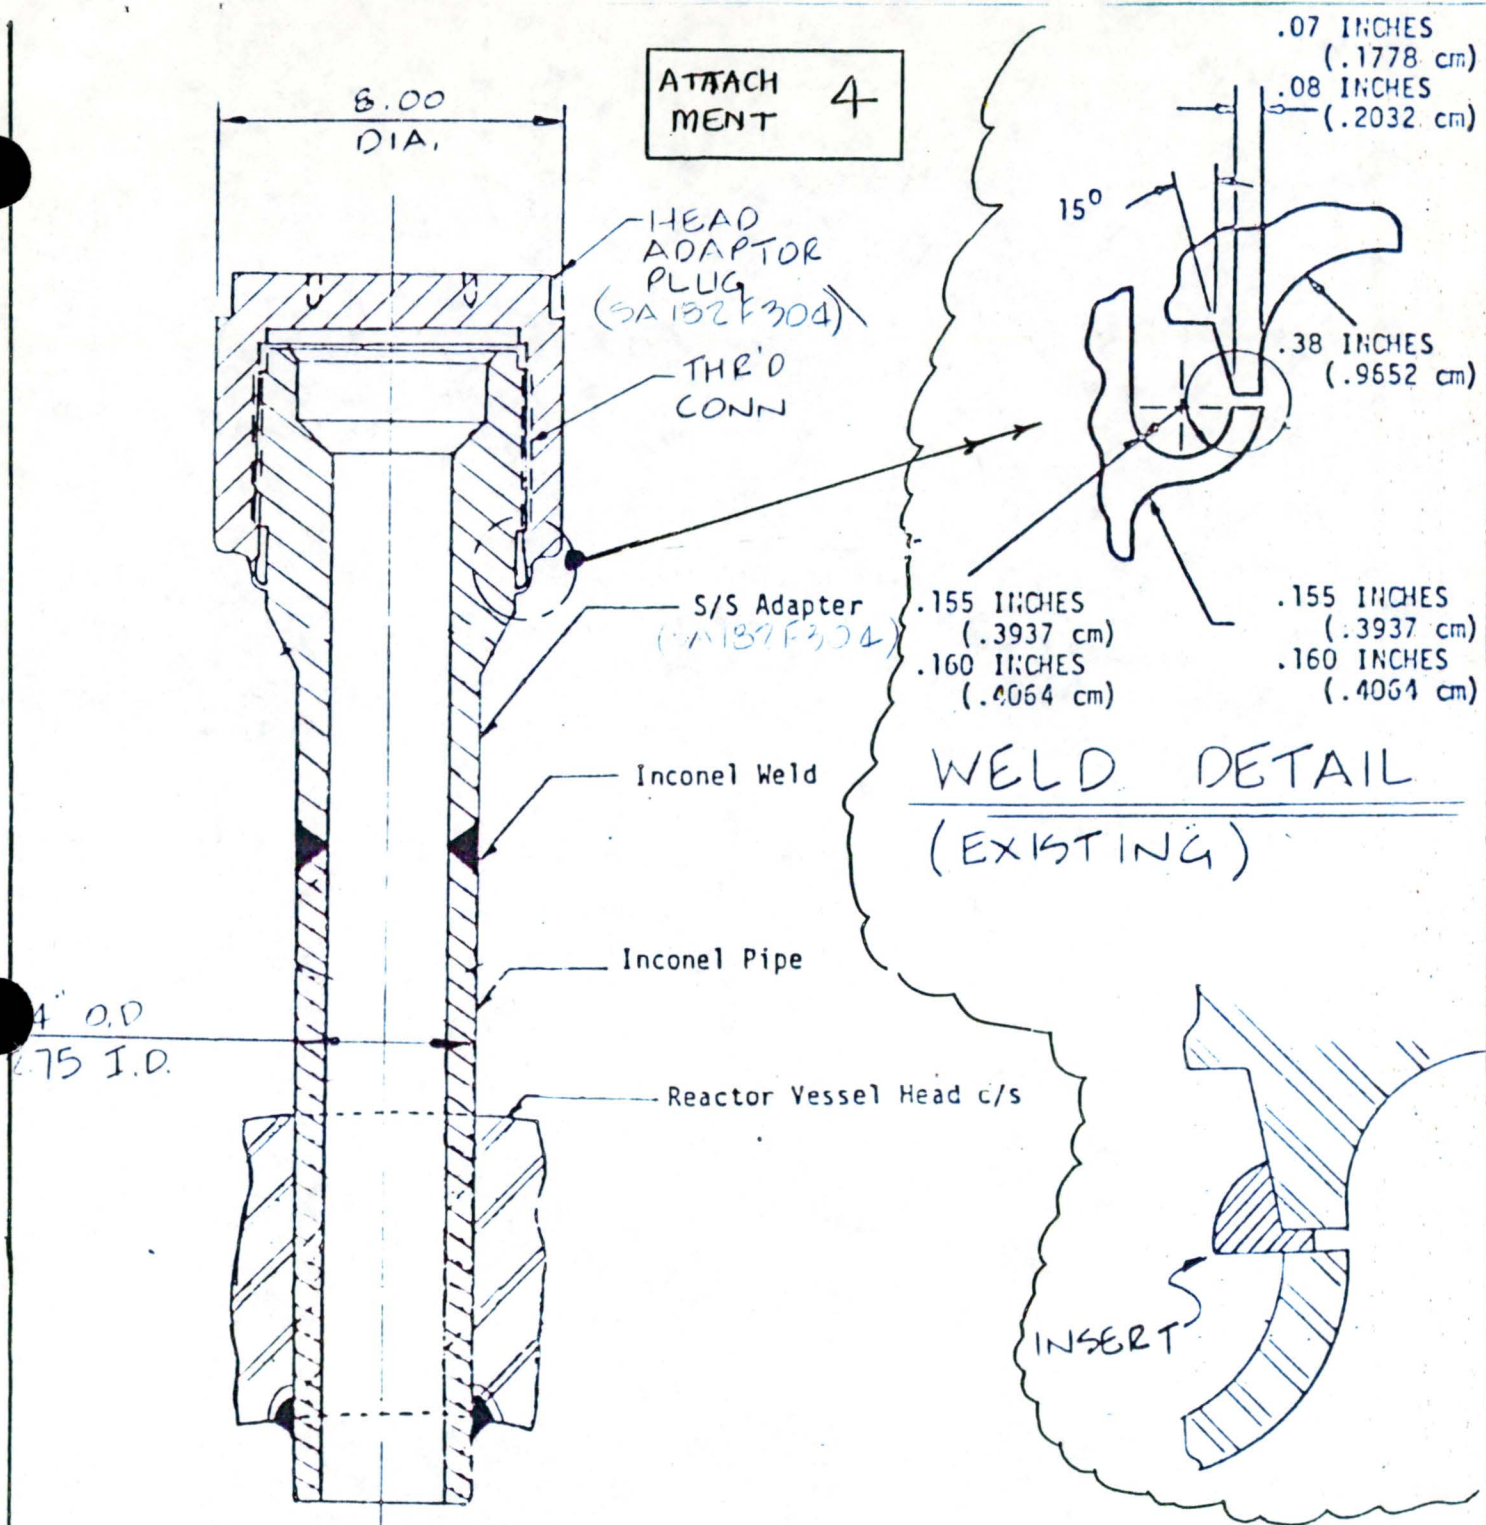
ATTACHMENT 4

The four inch diameter inconel reactor vessel head penetrations each have a stainless steel adapter welded on the end. The adapter has a male ACME thread and integral canopy as shown in Attachment 4. Full or part length CRDMs and spare adapter plugs have a matching female thread and a small appurtenance to match up to the canopy on the adapter. The CRDM pressure housing, spare adapter plug, and instrument pressure housings are threaded into the adapter and the canopy is seal welded.

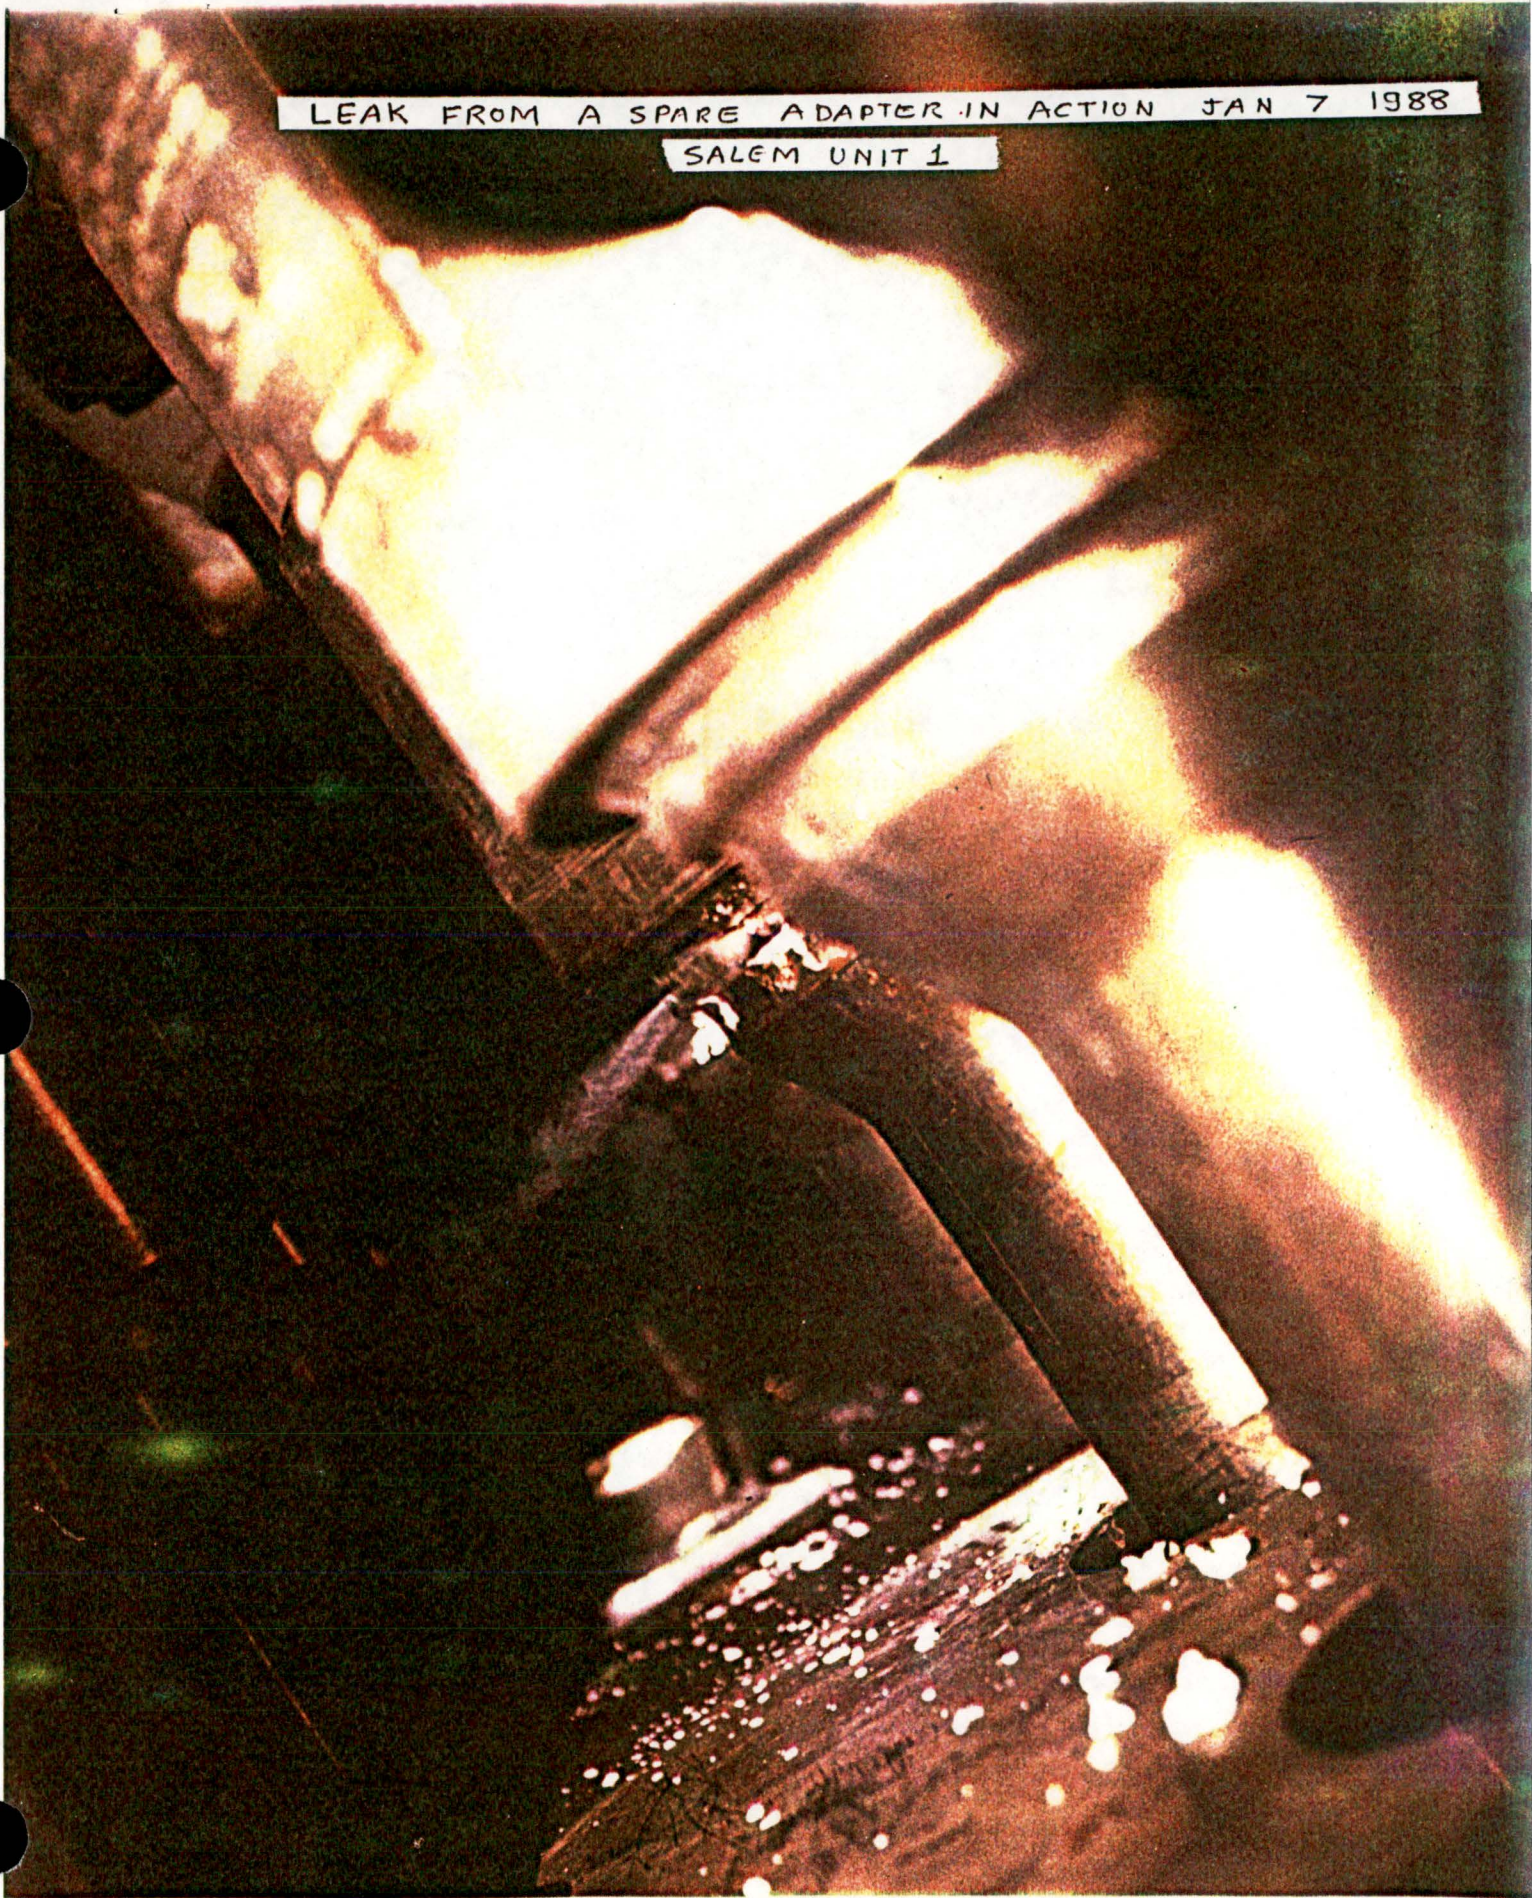
LEAK FROM A SPARE ADAPTER IN ACTION JAN 7 1988

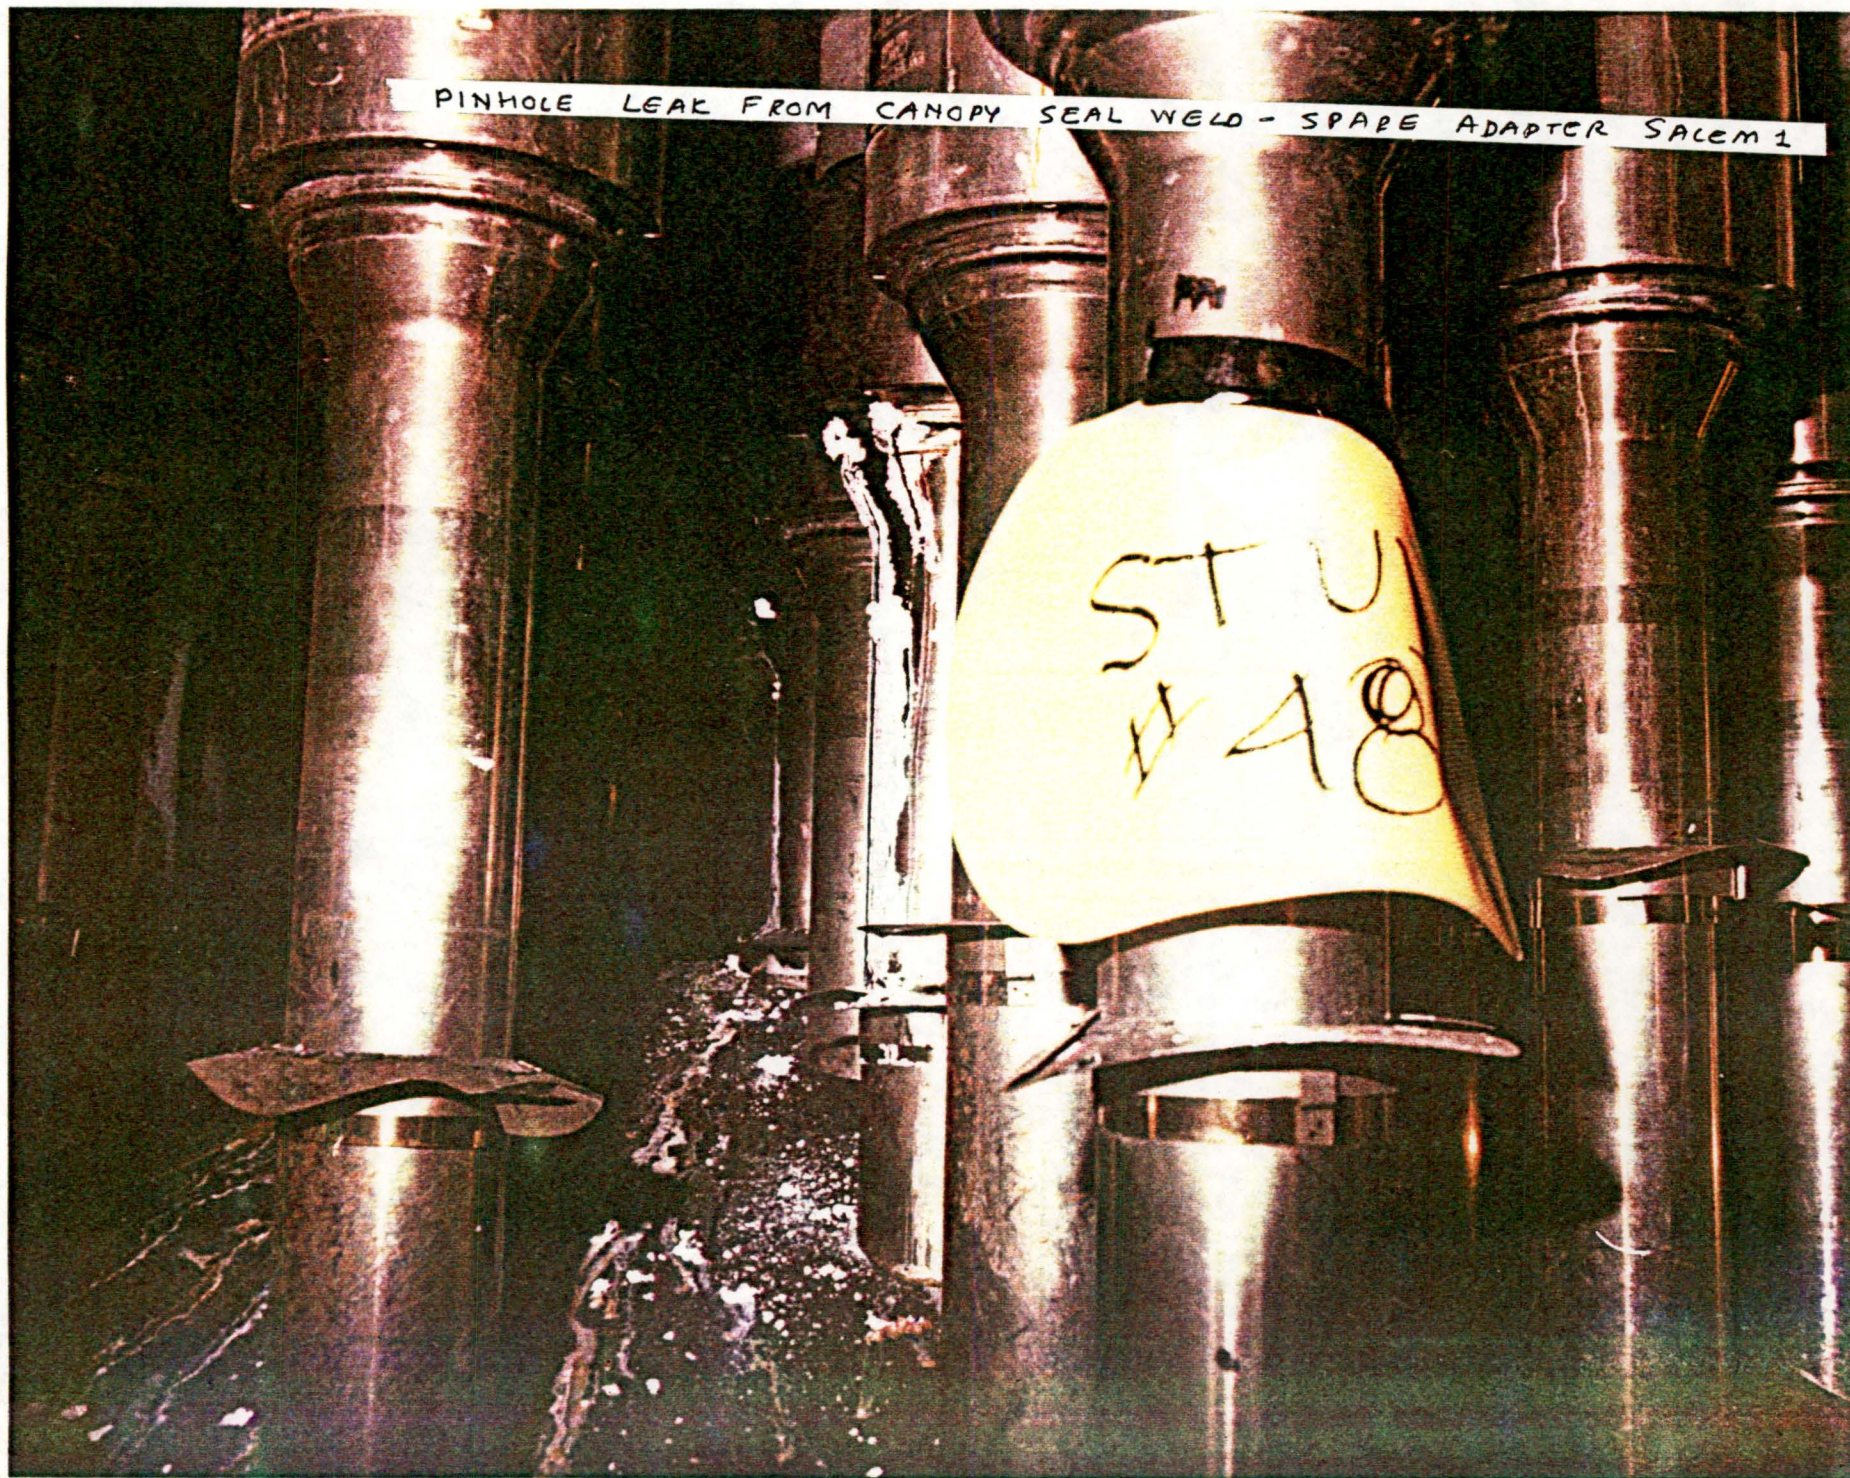
Visual examination of the Salem 1 defects indicates that they are pinhole leaks, in some cases multiple pinholes, located in or near the seal weld crown on the canopies. In no cases were linear, or crack-like indications found.

PINHOLE LEAK FROM CANOPY SEAL WELD - SPACE ADAPTER SALEM 1

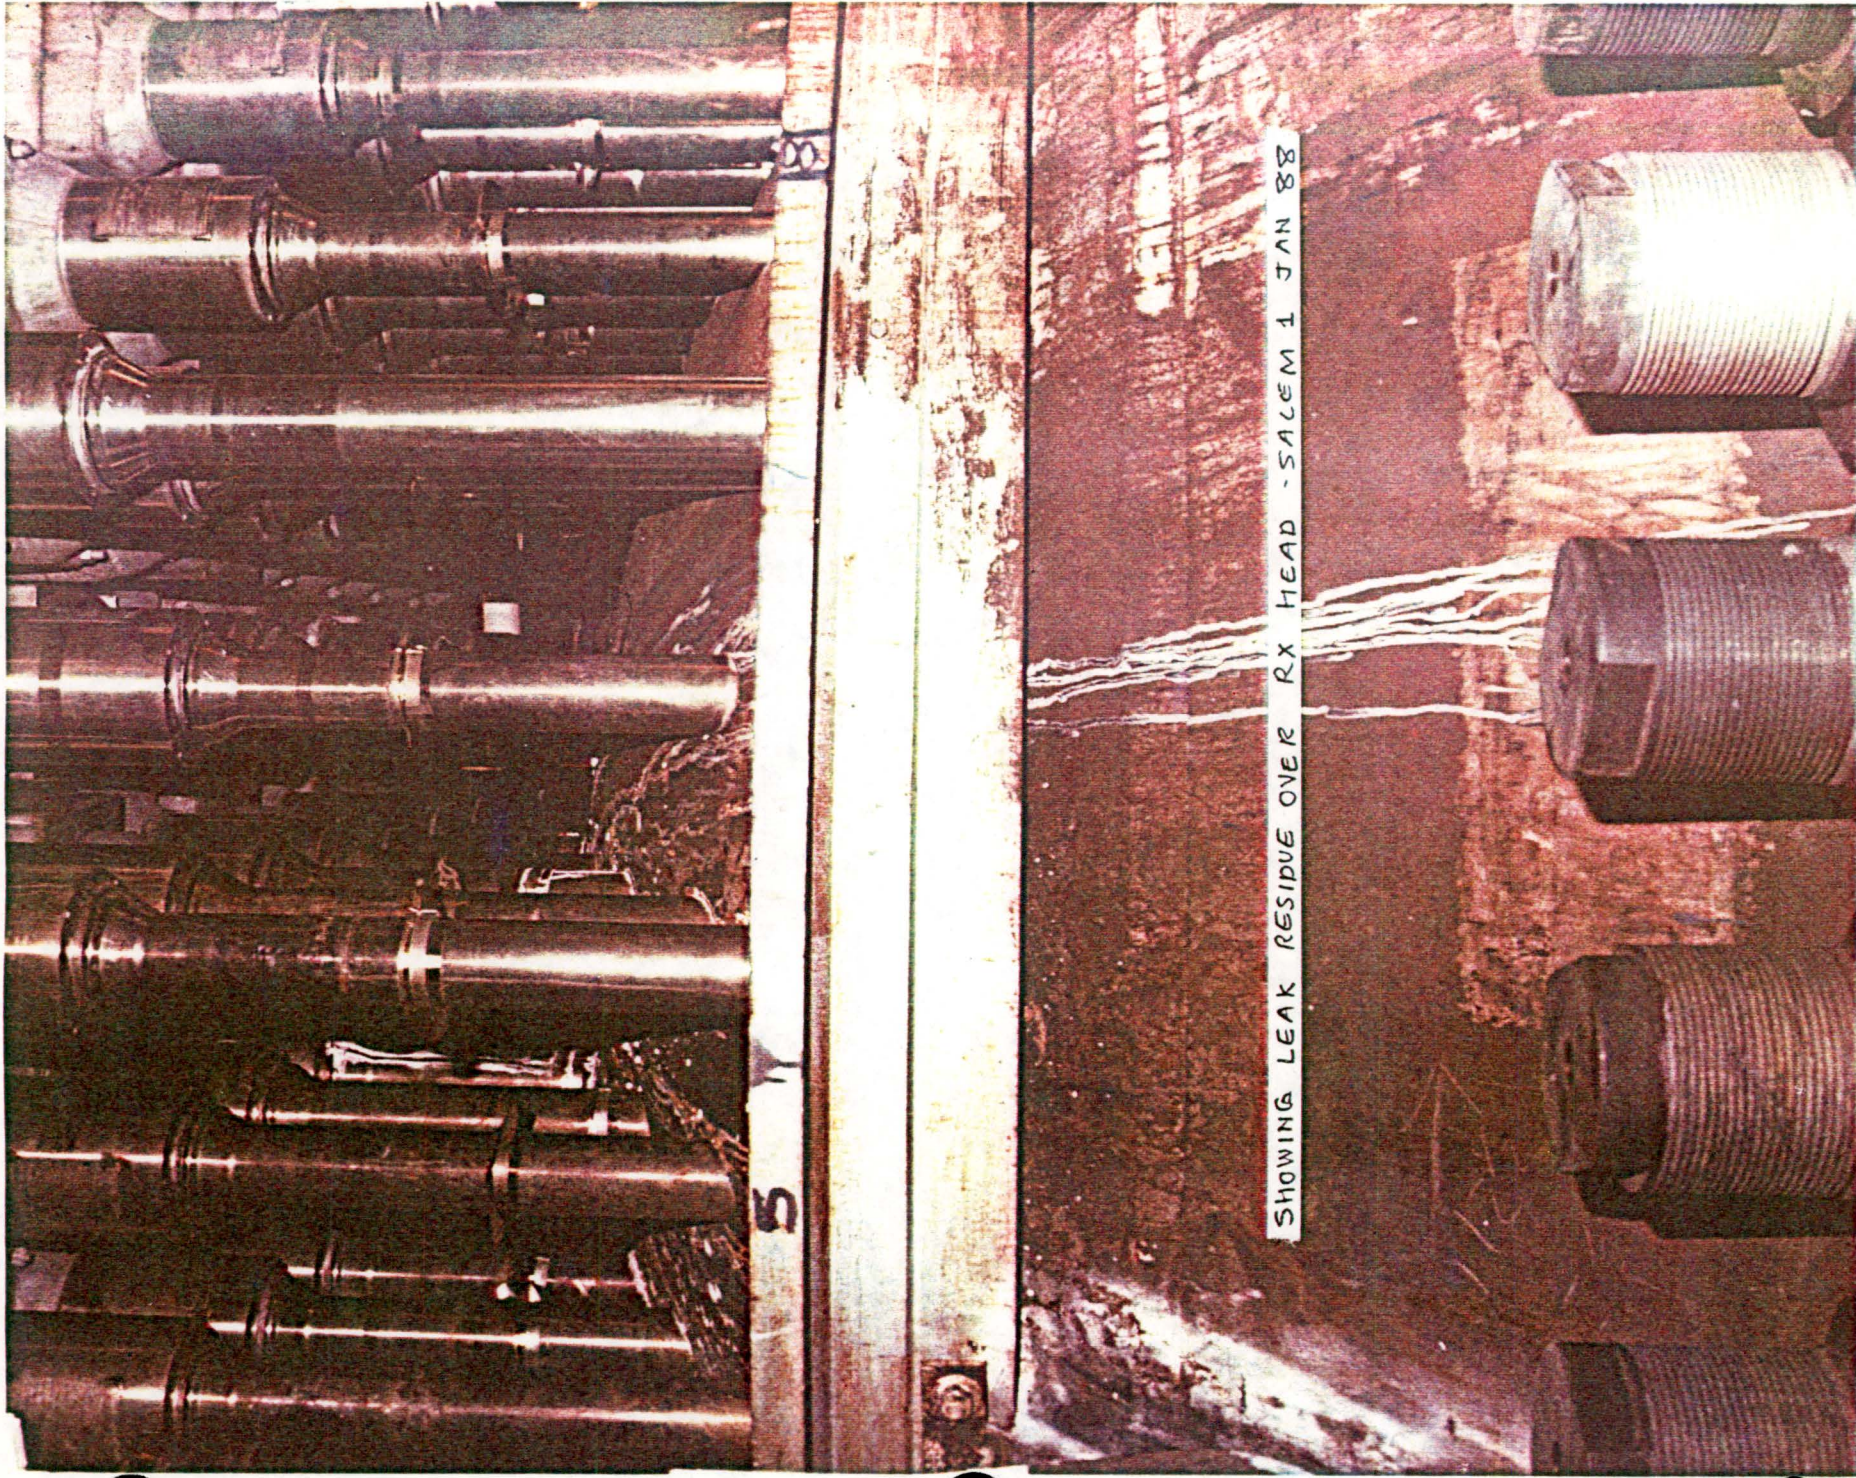
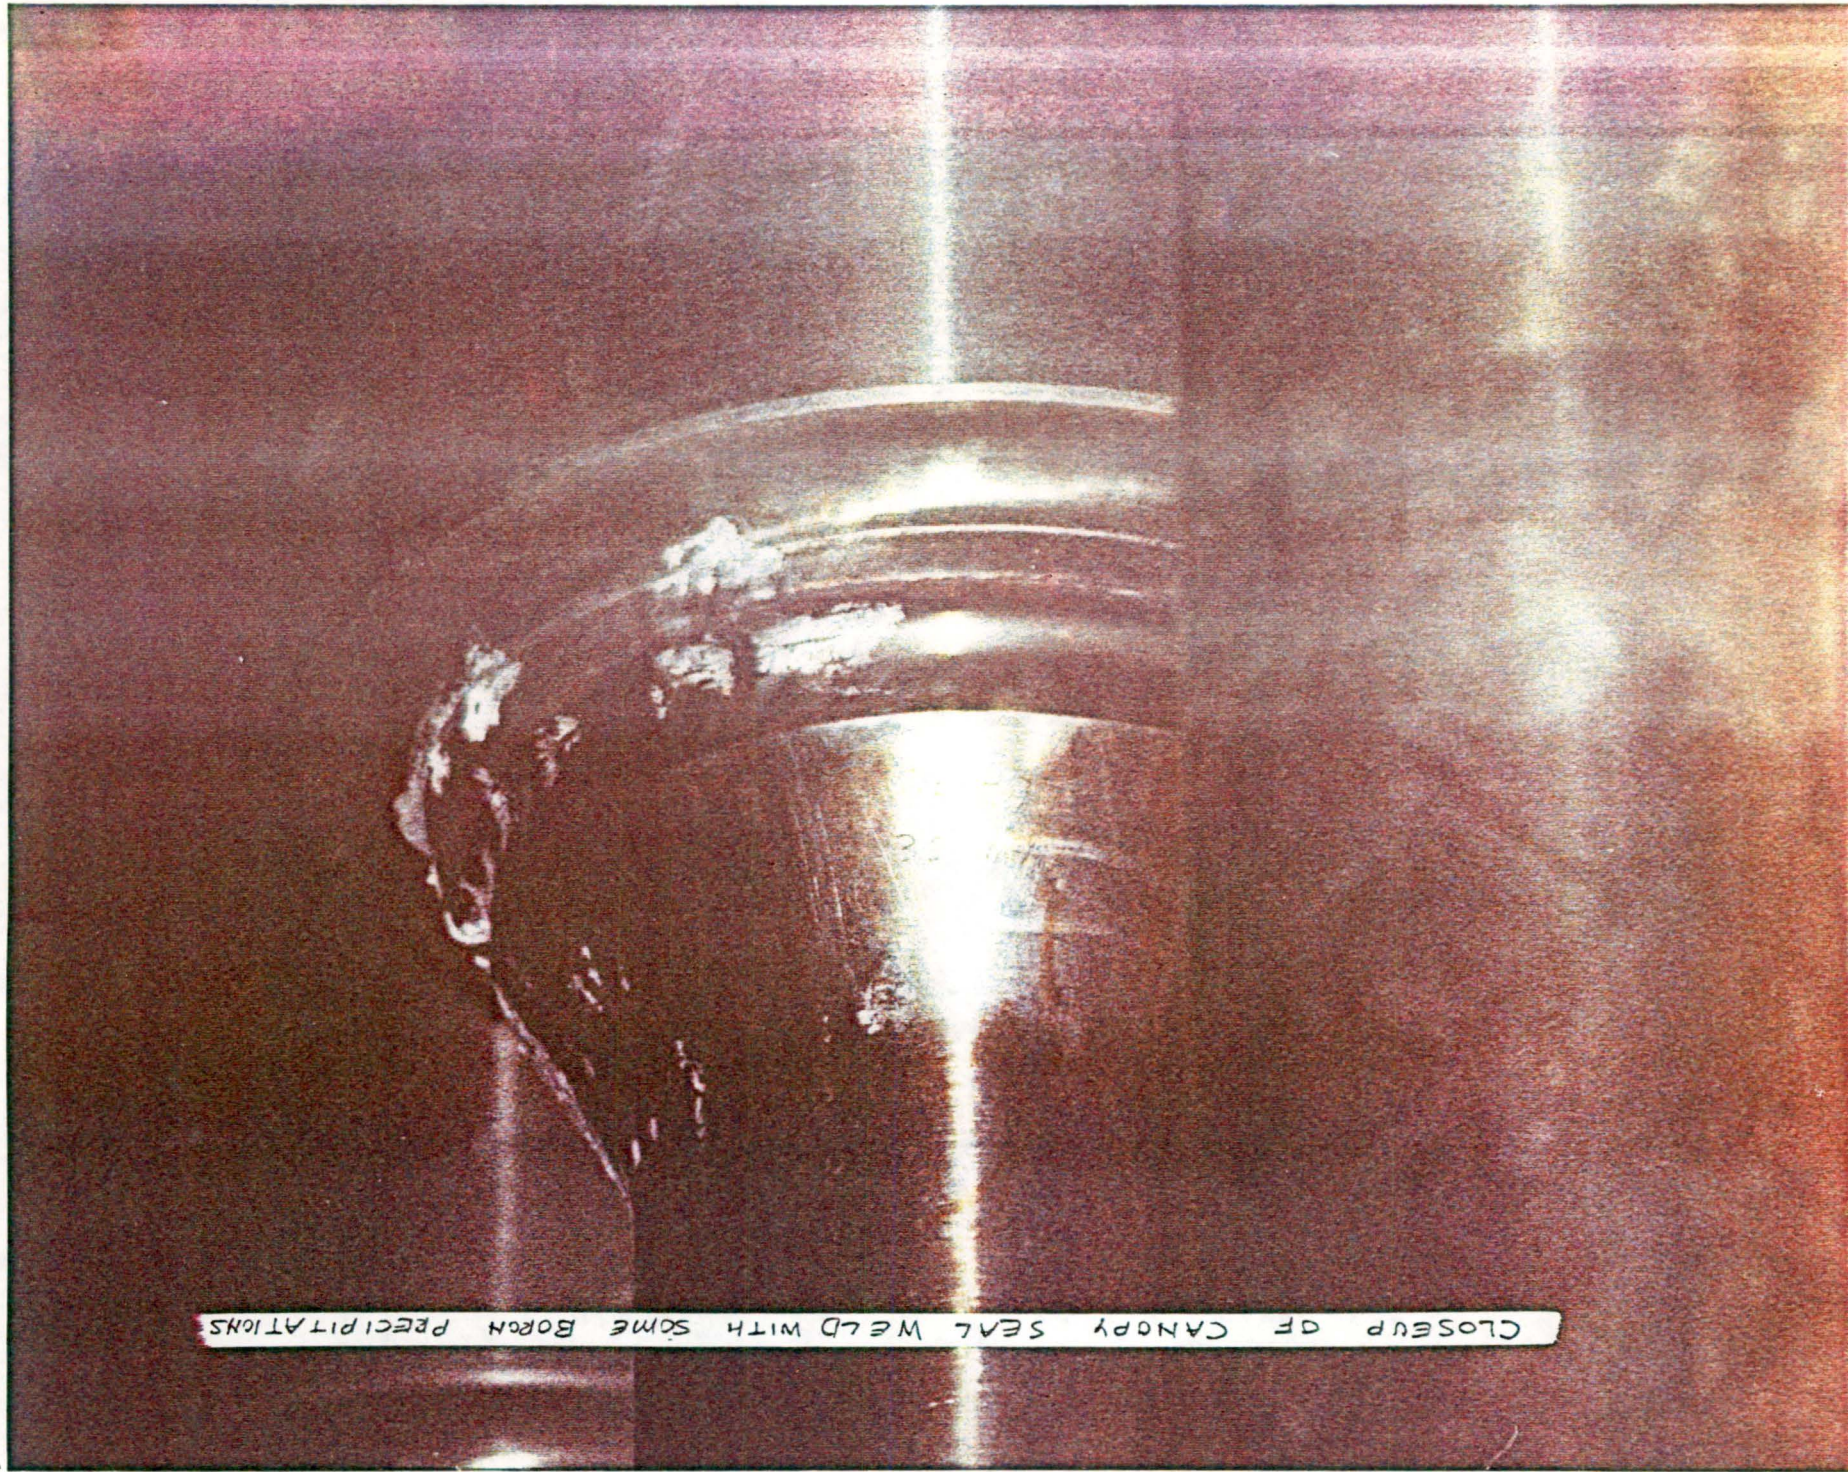
CLOSEUP OF CANOPY SEAL WELD WITH SOME BORON PRECIPITATIONS
