Public Service
Electric and Gas
Company

November 2, 1988
NLR-N88161

RESPONSE TO NRC BULLETIN 88-09
SALEM GENERATING STATION
UNIT NOS. 1 AND 2
DOCKET NOS. 50-272 AND 50-311

RESPONSE TO BULLETIN 88-09

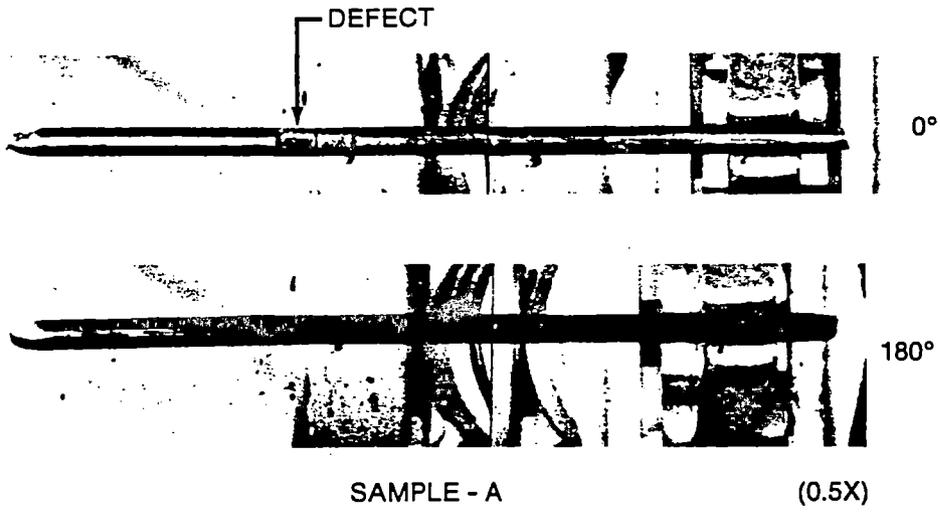
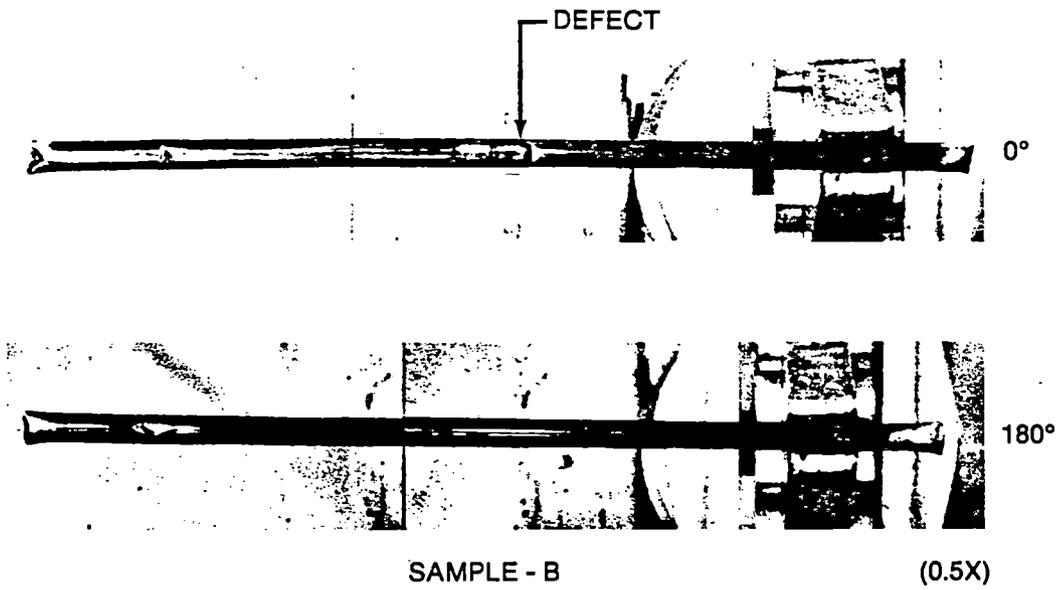
FIGURE 2-1. OUTSIDE DIAMETER SURFACE APPEARANCE OF THE AS-RECEIVED THIMBLE TUBE SAMPLES A AND B.

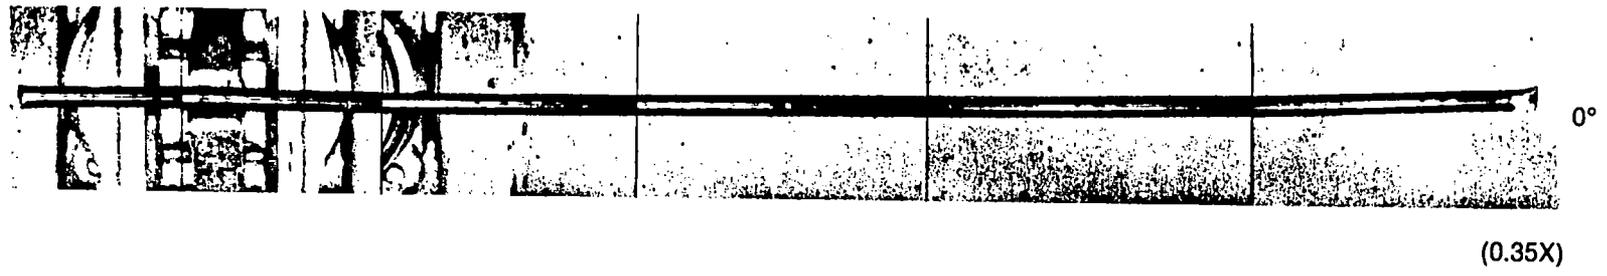
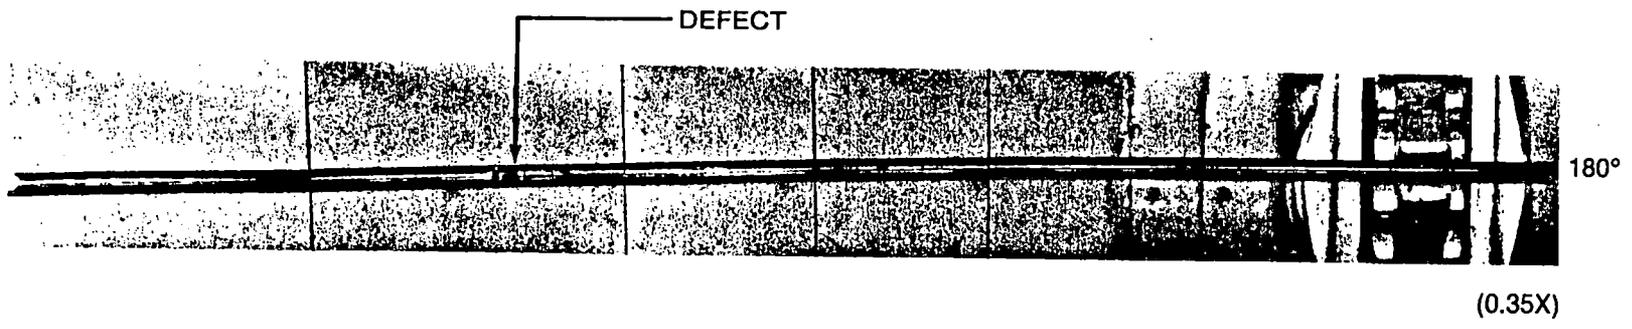
FIGURE 2-2. OUTSIDE DIAMETER SURFACE APPEARANCE OF THE AS-RECEIVED THIMBLE TUBE 'C'.

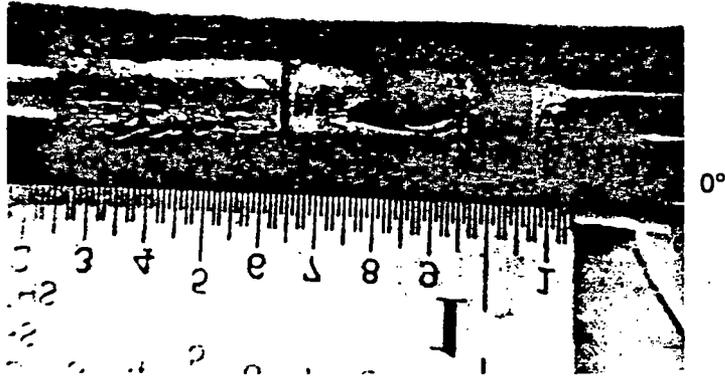
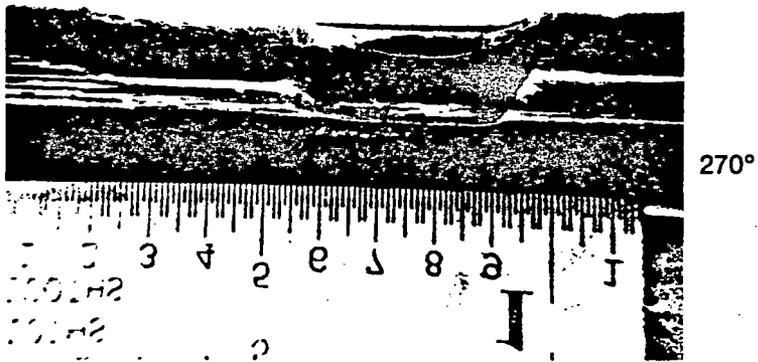
FIGURE 2-3.

**CLOSE-UP VIEW OF THE OUTSIDE DIAMETER SURFACE
APPEARANCE OF THE DEFECT REGION IN THE
AS-RECEIVED THIMBLE TUBE 'B'.**

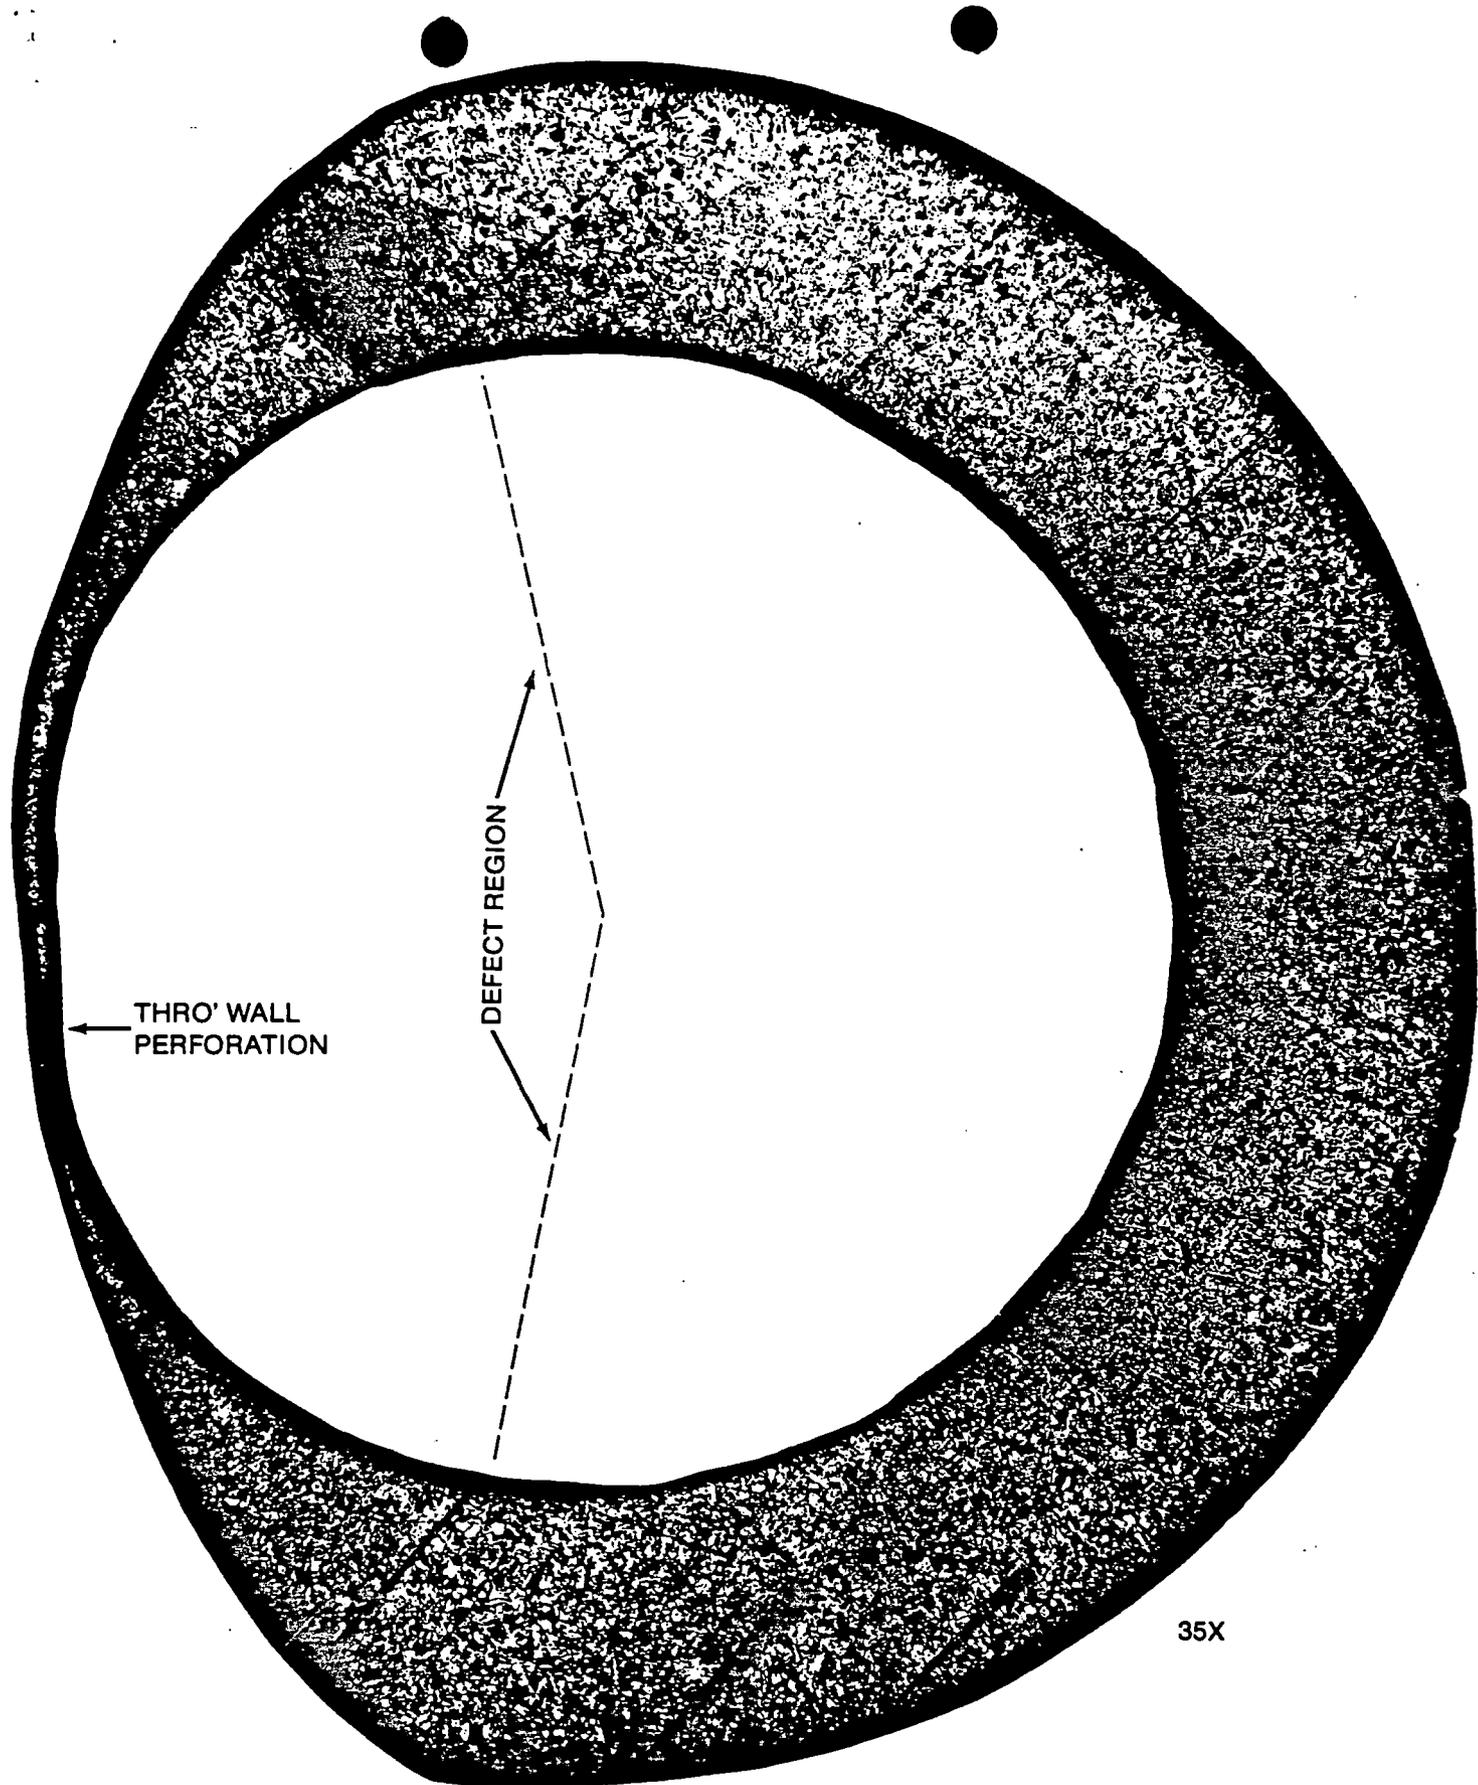
FIGURE 2-9.

MONTAGE OF LIGHT OPTICAL METALLOGRAPHS TAKEN ON A TRANSVERSE SECTION THROUGH THE DEFECT REGION OF THE TUBE SAMPLE 'A'.

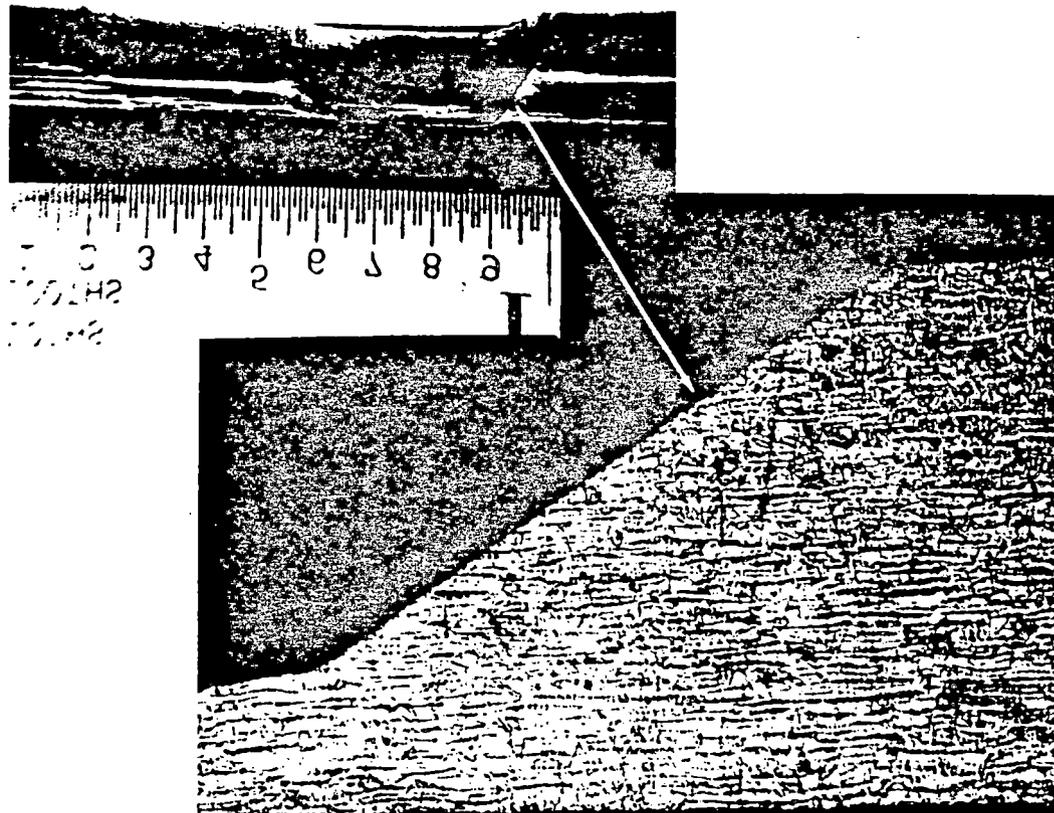
FIGURE 2-10. LIGHT OPTICAL METALLOGRAPH ON AN AXIAL SECTION OF THE TUBE 'B' AT THE DEFECT REGION.

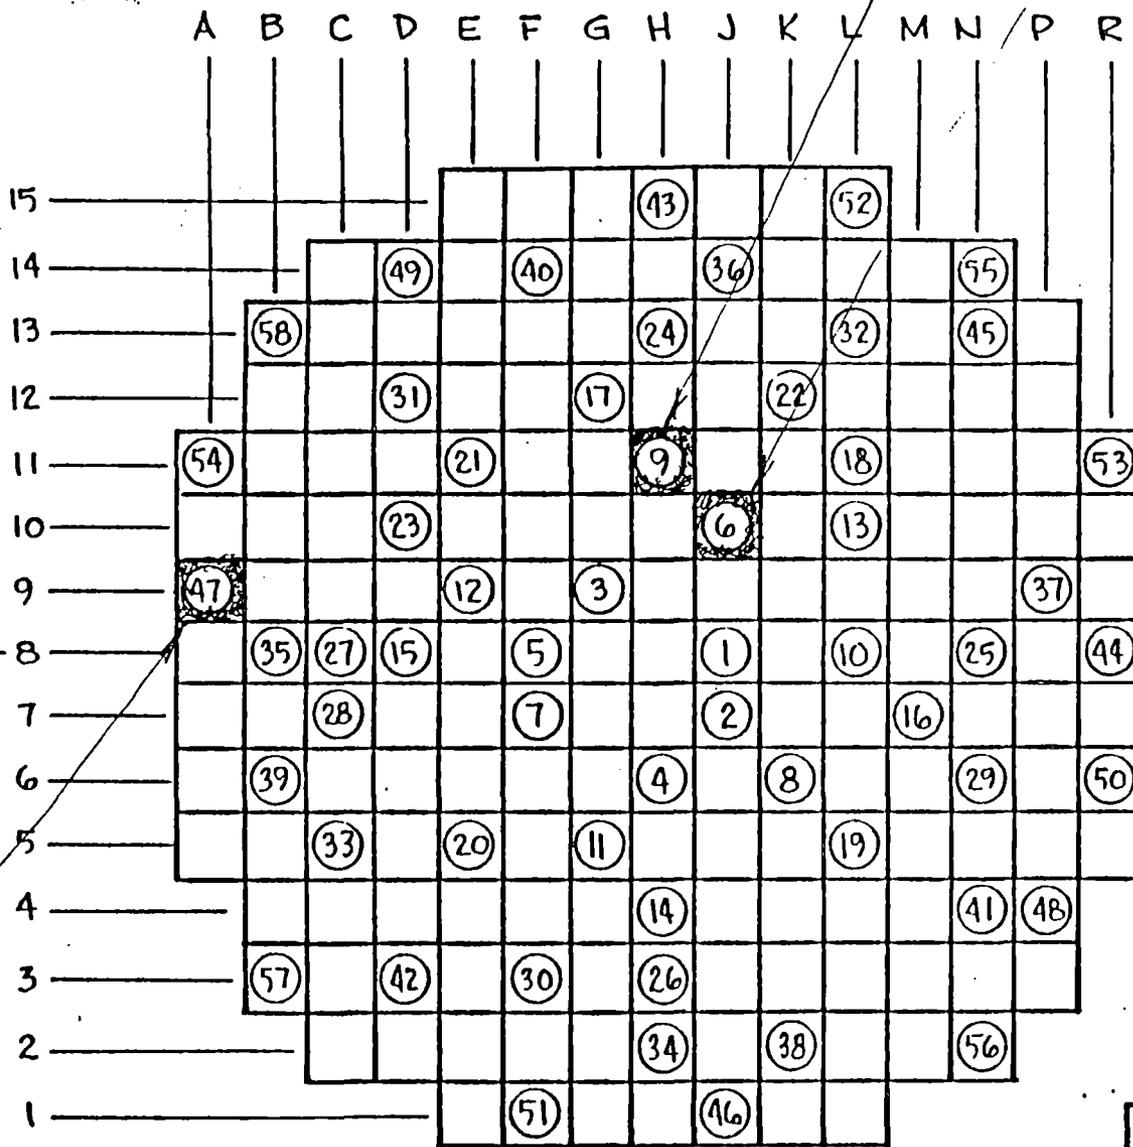
LOCATIONS OF UNIT 1 THIMBLE TUBE FAILURES (1981)

PSE&G has conducted an inspection program since October 1982. Salem Unit 1 began commercial operation in June 1977. During the third operating cycle in 1981, three thimble tube leaks developed. These leaks were isolated by closing the manual isolation valve for each line located in the seal table room. The cause of these leaks has since been determined to be flow induced vibrations between the core support plate and fuel assembly nozzles. During the third refueling outage, (January 1982) all thimble tubes were replaced in kind. During each subsequent refueling outage the thimble tubes have been eddy current tested to ensure that the thimbles were not degraded to an unacceptable degree. The results of the Salem Unit 1 inspection program are summarized below.

"Failed" 7/82

"Failed" - 3/82

"Failed" - 10/82
