U.S. NUCLEAR REGULATORY COMMISSION
REGION I

Report No. 50-272/89-17

Facility Name: Salem Unit No. 1

Areas Inspected: Loss of RHR pump event on May 20, 1989 due to inadvertent nitrogen injection from an accumulator and the licensee action associated with it.

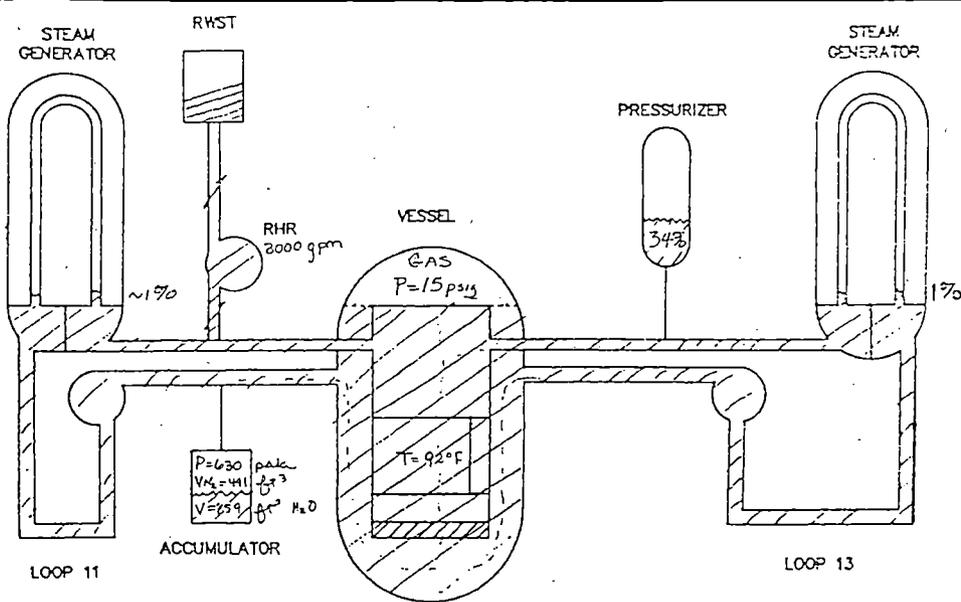
FIGURE 1

RCS VOLUME: 11,905 CFT
 AIR IN RCS: 4,086 CFT
 NITROGEN IN RCS: 0 CFT

TIME 9:25 am

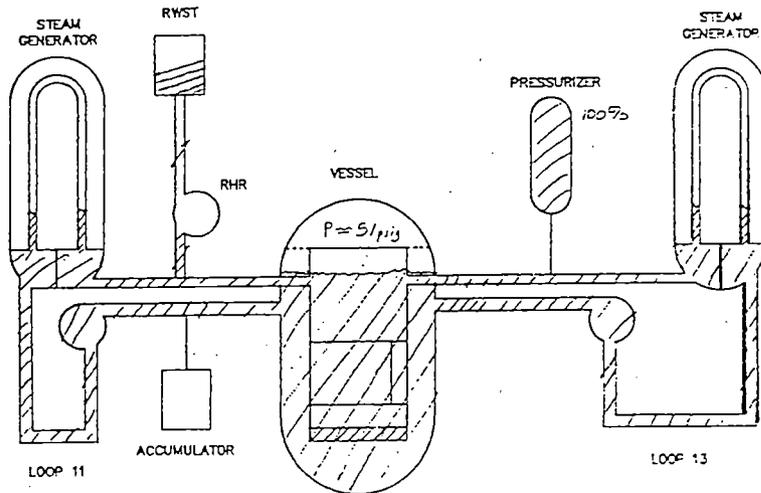
FIGURE 2

NITROGEN IN RCS: 2,307 CFT

TIME 9:27 am

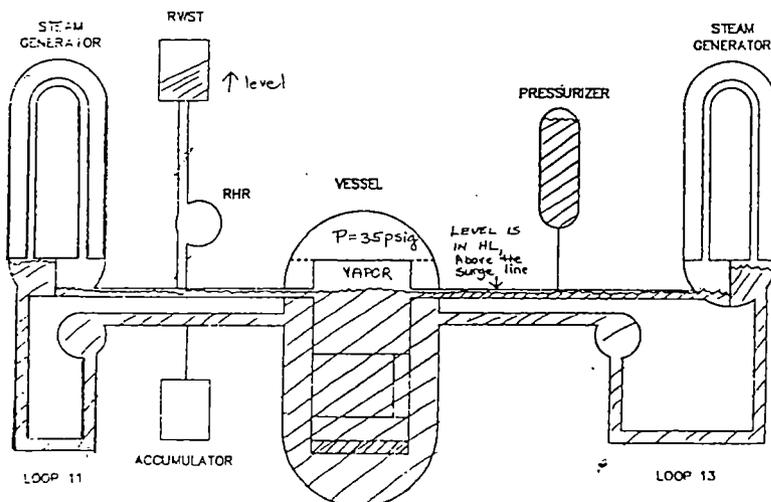
FIGURE 3

RHR PUMP IS GAS BOUND

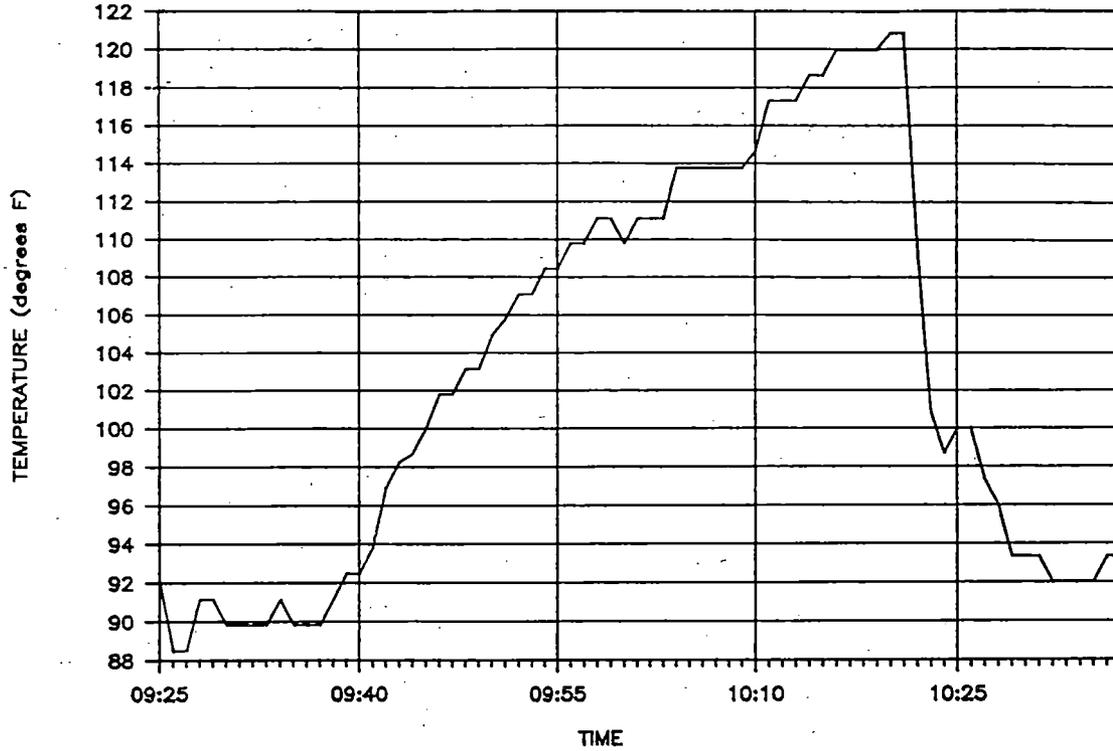
FIGURE 4

INCORE TEMP T21

CORE LOC E-11

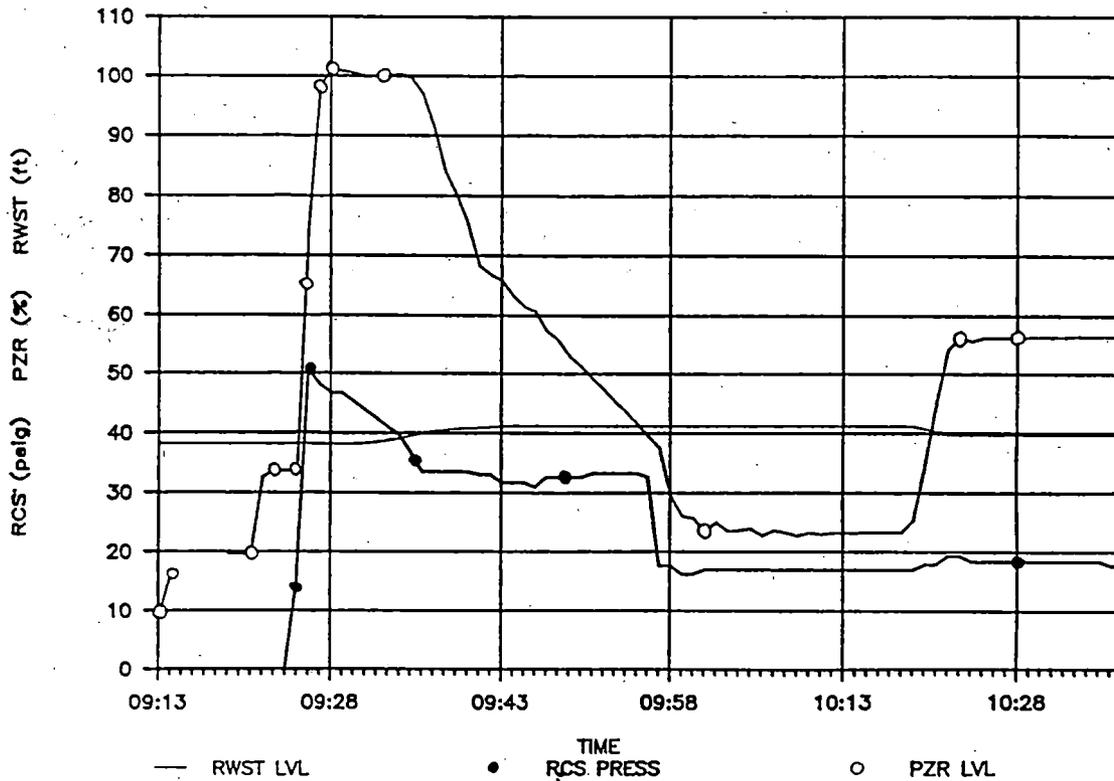
FIGURE 5

RWST & PZR LEVEL and RCS PRESSURE
