U. S. NUCLEAR REGULATORY COMMISSION

Report No. 50-272/89-11
50-311/89-10

Facility: Salem Nuclear Generating Station - Units 1 and 2

Inspection Summary:
Inspection 50-272/89-11; 311/89-10 on May 1, 1989 - June 5, 1989

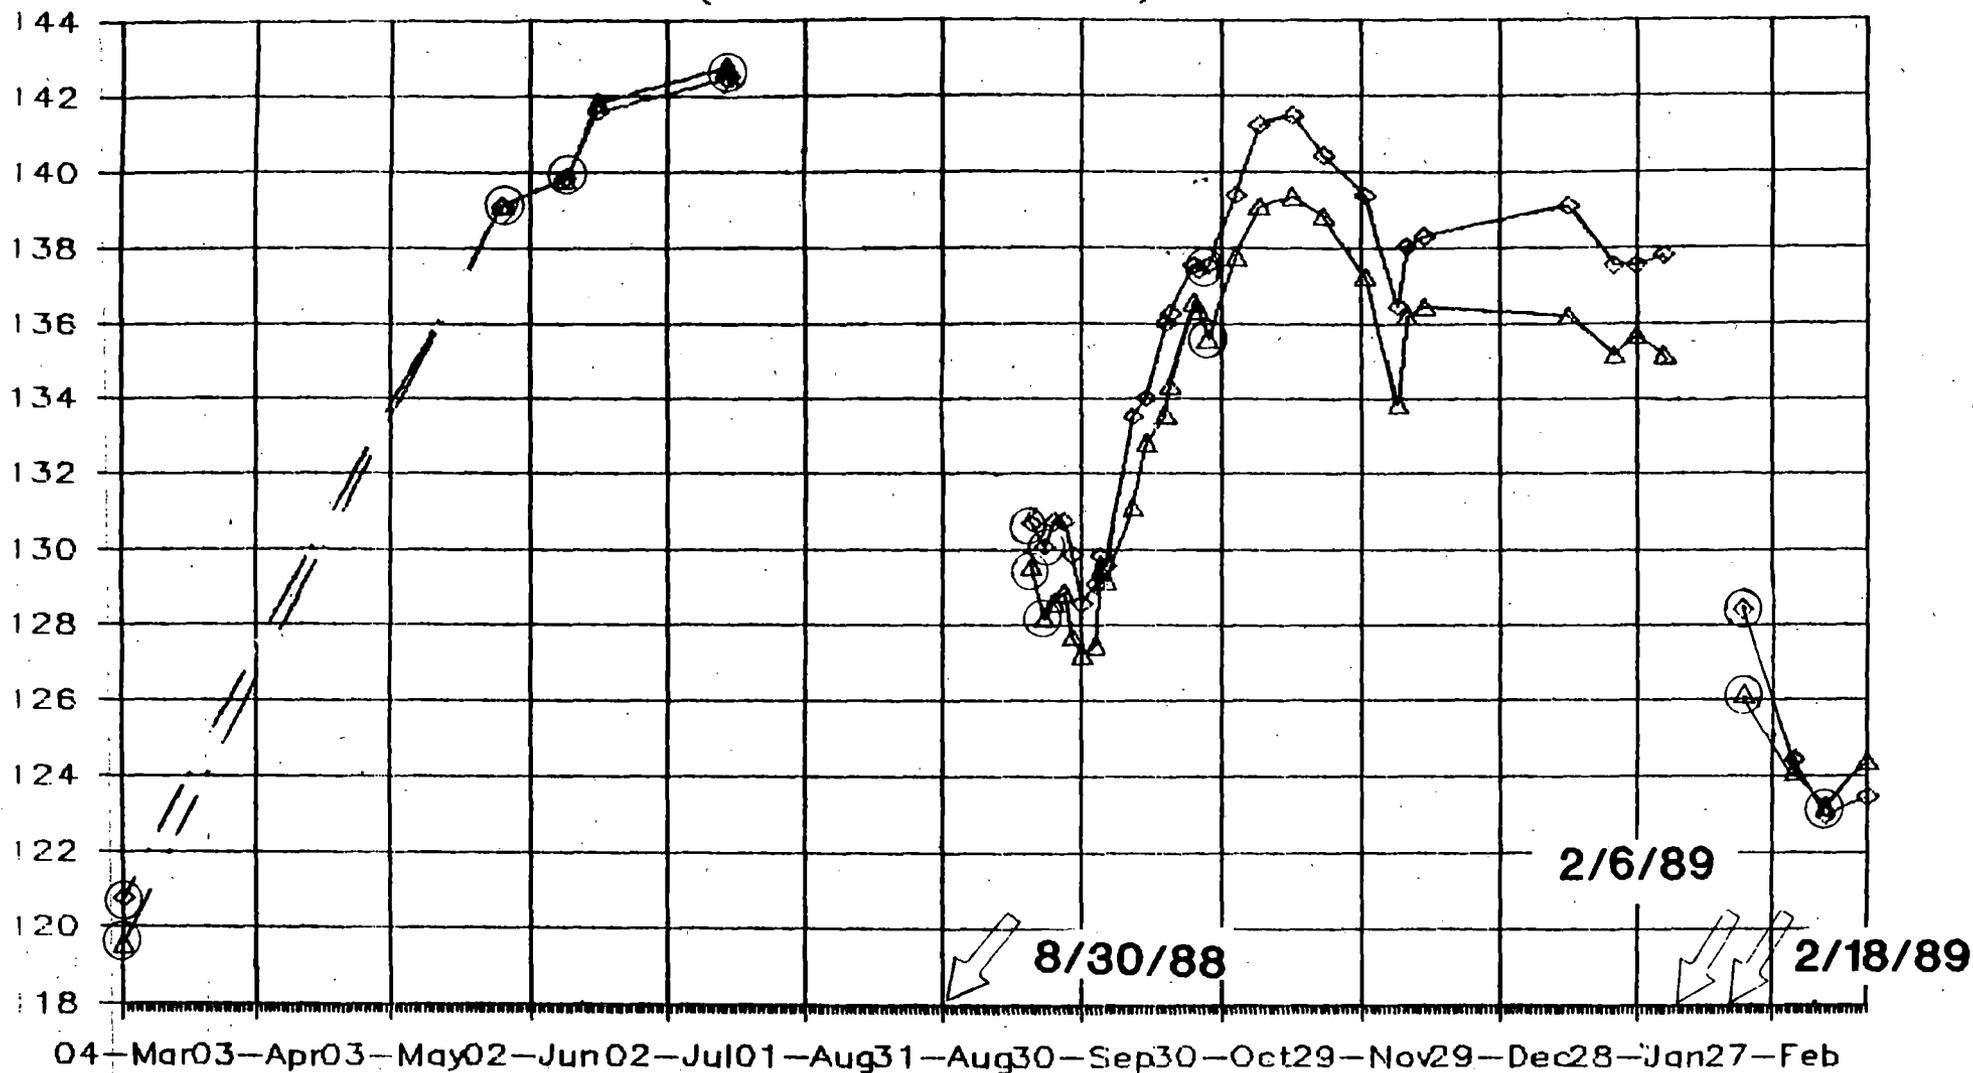
12 STM. GEN. STEAM FLOW

HAVE RECALIBRATED THE
SYSTEM APPROXIMATELY
ONCE PER CYCLE PRIOR
TO CYCLE 8

(100% DELTA P VALUES)
