U.S. NUCLEAR REGULATORY COMMISSION
REGION I INSPECTION REPORT

Report No. 50-272/89-27

Facility Name: Salem Unit No: 1

NRC ENFORCEMENT CONFERENCE

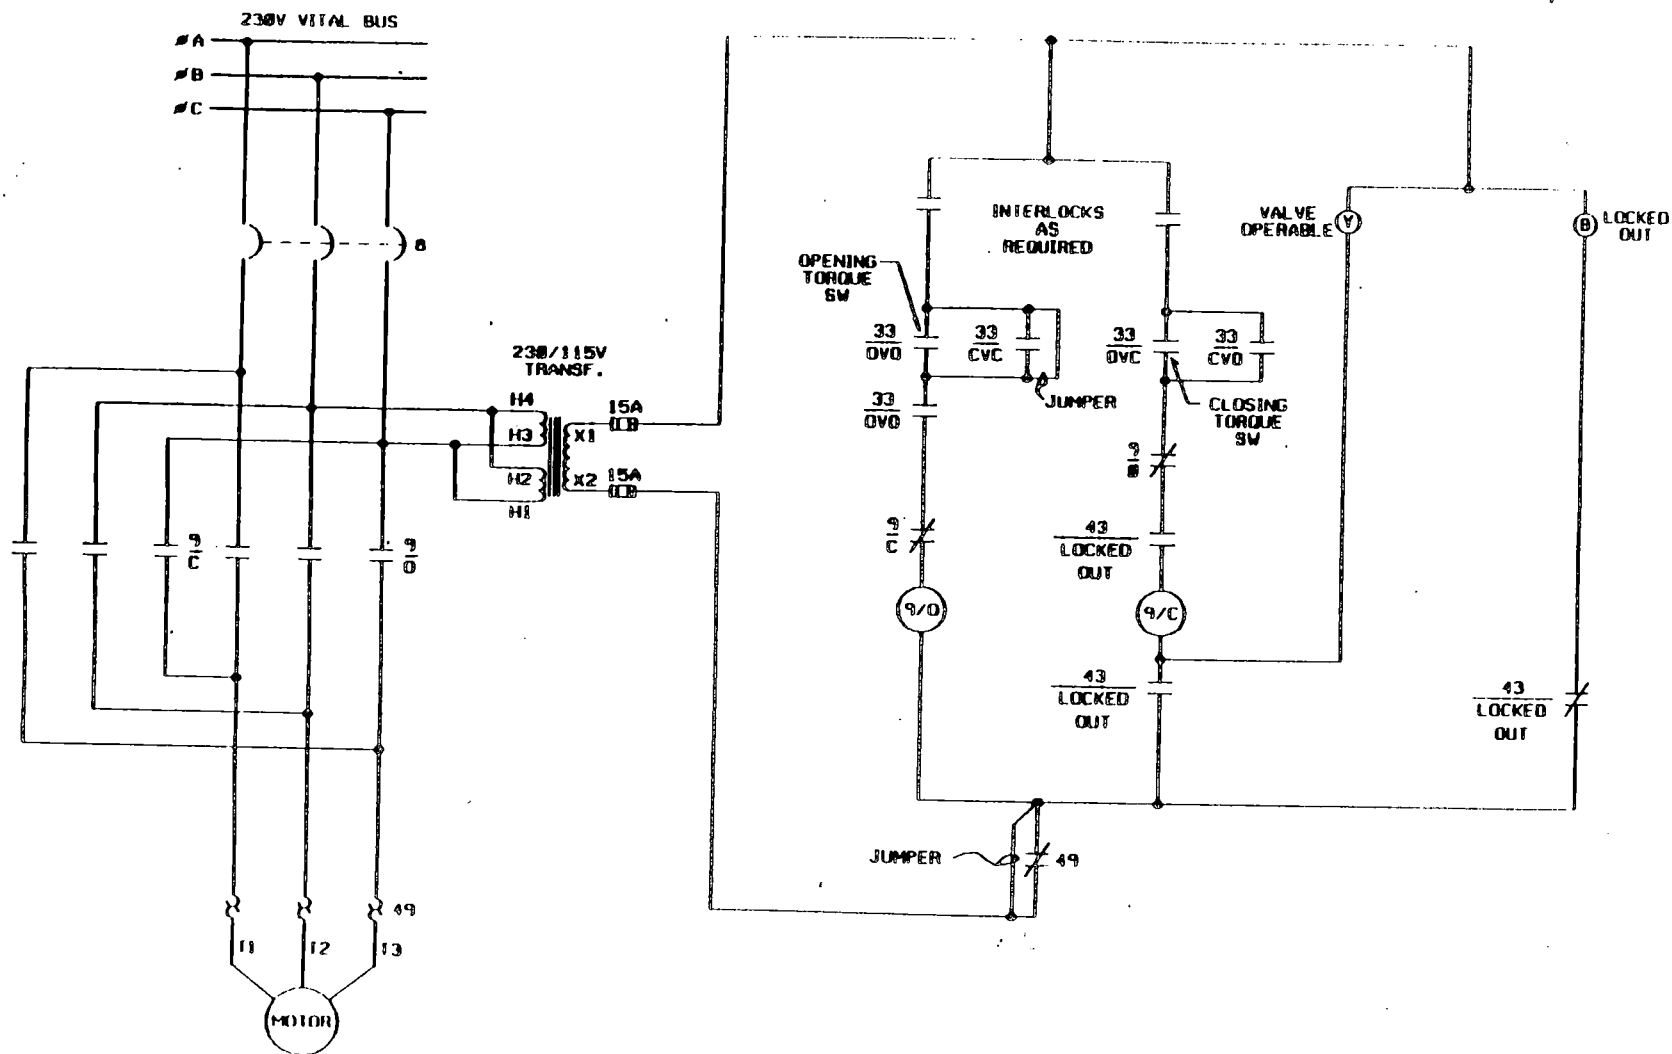
LICENSIED DESIGN

- CONTROL POWER LOCKOUT SWITCHES MET REQUIREMENTS
 - o REQUIRED TWO OPERATOR ACTIONS TO OPERATE VALVE
 - o SINGLE ELECTRICAL FAULT WOULD NOT REPOSITION VALVE

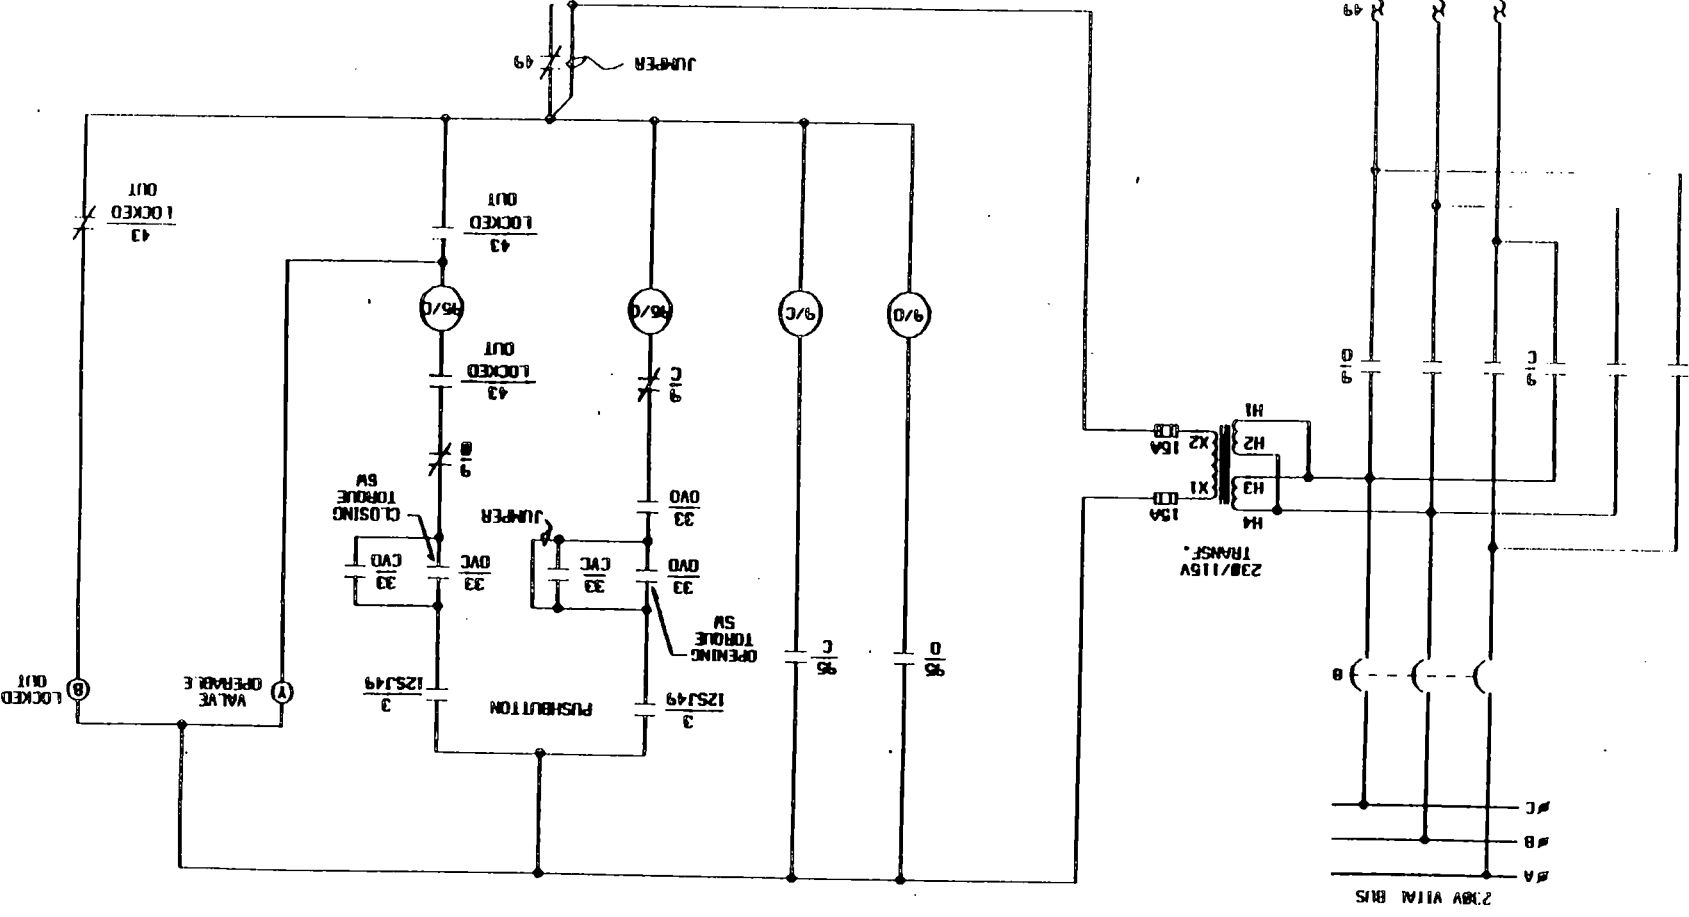
CURRENT INSTALLATION

- FAILURE TO IDENTIFY THAT DCR 1EC-2295 FOR UNIT 1 AND 2EC-2295 FOR UNIT 2 CONTAINED A USQ BY INTRODUCING A POTENTIAL SINGLE FAILURE WHICH COULD HAVE JEOPARDIZED THE ABILITY OF THE ECCS SYSTEMS TO PERFORM THEIR SAFETY FUNCTION DURING A LOCA

- EXECUTE MODIFICATIONS TO SJ49 CIRCUITS TO REESTABLISH ORIGINAL DESIGN REQUIREMENTS. TO BE ACCOMPLISHED DURING THE NEXT REFUELING OUTAGES.

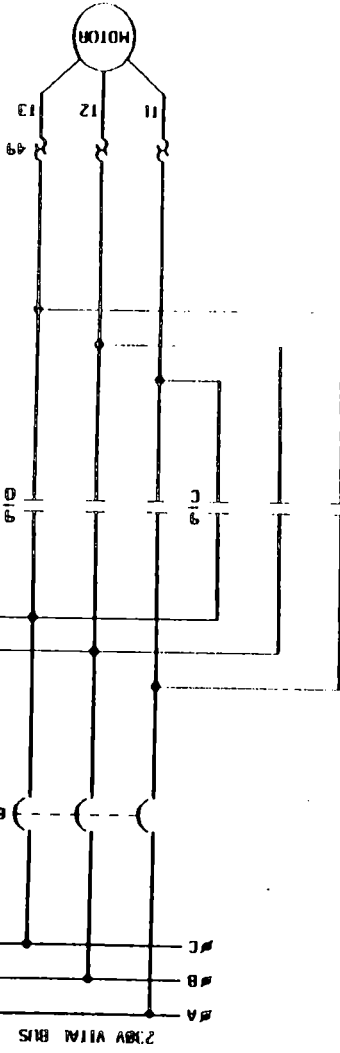
SJ49 MOV 230V POWER LOCKOUT

LOCKED OUT
VALVE OPERABLE

LOCKED OUT
LOCKED OUT

- * TAGGED SJ49 MOTOR BREAKERS IN OPEN POSITION TO ELIMINATE SINGLE FAILURE CONCERN.
- * REVISED OPERATOR LOGS TO REQUIRE VERIFICATION OF SJ49 OPEN POSITION, EACH SHIFT.
- * CONDUCTED BRIEFINGS WITH SHIFT PERSONNEL.
- * REVISED EOP'S TO ENSURE SJ49'S ARE POWERED-UP FOR SWITCHOVER TO RECIRCULATION.
