Public Service
Electric and Gas
Company

RESPONSE TO NRC BULLETIN 93-02
DEBRIS PLUGGING OF EMERGENCY CORE COOLING SUCTION STRAINERS
SALEM AND HOPE CREEK GENERATING STATIONS
DOCKET NOS. 50-272, 50-311, AND 50-354

ATTACHMENT 1
RESPONSE TO NRC BULLETIN 93-02
SALEM UNITS 1 AND 2

ATTACHMENT 2
RESPONSE TO NRC BULLETIN 93-02
HOPE CREEK

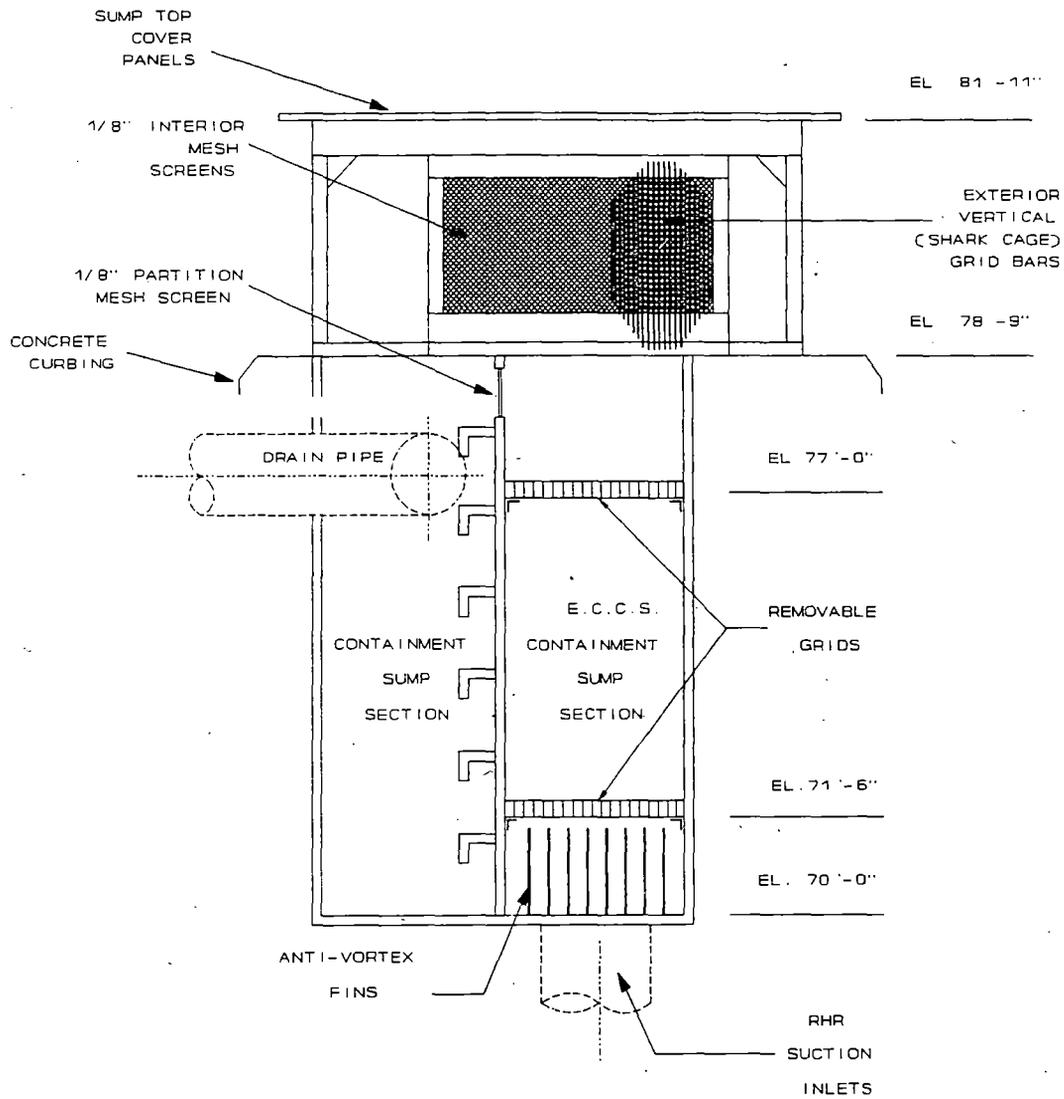
FIGURE - 1
CONTAINMENT SUMP

The impact of the bulletin on the Salem plants would be the potential for clogging of the containment sump intake. A diagram of the containment sump is provided in Figure 1. The containment sump is comprised of two subsections, the pocket sump which houses the containment sump pumps and the ECCS Section which supplies suction to the RHR pumps. A cage with an internal mesh screen and external metal bars covers the entire containment sump and is used to keep debris from entering the sump.

Although unlikely, should the fibrous filaments get through the roughing filter barriers, there is a very high probability that these fibers would be trapped by the fins of the cooling coils and not make it through the fan and out into containment. Should condensation draining from the coils after a LOCA event carry these filaments to the drain system and subsequently to the containment pocket sump, the ECCS suction would remain unaffected since an inner screen separates the two sump sections (see Figure 1 to this Attachment). ECCS suction through the cage would not be impaired.
