RESPONSE TO NRC BULLETIN 93-02
DEBRIS PLUGGING OF EMERGENCY CORE COOLING SUCTION STRAINERS
SALEM AND HOPE CREEK GENERATING STATIONS
DOCKET NOS. 50-272, 50-311, AND 50-354

ATTACHMENT 1
RESPONSE TO NRC BULLETIN 93-02
SALEM UNITS 1 AND 2

ATTACHMENT 2
RESPONSE TO NRC BULLETIN 93-02
HOPE CREEK

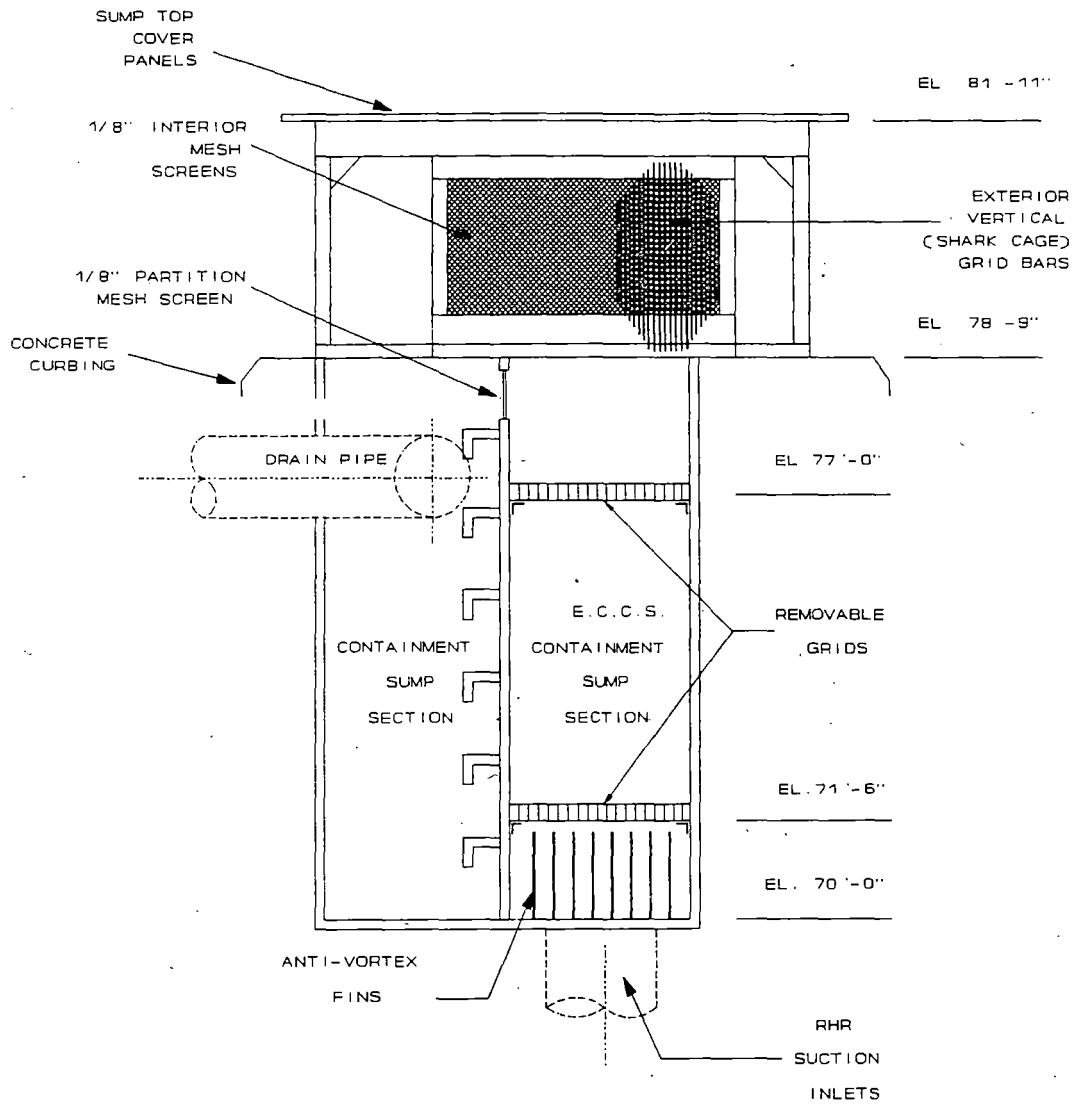
FIGURE - 1
CONTAINMENT SUMP

The impact of the bulletin on the Salem plants would be the potential for clogging of the containment sump intake. A diagram of the containment sump is provided in Figure 1. The containment sump is comprised of two subsections, the pocket sump which houses the containment sump pumps and the ECCS Section which supplies suction to the RHR pumps. A cage with an internal mesh screen and external metal bars covers the entire containment sump and is used to keep debris from entering the sump.

Although unlikely, should the fibrous filaments get through the roughing filter barriers, there is a very high probability that these fibers would be trapped by the fins of the cooling coils and not make it through the fan and out into containment. Should condensation draining from the coils after a LOCA event carry these filaments to the drain system and subsequently to the containment pocket sump, the ECCS suction would remain unaffected since an inner screen separates the two sump sections (see Figure 1 to this Attachment). ECCS suction through the cage would not be impaired.
