**Salem Generating Station**

LICENSEE EVENT REPORT 93-011-00

TITLE (4)  
**Reactor Trip from 85% Power; 4 Circulating Water System Circ. Pumps Tripped due to Debris.**

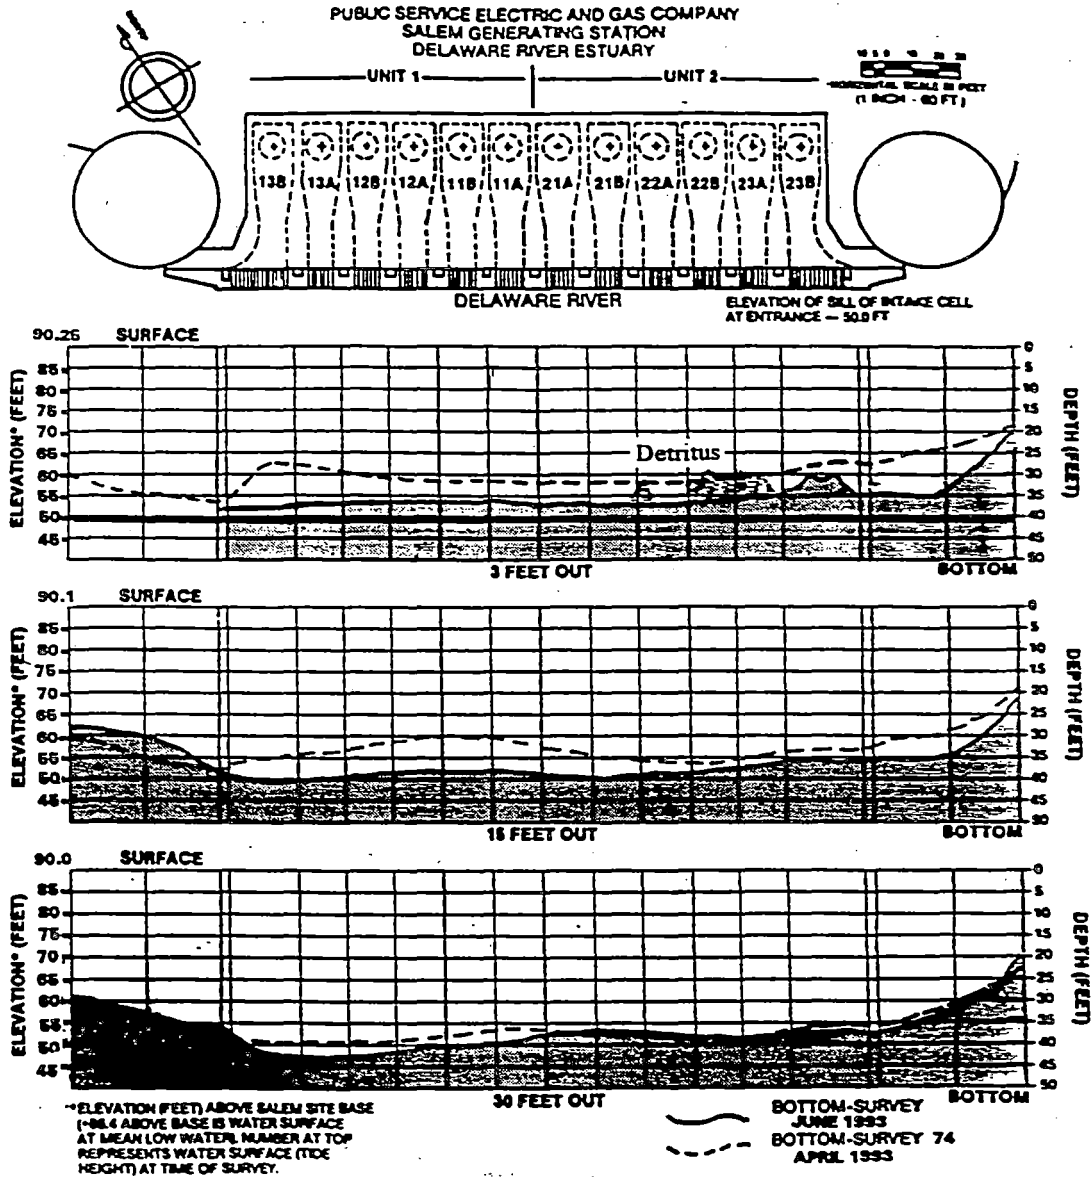
ATTACHMENT 1

Post-trip inspections of the CWS intake bay structure showed large mats of debris extending approximately 30 feet out from the structure at a depth of approximately twenty-five feet. Debris from the Unit 1 trash rack cleaning activity was removed by the traveling screens and the amount of differential pressure across the traveling screens decreased. The affected circulators on each Unit were then returned to service.

In December 1992, inspections did not reveal excessive buildup of grasses or debris. Throughout the Spring of 1993 severe weather conditions resulted in greater than normal quantities of marsh grasses

and debris coming down river and affecting CWS operation. Several times, unit power has been reduced to mitigate the effect of the debris buildup on the CWS traveling screens and to allow traveling screen and main condenser waterbox cleaning. [See Attachment 1 "Bathymetric Profiles In Front Of The Circulating Water Intakes - June 1993", which shows the extent of the debris (detritus) buildup prior to this event and following subsequent debris removal in June 1993].

Unit 1 circulator trash rack cleaning was completed prior to subsequent startup of the Unit and synchronization to the grid on June 1993. The circulating water intake structure (common to both units) was dredged to remove river debris and silt accumulation and the displaced debris was removed from the trash racks of both Units.

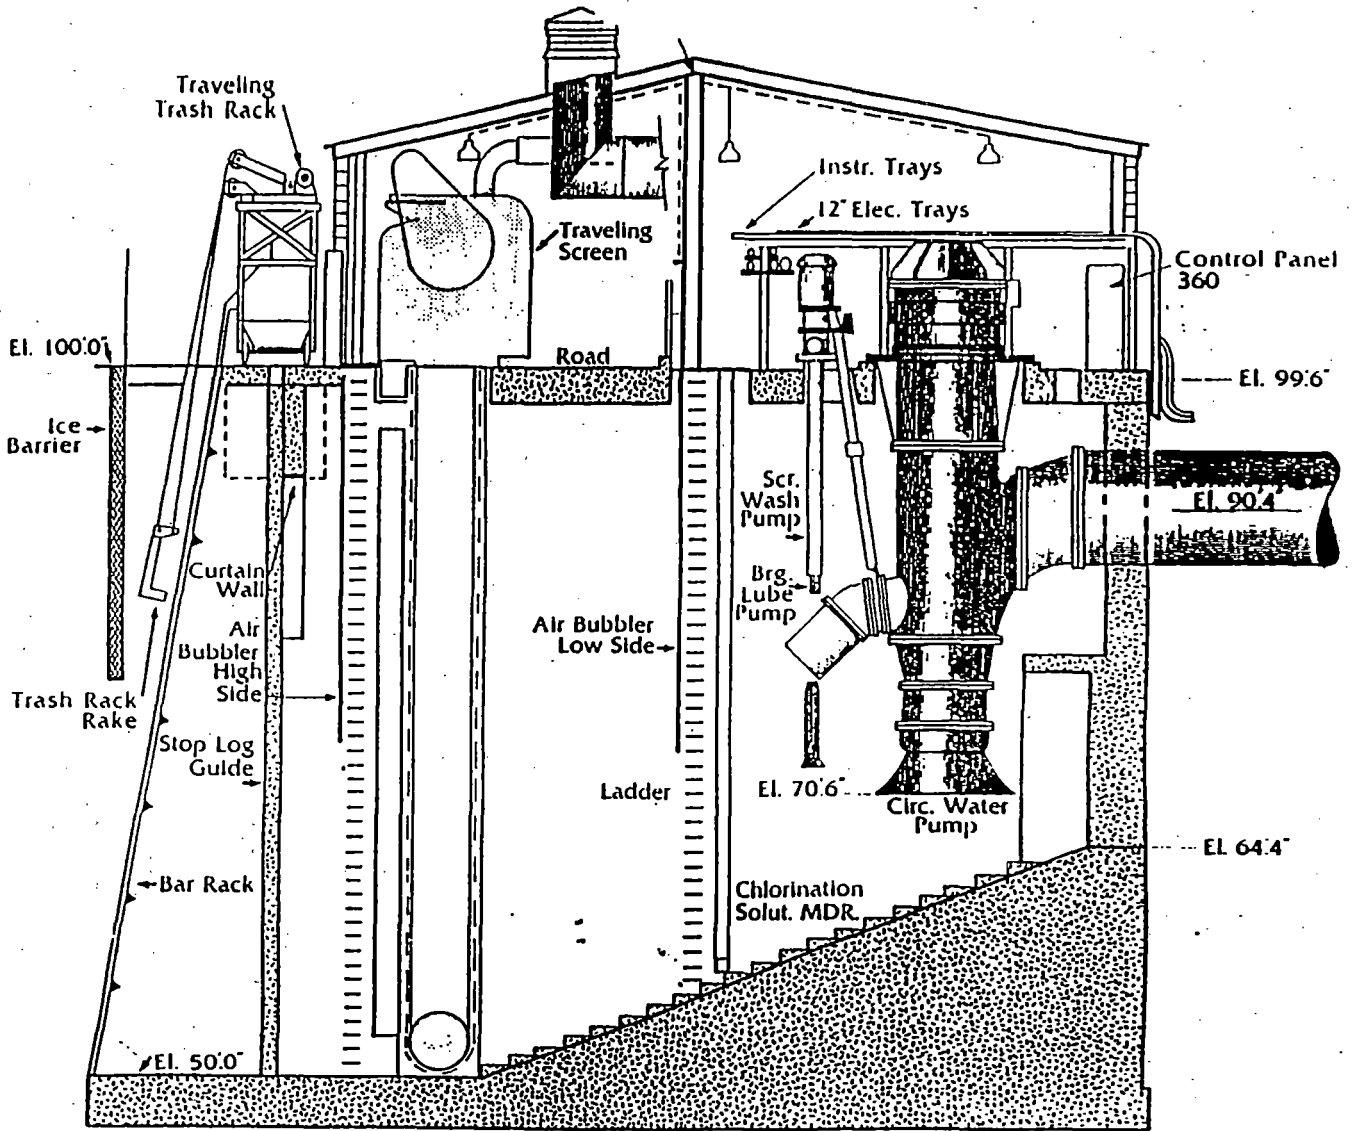
ATTACHMENT 2

Specific factors to the cause of this event include debris removal by the diver, maintenance of the trash rake which limited its ability to adequately clean the trash racks, and not implementing an outstanding corrective action to modify the trash rake (See Attachment 2 "Circulating Water Intake Cross Section").

The rake only cleans the rack approximately 25-feet down from the CWS deck leaving the lower 25-foot half of the rack uncleaned and therefore susceptible to accelerated debris buildup. It could not be determined when the rake cable was reduced to its current length of travel.

The circulating water trash rack rake will be overhauled or replaced as part of the Salem Revitalization effort in 1994.
