Salem Generating Station

SALEM GENERATING STATION
LICENSE NO. DPR-75
DOCKET NO. 50-311
UNIT NO. 2

LICENSEE EVENT REPORT 93-009-00

TITLE (4) **ESF Actuation: Automatic Start of Motor Driven Auxiliary Feedwater Pumps.**

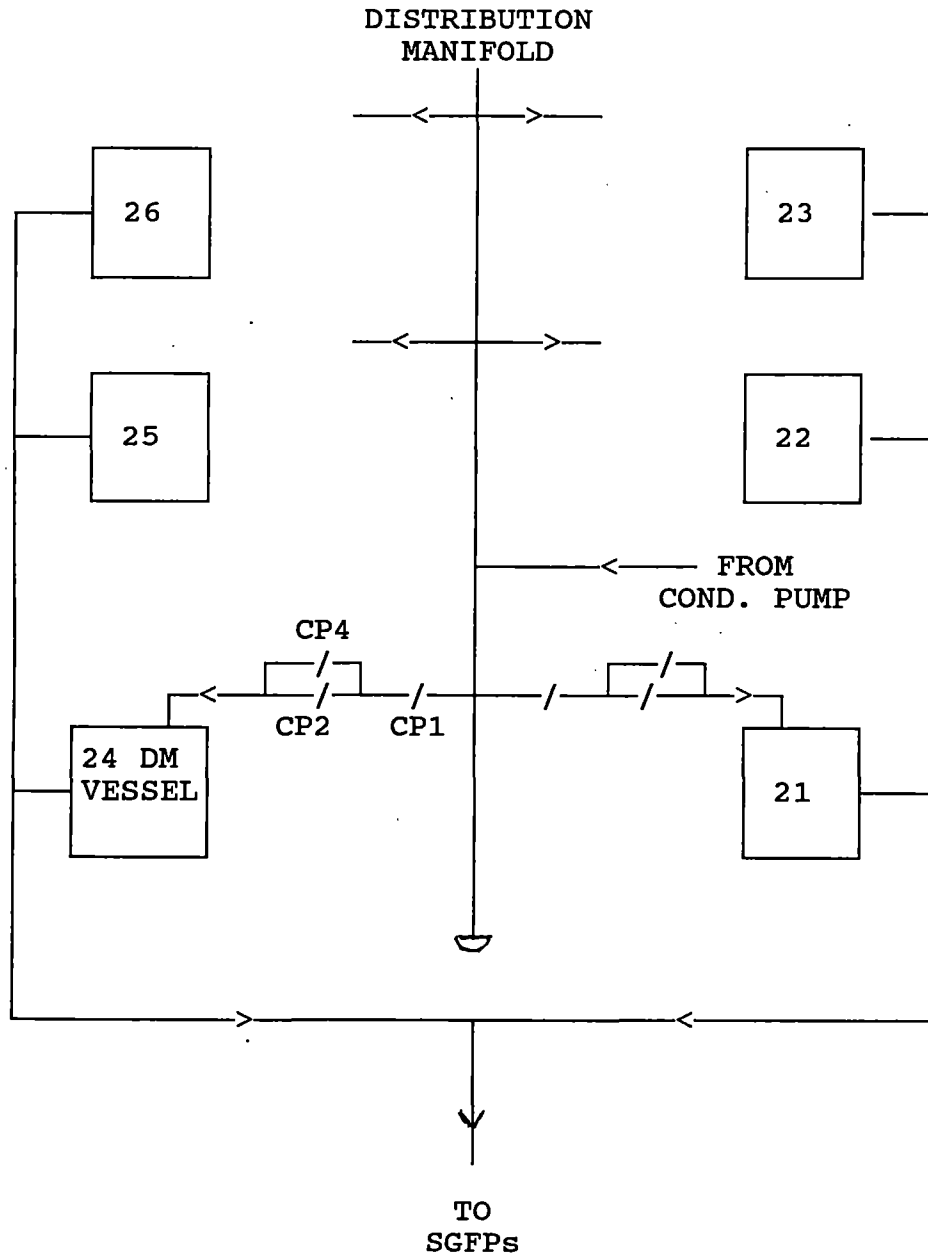
ATTACHMENT 1

Prior to this event, the CPS 24 DM vessel had been cleared and tagged in support of maintenance. Tagging included the DM vessel inlet manual isolation valve, 24CP1 (Posi-Seal Butterfly Valve). Concurrent to the vessel maintenance, air leakage testing of the 24 DM vessel automatic inlet isolation valve actuator, 24CP2 was conducted. This manipulation generated an "OPEN" signal to the valve actuator from the valve OPEN/CLOSE control switch. Per design, the 24 DM vessel pressurizing bypass valve, 24CP4, opened and 24CP2 controls received an "OPEN" arming signal, which would cause 24CP2 to automatically open with less than 8 psid across the valve. Control air to 24CP2 was tagged closed preventing automatic valve operation. The 24CP2 valve "OPEN" signal remained armed (per design). There is no positive indication when the valve is armed. (reference Attachment 1, schematic of system)

On June 21 maintenance on 24 DM vessel was completed and a flange, which had been removed to allow the vessel to drain, was reinstalled. Prior to this event, it was not recognized that 24CP1, which although closed, was leaking past its valve seat. Consequently, leakage occurred through the open 24CP4 via 24CP1. This leakage initiated 24 DM vessel fill despite the fact that the 24CP1 valve was tagged closed.

On June 22, a tagging release of 24 DM vessel was completed. When the 24CP1 was opened, the rate of vessel fill increased. With the 24 DM vessel vent valve closed, an air bubble formed in the vessel. Condensate System pressure (610 psi) caused the vessel to pressurize. Once the differential pressure decreased to 8 psid across 24CP2, the valve automatically opened due to the armed OPEN signal.

Pressurizing of the 24 DM vessel caused the air bubble to compress. Once the 24CP2 opened, the air bubble released into the Condensate System piping causing a pressure transient which resulted in momentary low suction pressure to the SGFPs inlet piping and the subsequent trip of the SGFPs.
