Public Service
Electric and Gas
Company

NLR-N93160

REVISED REPLY TO A NOTICE OF VIOLATION
NRC INSPECTION REPORT NOS. 50-272 & 311/93-08 AND 50-354/93-06
SALEM AND HOPE CREEK GENERATING STATIONS
DOCKET NOS. 50-272, 50-311 AND 50-354

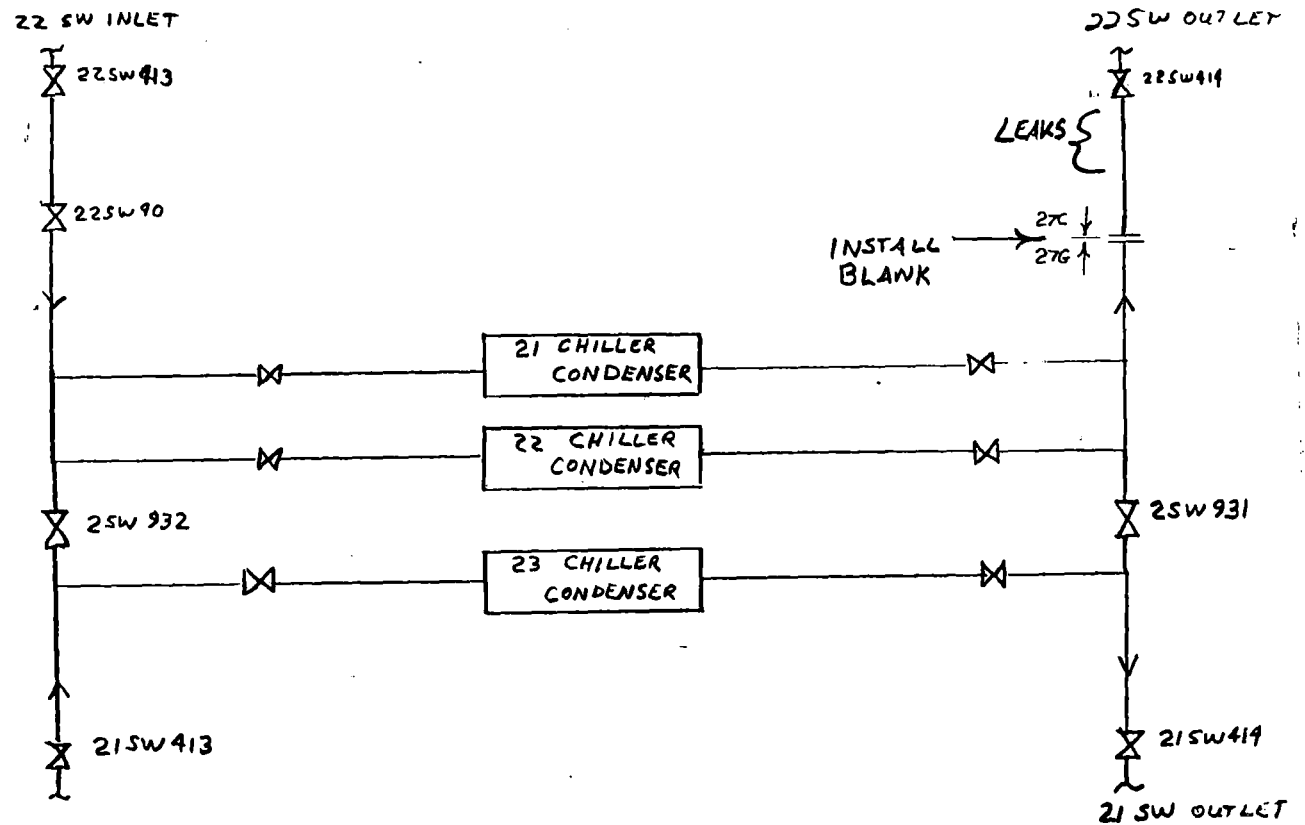
FIGURE DEPICTING INSTALLATION OF BLANK FLANGE

On June 11, 1993 a portion of pipe in the Salem 22 service water (SW) chiller return header was leaking and in need of replacement. (See attached figure). This pipe was upstream of isolation valve 22SW414. Two chiller condensers were required to maintain operability of the Emergency Control Room Air Conditioner (ECAC). This meant that, in addition to Chiller Condenser 23, either Chiller Condenser 21 or 22 was required to be in operation. In order to maintain Chiller Condenser 21 or 22 in operation, (with Chiller Condenser 23 operating) a blank flange was installed upstream of isolation valve 22SW414 between existing break flanges. Our previous response stated that the blank flange merely supplemented the closed isolation valve (22SW244) for SW header separation. However, that information was miscommunicated. The blank flange and valve 22SW414 served as isolation points for the leaking section of pipe. The cognizant engineer prepared T-Mod TMR 92-043 to document installation of the temporary blank flange in the SW system.

The blank flange was installed to support maintenance (pipe replacement). The blank flange was installed per ASME Code requirements and performed the same function as closed valve 22SW414. (There were no components, other than a closed drain valve, between the blank flange and valve 22SW414). When the piping replacement was completed, the blank was removed. In interpreting the blank flange installation to be a maintenance activity, the applicability review concluded that a safety evaluation was not necessary.

However, NAP-59, Section 6.2.1 indicates that temporary design changes involving disconnected piping or removal of components should be considered a "change." Since Salem UFSAR Figure 9.2-1B, Sheet 5 depicts this section of the Service Water system, the applicability review should have resulted in a safety evaluation.

3. With regard to T-MOD TMR 92-043, the blank flange was removed upon replacement of the leaking pipe and the condition no longer exists.
