U. S. NUCLEAR REGULATORY COMMISSION
REGION I

Report Nos. 50-272/94-11
50-311/94-11
50-354/94-09

Facilities: Salem Nuclear Generating Station
Hope Creek Nuclear Generating Station

Dates: March 27, 1994 - April 30, 1994

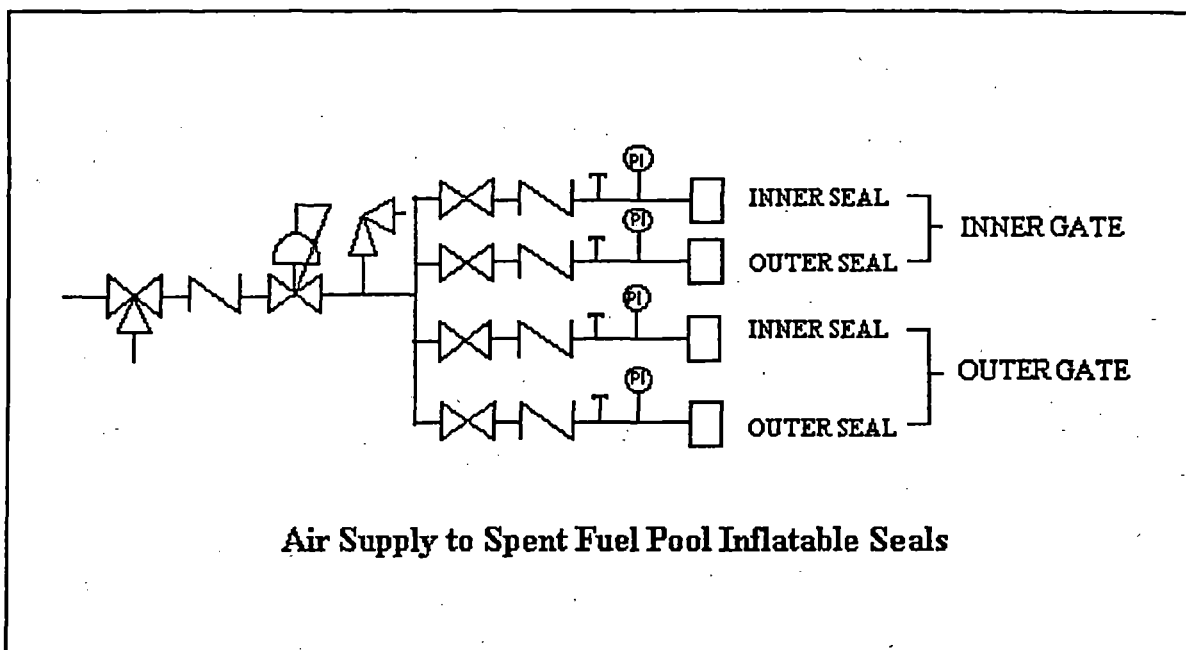
Figure 1

On April 13, 1994, a Hope Creek nuclear control operator (NCO) observed fuel pool skimmer surge tank level decreasing rapidly, indicating leakage from the SFP. The SFP low level alarm sounded, followed by a report that the SFP outer gate inflatable seals were leaking. The inner gate seals (2 seals per gate) had just been replaced and were still deflated. The licensee discovered that the air supply isolation valve to the inflatable seals was in the closed position and opened it, re-inflating the gate seals and stopping the leak. SFP level was restored to normal within 50 minutes of leak discovery. The water leaked from the SFP to the reactor cavity, with some spillover into the dryer-separator pool. No leakage into the drywell was discovered and no refuel floor radiation monitor alarms were received.

Licensee root cause analysis revealed equipment, procedure and personnel problems during the April 11-13 replacement of the SFP inner gate inflatable seals. The inflatable seals' air supply isolation valve was listed as normally closed in the Tagging Request Inquiry System (TRIS). This valve was recorded as open on April 5 after SFP gate installation and was subsequently closed sometime before inner gate seal replacement on April 13. The SFP gate inter-space drain valve, required to be open by procedure HC.OP-IO.ZZ-0001(Q), *Refueling to Cold Shutdown*, was improperly left closed after gate installation, which disabled the alarm for leakage into the inter-space region between the two SFP gates. The work order for gate seal replacement referenced the wrong procedure and excluded the correct procedure from the package. Mechanical maintenance practices for SFP gate seal replacement did not meet management expectations in that the job supervisor proceeded without an approved procedure. Maintenance personnel repositioned valves without a tagout. Lastly, the in-line check valves to the outer gate seals leaked, since those seals deflated during this event.

while the work order did not require a tagout. The procedure required pressurizing and depressurizing the SFP gate inflatable seals, but did not specify which seals or how to do it. Additionally, the licensee knew of the inner gate seal leak when installing the gates on April 4, but completed the installation and drained the reactor cavity without repairing it. The inspector also found that the licensee had never performed preventive or corrective maintenance on any of the valves or the pressure regulator in the air supply system (refer to figure 1., above). The existing design permits failure of a single component to permit loss of air to the seals. The inspector also determined that the loss of spent fuel pool inventory required failure of multiple barriers, including: hardware (check valve leakage), process controls (incorrect positioning of the three-way valve, failure to hang tags, inadequate control of isolation valve position), and people (lack of recognition that the newly replaced seal did not properly inflate, failure to check the three-way valve, failure to clarify and correct the work package reference to an incorrect procedure for seal replacement, performing work without a procedure, failure to recognize that the tag requirement had not been met).

Licensee corrective actions addressed the identified root causes and included other considerations as well. The TRIS for the air supply isolation valve was changed to reflect a normal position of locked open. Operators responsible for the failure to reopen the gate

inter-space drain valve were appropriately disciplined. The mechanical maintenance engineer discussed the importance of procedure compliance with all members of the mechanical maintenance shop, directed the creation of a new procedure dedicated to SFP gate seal replacement, and instituted a work package evaluation program to ensure procedure effectiveness. The operations department initiated a work order to replace the in-line check valves to each of the four inflatable seals. Additionally, the licensee wrote and answered a deficiency report to evaluate the effect of flooding the reactor well drywell cavity with the drywell head installed. This evaluation showed no negative impact on the drywell head by hydraulic forces or water damage/corrosion effects. Long term corrective actions included operator checks of SFP gate seal pressures, recurring tasks for periodic calibration of the gate seal pressure gages and in-line check valve replacement, and a design change request to improve gate seal air supply reliability.
