U. S. NUCLEAR REGULATORY COMMISSION
REGION I

REPORT/DOCKET NOS. 50-272/94-80
50-311/94-80

FACILITY: Salem Nuclear Generating Station

INSPECTION DATES: April 8-26, 1994

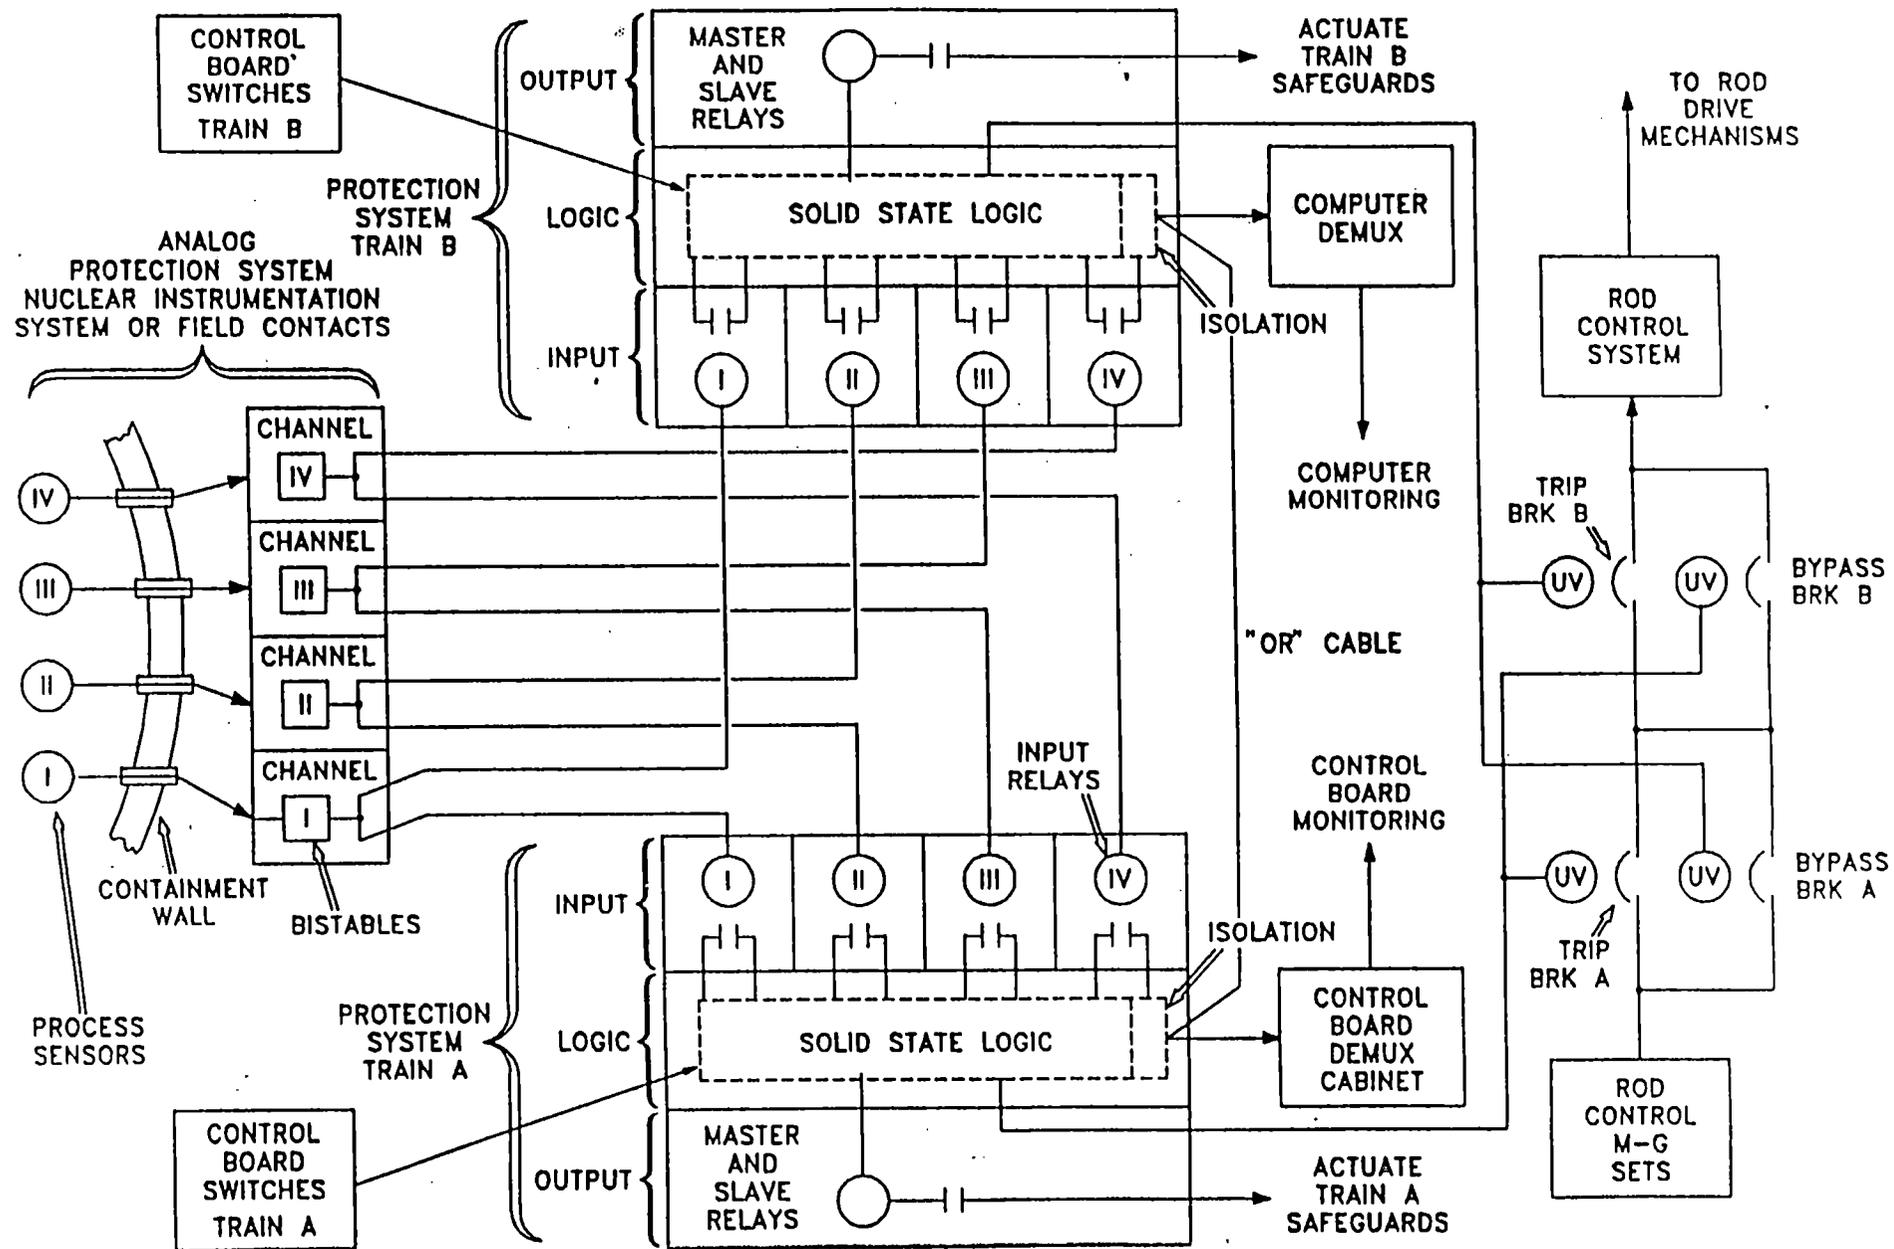
**ATTACHMENT 2
SAFETY INJECTION SYSTEM LOGIC DIAGRAM**

During the plant transient that occurred on Salem Unit 1 on April 7, 1994, the solid state protection system responded to a sustained low T_{vac} condition and coincident short duration high steam flow indications. The low T_{vac} condition was a result of actual plant conditions experienced during the rapid plant power reduction. The short duration high steam flow signals occurred following the main turbine trip. These high steam flow signals were not the result of an actual high steam flow condition resulting from a postulated steam line break; but rather, were caused by a pressure wave in the main steam lines that occurs when the turbine stop valves rapidly close during a turbine trip.

A review of the sequence of events generated by the plant computer following the reactor trip and turbine trip indicated that protective action signals were generated in response to the high steam flow/low T_{ave} signals two times. The sequence of events program divides each one second time interval into 60 cycles and identifies events that occur and/or clear within each one cycle time interval. AIT review of the sequence of events computer printout determined that the coincident high steam flow and low T_{ave} conditions were logically satisfied twice just after the reactor trip on April 7. The first occurrence occurred and cleared within one electrical cycle (0.0167 second). The second occurrence occurred during one cycle and cleared in the next cycle. Since it is not possible to determine when, within the first cycle, that the initiation occurred, or when, within the second cycle, the trip condition cleared, the actual duration that the trip signal was present cannot be determined other than it was present for a maximum of two cycles (0.033 second).

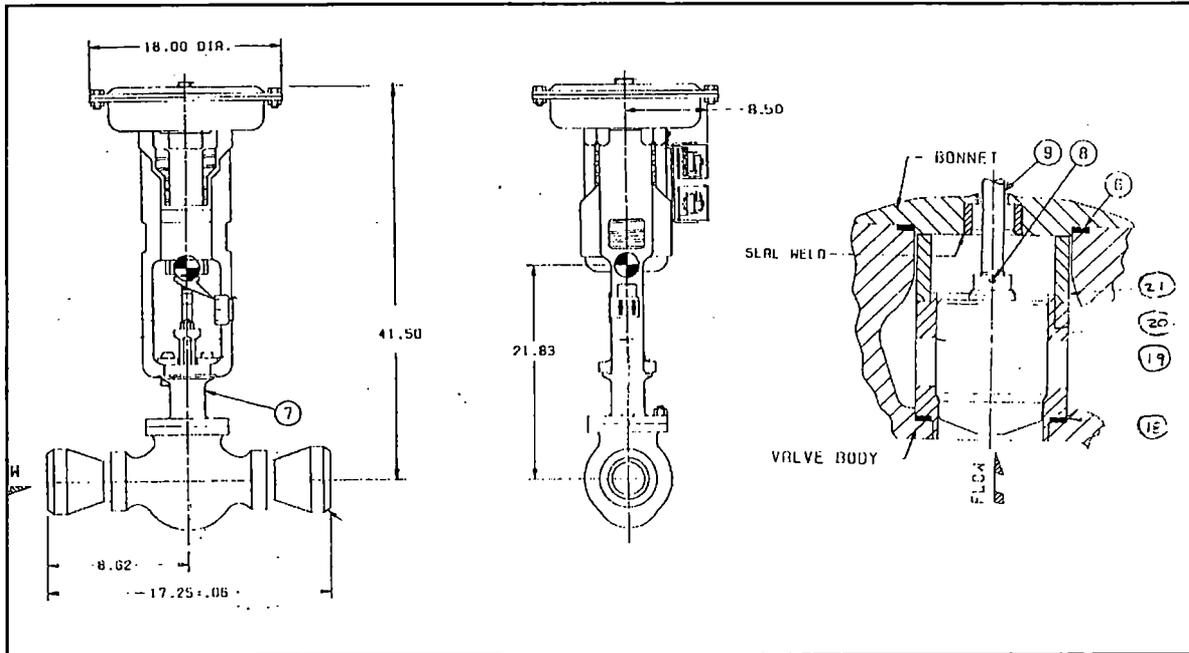
Figure 1. Pressure Operated Relief Valve

Post-event examination showed that both PORVs incurred wear of the valve internals; however, the valves still worked after the event. Prediction of future valve operation, particularly due to the galling observed in PR2's valve stem, is judged impractical by the AIT. The galling could

lead to failure at any time, or the valve may operate numerous additional times before failure. Damage to PR1 was found to be generally less severe than to PR2. The licensee subsequently replaced the worn internals, which the AIT considered an appropriate action.

The licensee post-event, preliminary examination of PORV PR2 showed galling of the stem where it passed through the bonnet and severe wear/scrapes, but little or no galling, along part of the plug and cage. The damage was concentrated on the side toward the outlet, which the licensee indicated was consistent with past experience. The licensee also indicated the cage appeared softer than the plug. The seat did not exhibit obvious cutting. The plug was reported as freely movable in the cage by hand. Valve PR1 did not exhibit stem wear, although there was some wear to the plug and cage and there was a possible cut in the valve seat. Both valves had an axial crack on both sides of the anti-rotation pin. This crack passed through the backseat.

The galling (or deep gouging) observed on the stem of PR-2 is of concern. The valve is designed with a clearance around the stem such that it should not touch the bonnet. With this clearance closed and with the stem dragging against the inside of the bonnet, the ability of the plug to open or close could be severely affected. Of interest, the stem damage and plug damage were both on the downstream side of the internal assembly which leads to the hypothesis that the damage could have been at least partly flow-induced.

Subsequent to the event, the licensee replaced the valve internals using the 316 stainless steel stellite plug in a 17-4 PH cage.

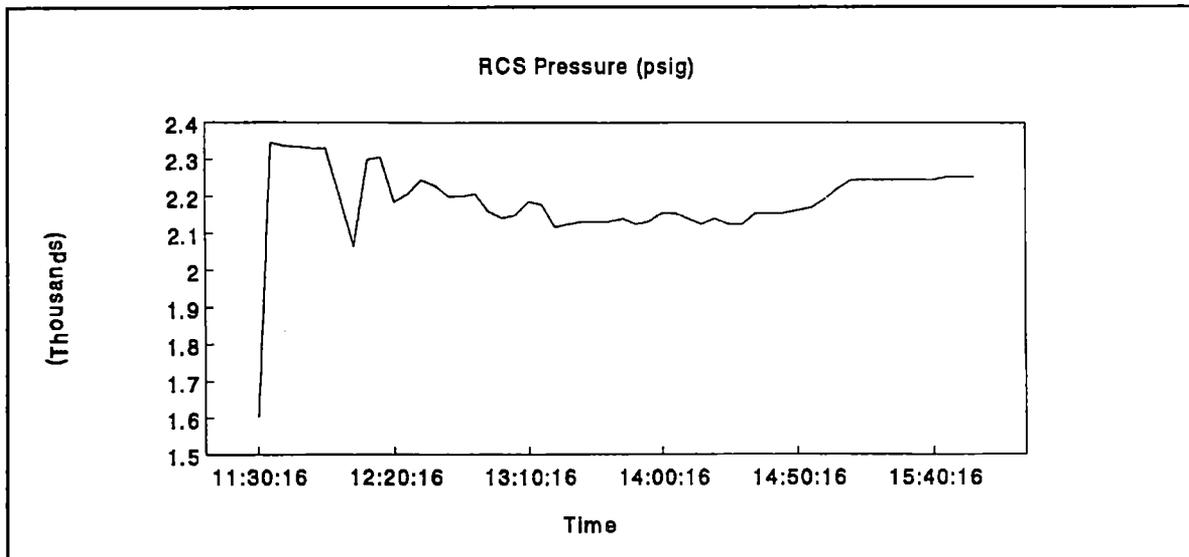
Figure 2. Reactor Coolant System Pressure

The PORVs actuated over 300 times during the event to relieve water and successfully prevented an RCS overpressure condition. Figure 2 in Attachment 7 depicts the RCS pressure during the transient after the second SI actuation. It was during the period from about 11:30 a.m. to 12:00 noon that the PORVs experienced the greatest amount of operation.

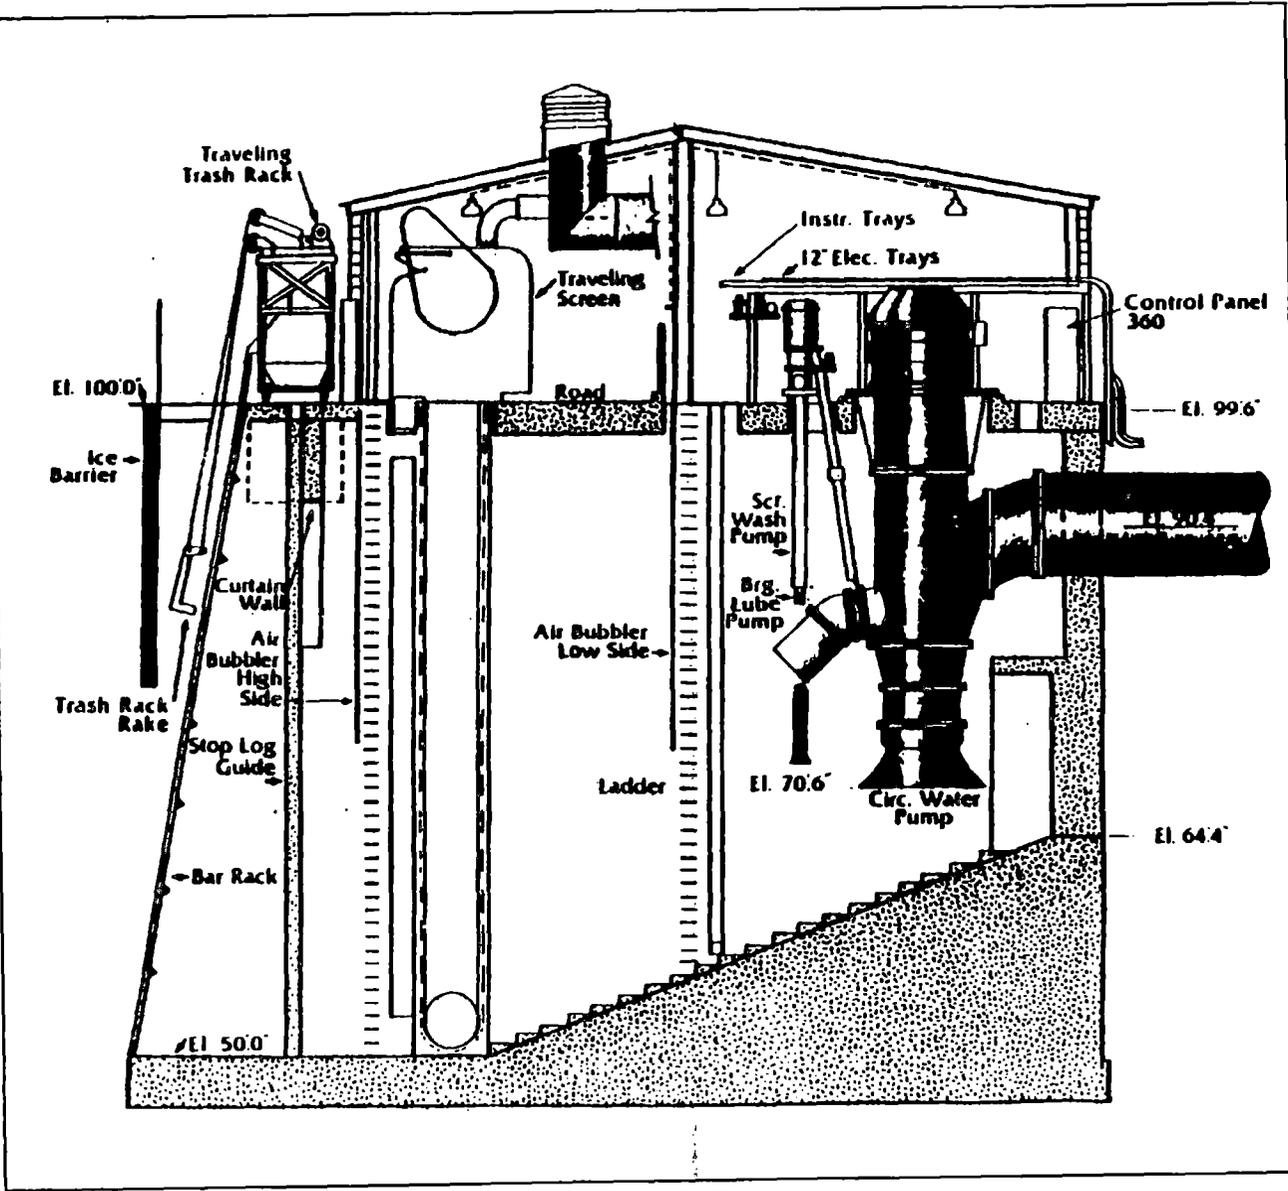
Figure 4. Salem CW Intake Structure and Equipment

In anticipation of additional grass intrusion events, the licensee had removed the front covers of the traveling CW screens and laid fire hoses that were used to wash accumulated grass and debris from the screens before the built-in screen washes were reached. Quick-disconnects had been provided on covers in the screen drives so that shear pins could be replaced quickly (3 to 7 minutes).

Despite the fire hoses and running the screens as fast as possible, the screen loads became so heavy during the event that shear pins were failing and screen clogging was causing a significant water level drop across the screens. One licensee representative estimated that the water level drop across the trash racks was about 1 - 1½ ft. CW pumps tripped when level reached a 10 foot differential across the screens.
