LR-N97365

**SUPPLEMENTAL INFORMATION
NRC GENERIC LETTER 96-06
LICENSE CHANGE REQUEST S96-13, CFCU RESPONSE TIME
SALEM GENERATING STATION UNIT NO. 1 AND 2
DOCKET NOS. 50-272 AND 50-311**

ATTACHMENT 1 TO LR-N97365
SUPPLEMENTAL INFORMATION RELATED TO
NRC GENERIC LETTER 96-06

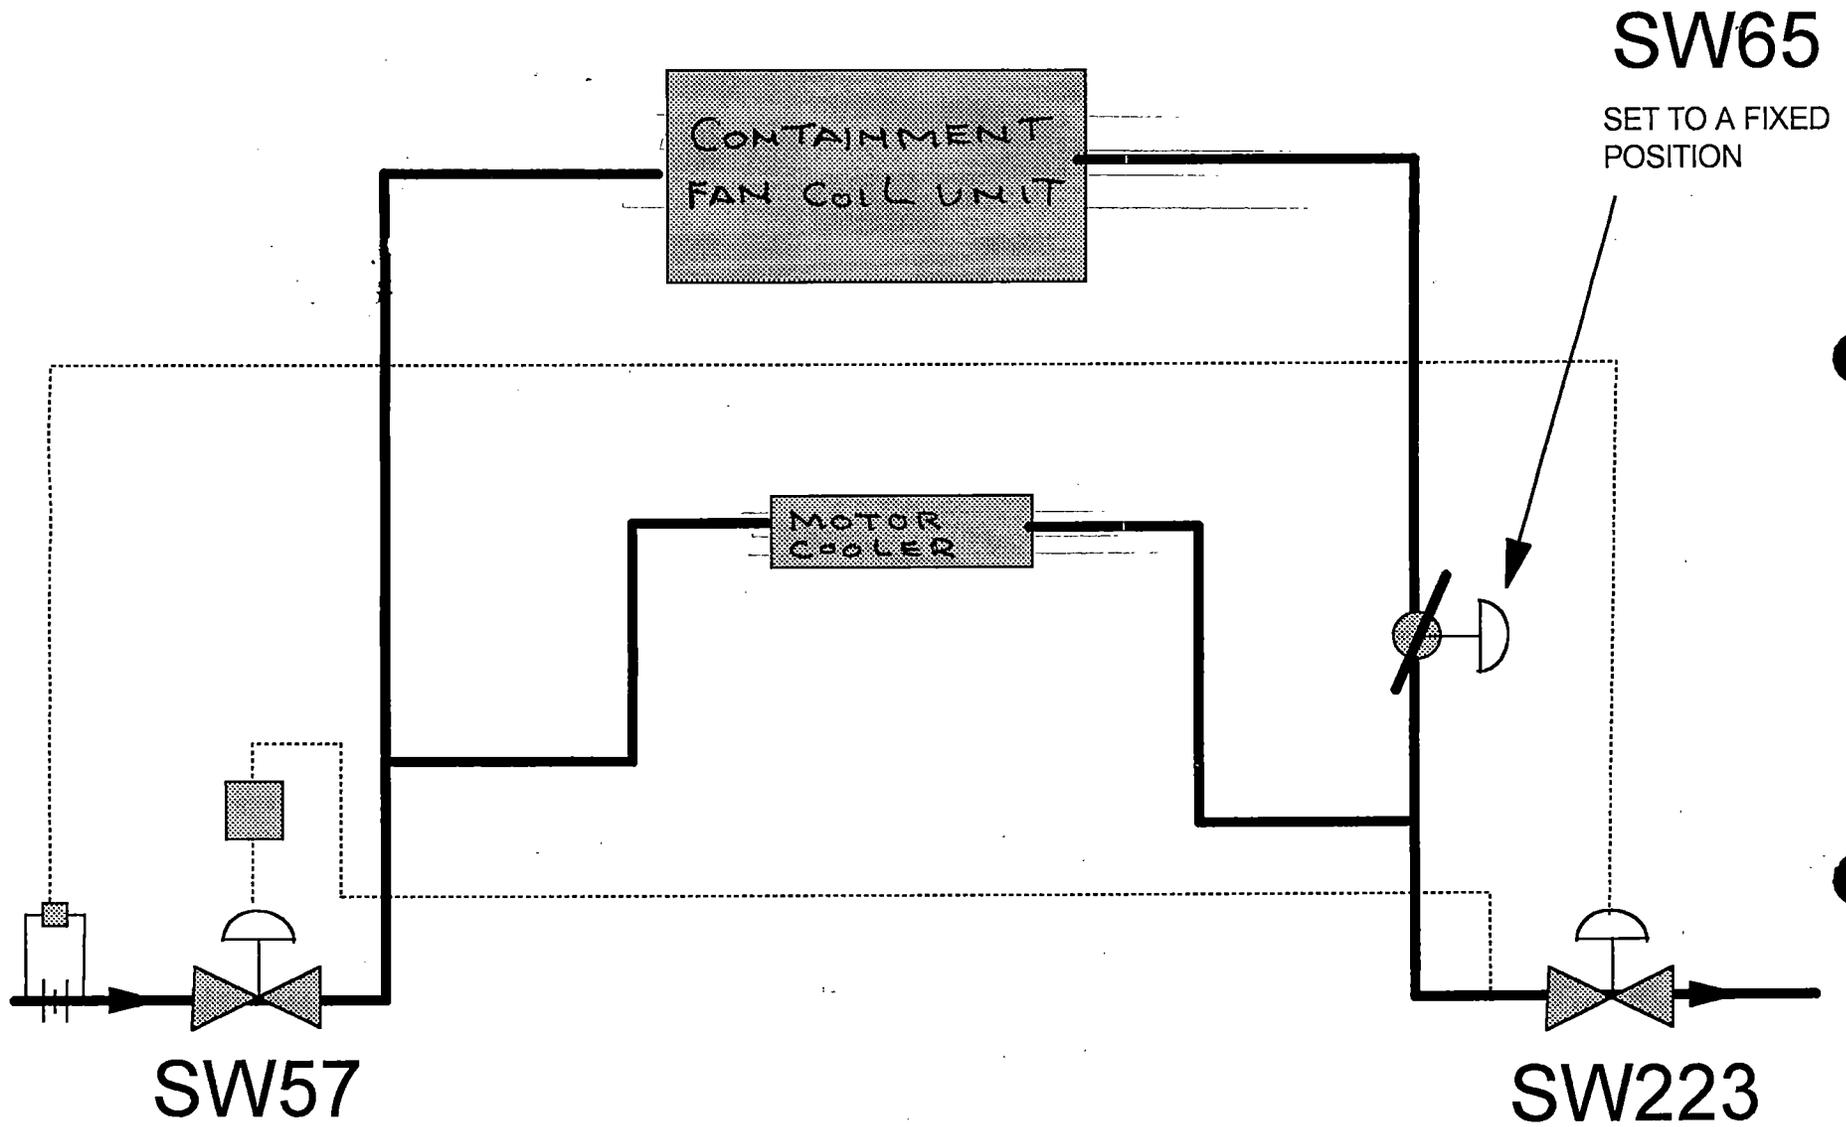
Figure 1
LR-N97365

A simplified one-line schematic of a typical CFCU and SW65 valve piping arrangement is provided as Figure 1. Figure 2 is a detailed illustration of a typical piping arrangement in the vicinity of the SW65 valve.

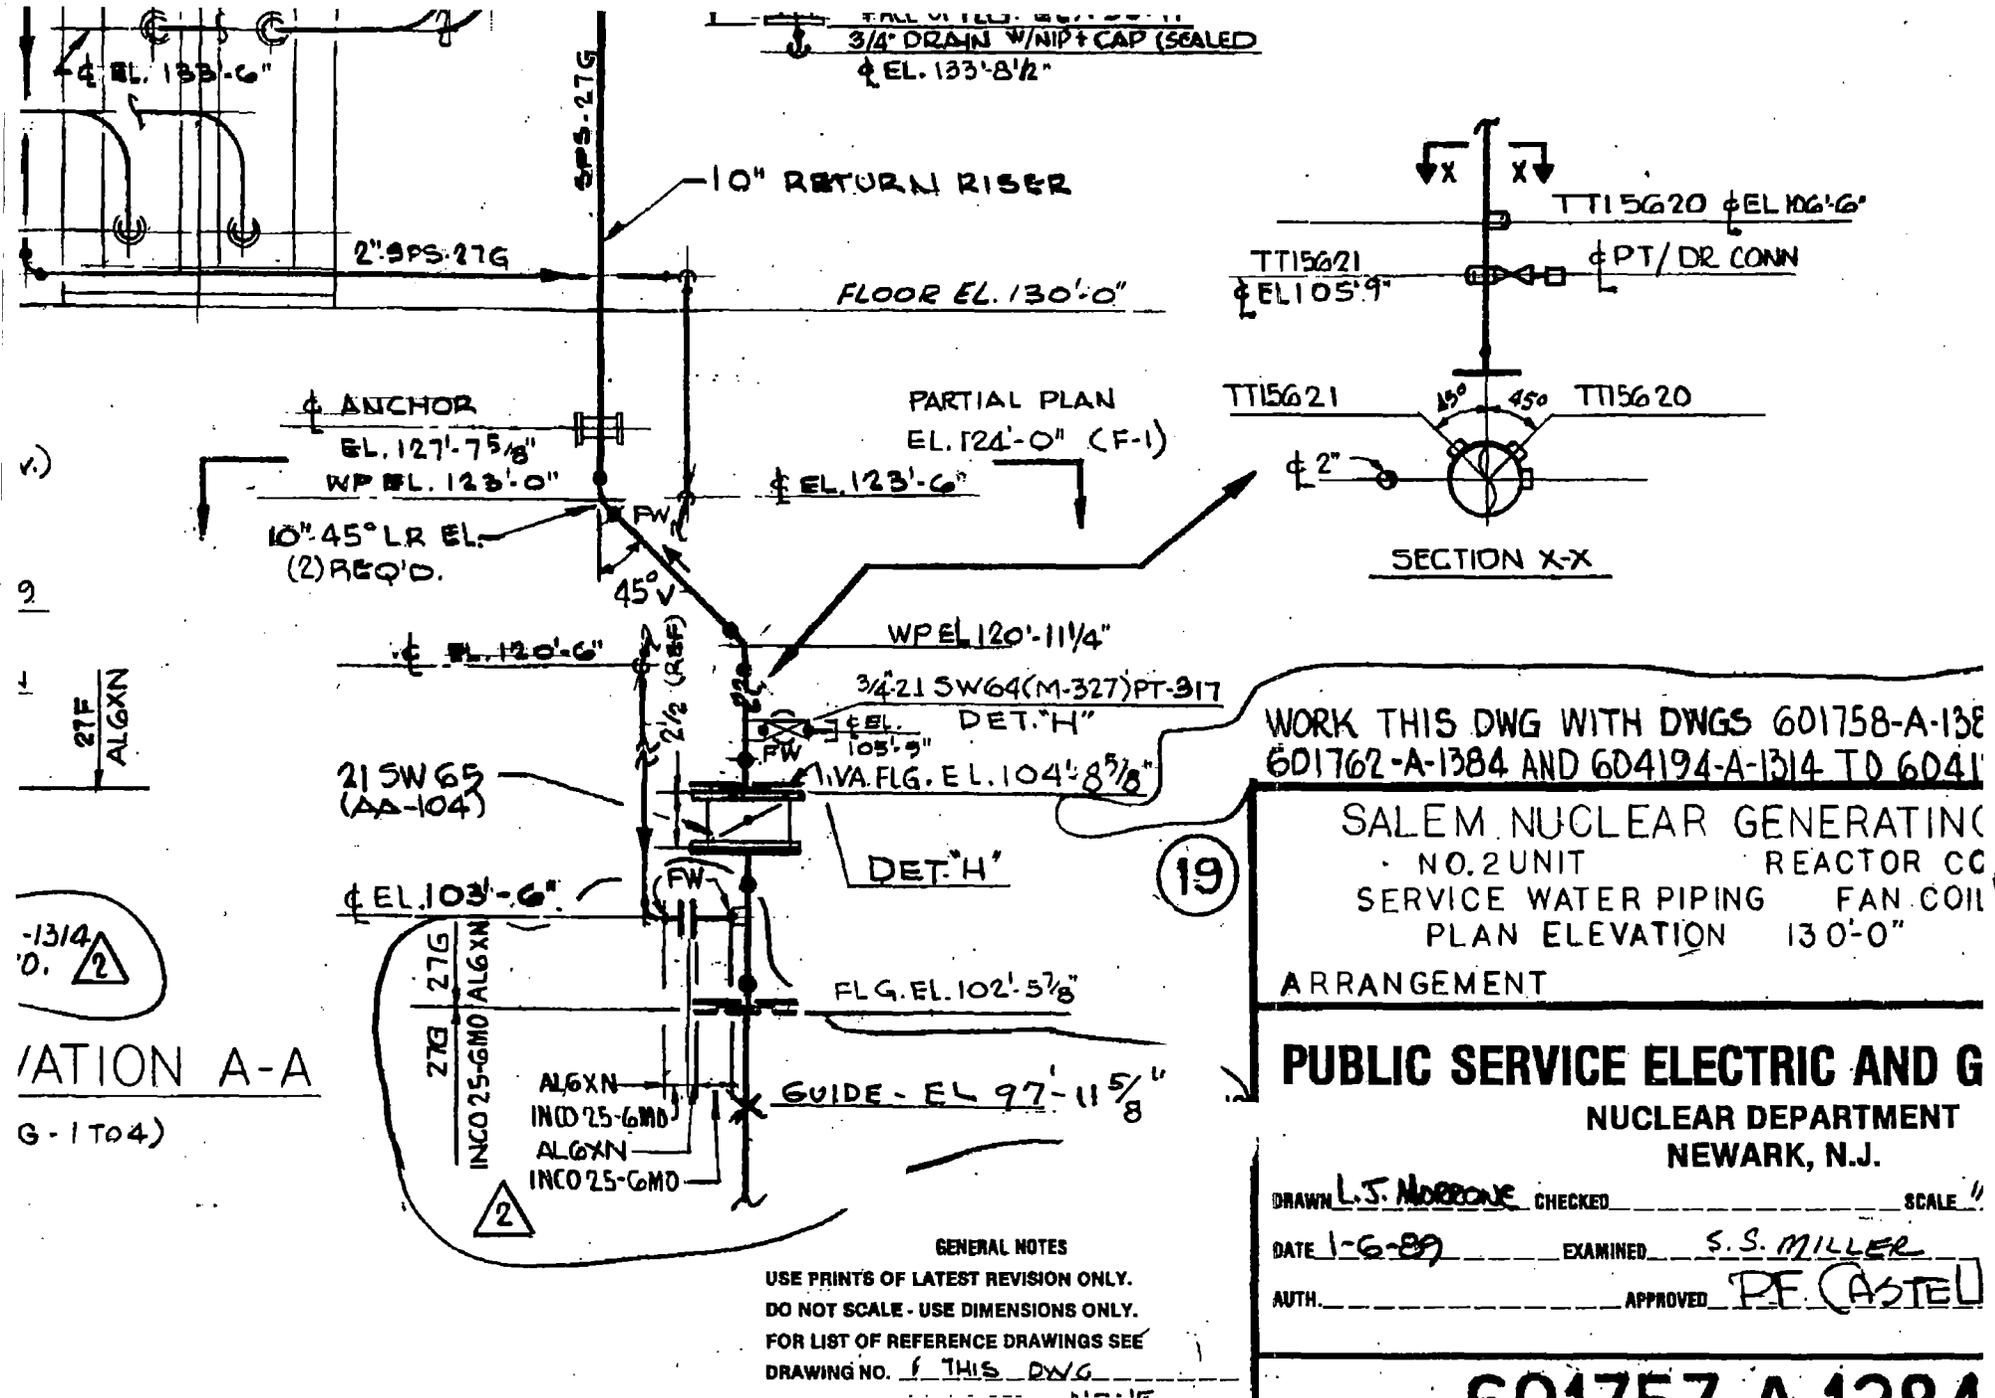
Figure 2
LR-N97365

It is worth emphasizing that the SW65 valves do not experience cavitation at normal operating conditions. As such, the piping, valve and local branch connections have minimal predisposition to fatigue failure. As can be seen on Figure 2, the SW65 valve is located in a straight return run of vertical 10-inch pipe at approximately elevation 105' in the containment building. The routing is straight since it only passes through this elevation (elevation 100') from the CFCU base elevation of 130' to the next level down (elevation 78') where it exits the containment (approximately elevation 95'). The pipe is well supported with a full anchor (i.e. 6 way restraint) at elevation 127' above the SW65 valve and a close fit guide below (1/8 to 1/16 inch clearances) at elevation 98'. A review of the calculated stresses imposed by dynamic loading from a design basis earthquake plus deadweight and pressure, shows a maximum stress of 6199 psi versus an allowable stress of 39260 psi. As such, substantial margins exist to accommodate the additional loading which would occur as a result of local cavitation.
