UNITED STATES  
NUCLEAR REGULATORY COMMISSION  
OFFICE OF INSPECTION AND ENFORCEMENT  
WASHINGTON, D. C. 20555

IE Circular 78-18

UL FIRE TEST

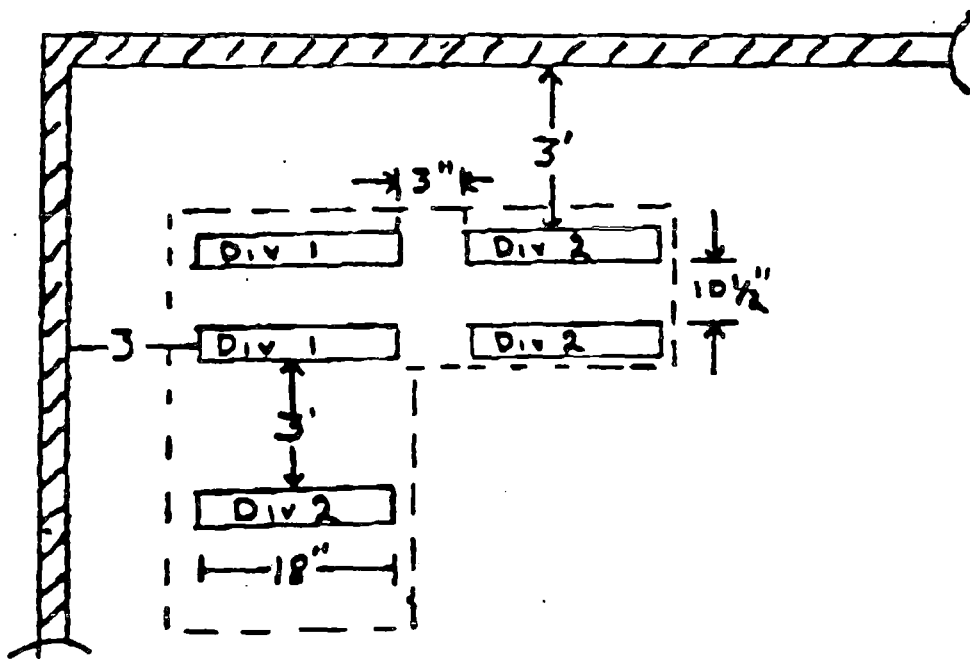
Figure 1

The configuration of the fire test was selected to simulate a section of a plant area with vertical cable trays containing redundant safety divisions arranged such that the redundant divisions could be simultaneously exposed to a potential fire resulting from an inadvertent spill of flammable liquid in the area. The arrangement of the cable trays and the designation of the redundant tray divisions is shown in Figure 1. Figure 2 shows the location of the fire detectors and the three groups of sprinklers. Each of the five cable trays contained cable insulated with polyvinyl chloride and was enclosed in a separated ceramic fiber blanket fire barrier from floor to ceiling in accordance with the manufacturer's recommendations. The sprinkler and detector arrangement was as permitted by NFPA Code. However, no water was actually used at any time during this test due to the failure of some sprinkler heads to actuate, as explained below.

Preliminary information indicates that the flammable liquid or flames penetrated the protective barriers at the bottom of the vertical trays and caused fire damage to the polyvinyl chloride insulation on cables in four of the five trays.

The most probable cause of the fire damage in certain cable trays appears to be related to the absorption or seepage of heptane under the ceramic fiber blanket at the juncture with the floor. Once the heptane entered the interior regions of the cable tray, then ignition apparently occurred via the small opening at the floor or through a vapor/air path within the joints. There is some indication that some cable damage was caused by absorption of heptane on the inside of the barrier (wicking effect) and its ignition which heated a cable tray ladder rung, causing damage to a cable in contact with the rung. The ingress of the heptane into the ceramic fiber needs to be further evaluated since this appears to be the most significant failure mode.

1. To protect against spills of flammable liquids, barriers or curbs may be needed to prevent entry of the flammable liquid behind fire barriers. A wick effect may also need to be considered in the design of fire barriers.
2. Some small fires may not actuate sprinkler heads. To reduce this possibility in sprinkler systems to be installed, fast response sprinkler heads should be considered (less than approximately 3 minutes in the UL Standard 199 "Automatic Sprinklers for Fire Protection Service").
3. The location of the fire detection devices and the sprinkler heads relative to the fire and components being protected is of great importance. The path of the air movement in the area influences the actuation of such devices and should be considered in the system layout.

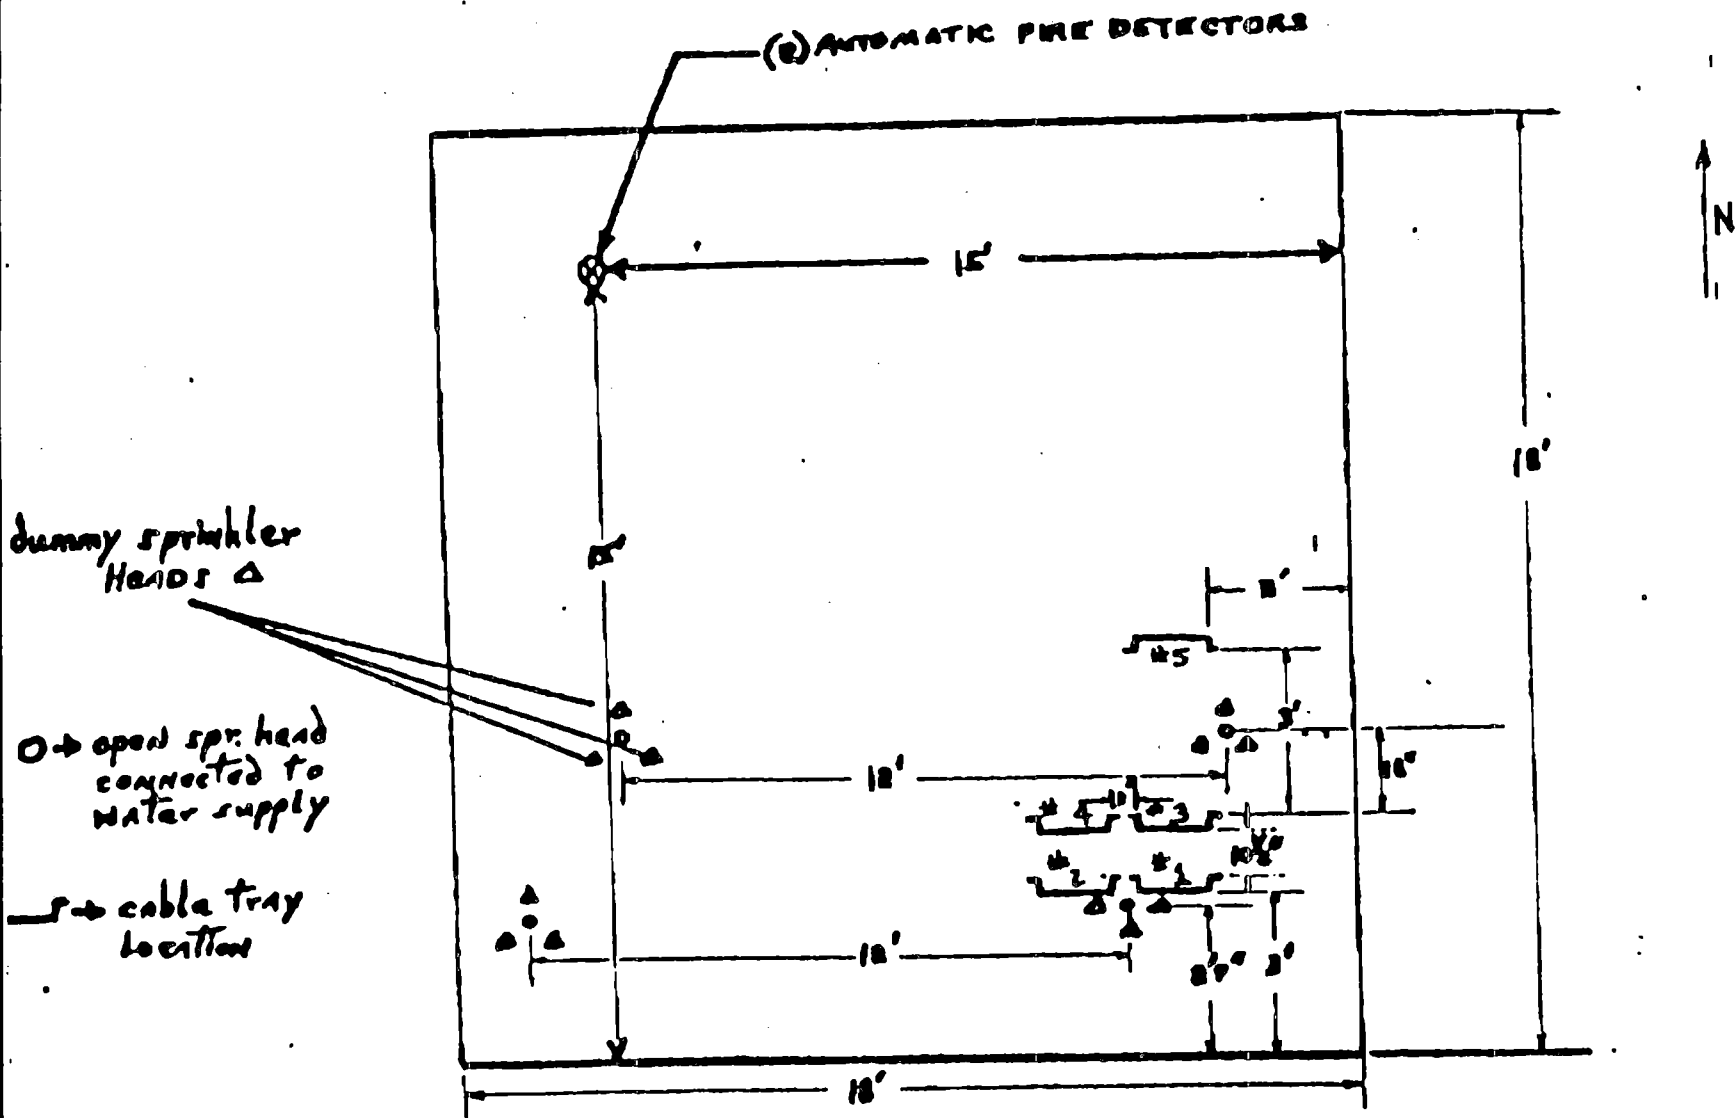
FIGURE 2  
TOP VIEW GENERAL

Each sprinkler location in the test arrangement contained three nominally identical temperature sensing sprinkler heads with fusible links adjacent to an open sprinkler head which was connected to a manual water supply valve. The temperature sensing heads were wired to signal when their links fused. After all three temperature sensing heads at a given location activated, then the water supply for the open head was to be manually admitted. The sprinklers were of a type which actuate at the slow end of acceptance for reaction time. The test procedure required that all three temperature sensing heads had to activate before water would be turned on. In this way, it was expected to get some data on variability in the response time of identical sprinklers.

The test was started by igniting the two gallons of heptane that was poured into the floor pan. A fully developed fire occurred almost immediately. The ceiling smoke detector alarmed in about 15 seconds. In about 50-60 seconds, two of the three temperature sensing sprinklers located between the wall and cable trays 1 and 2 activated. The fire between cable trays 1, 2, 3, and 4 appeared most intense, apparently because of a chimney effect between the four trays. The flames between cable trays 3 and 5 did not appear to be so intense. The ceramic fiber blanket absorbed some of the heptane so that after the heptane in the pan burned, most of the flame seemed to come from the bottom outside surface of the ceramic fiber blanket. No additional temperature sensing sprinkler heads at any location activated; thus, the sprinkler water supply was not turned on for any of the three sprinkler locations. The apparent slow response of the third temperature sensing sprinkler is being investigated, since this was not intended to be a slow response sprinkler.
