VIRGINIA ELECTRIC AND POWER COMPANY  
RICHMOND, VIRGINIA 23261

Subject: Steam Generator Inspection  
Surry Power Station Unit No. 1

Steam Generator Tube Inspection  
Program and Plugging Criteria  
Surry Power Station - Unit No. 1  
December, 1978

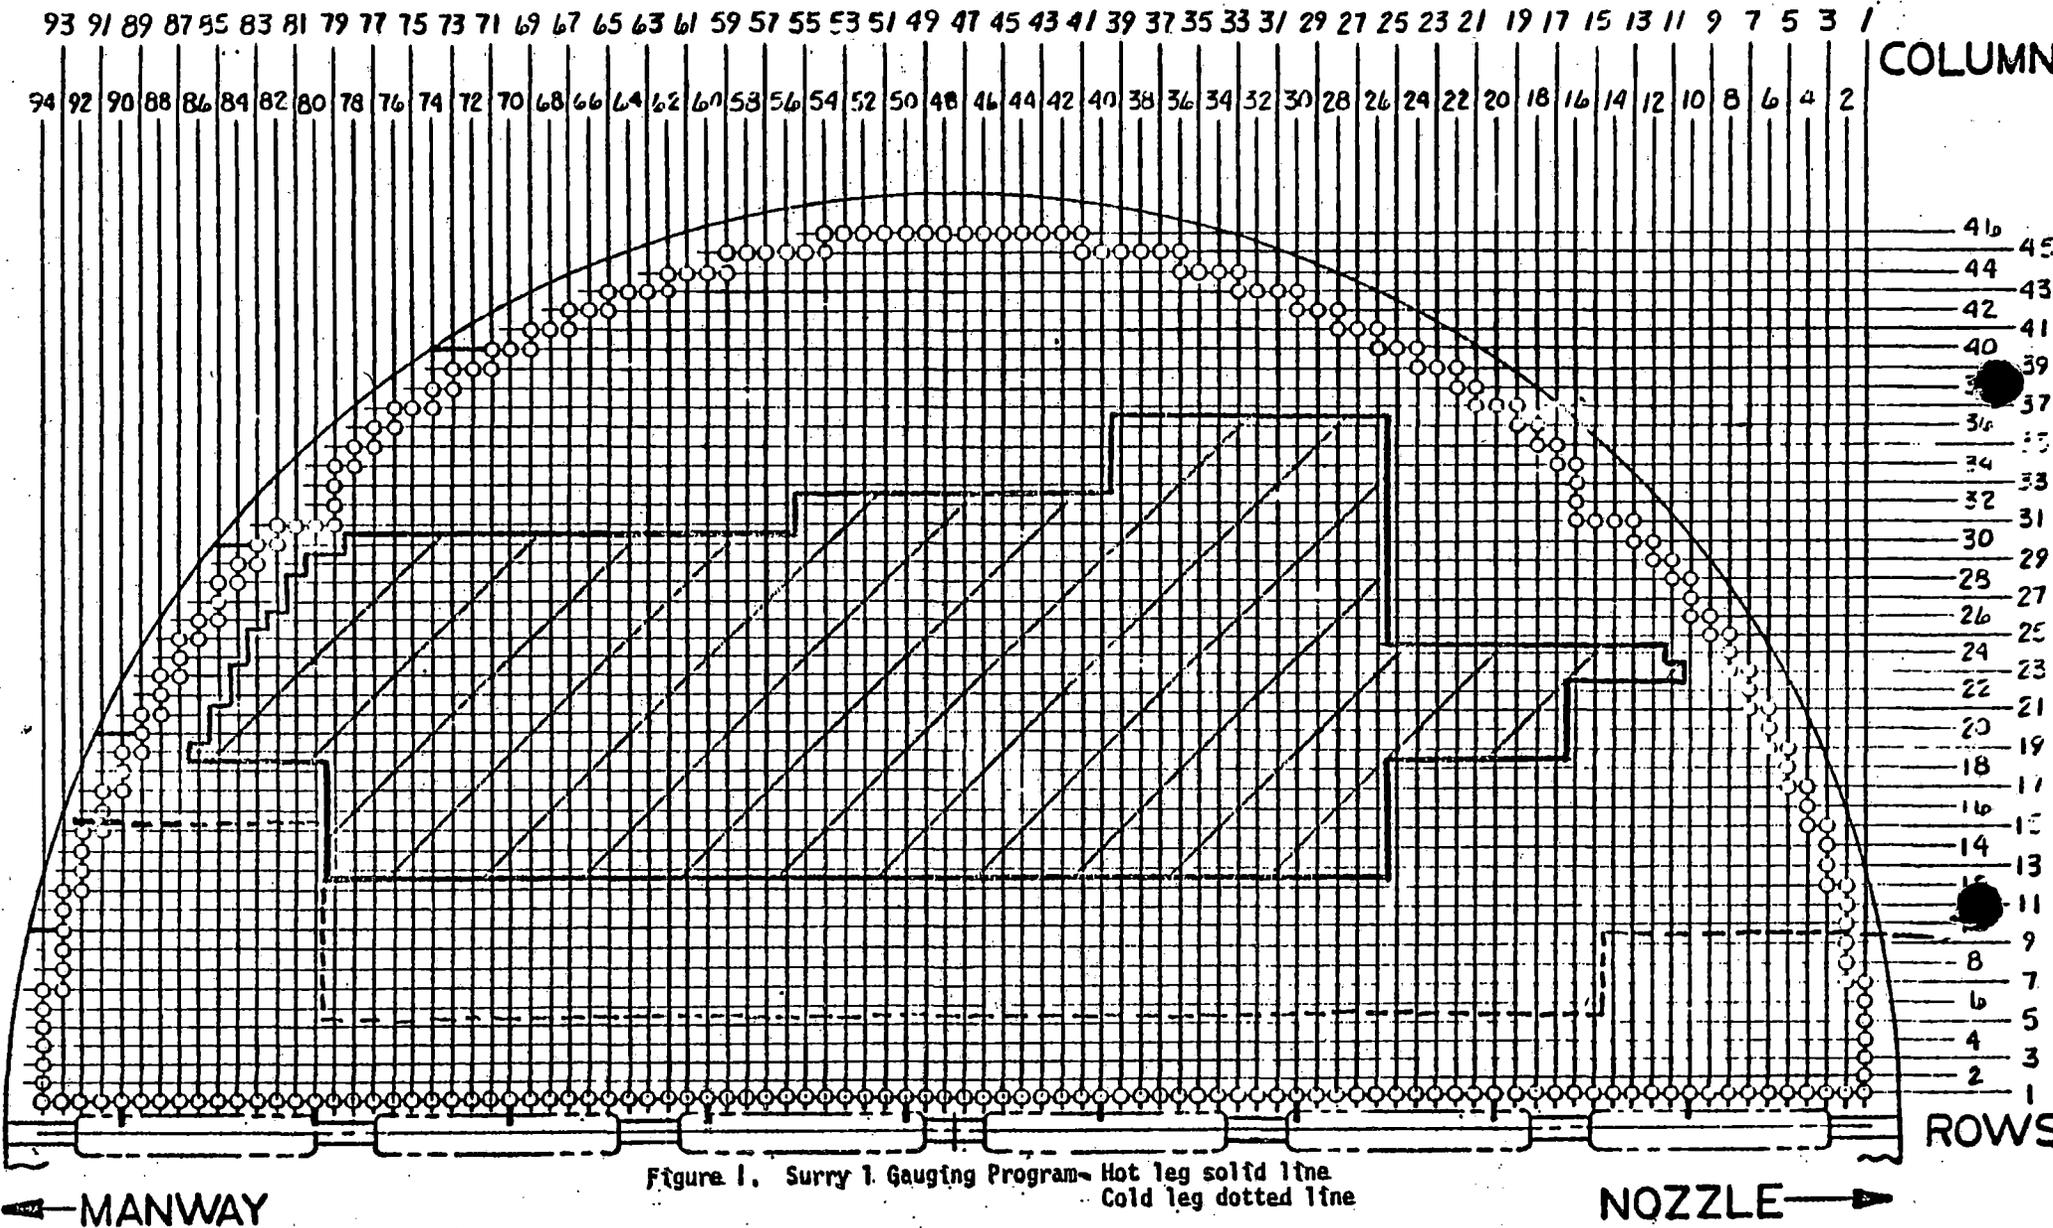
The tube gauging program is intended to encompass those regions where significant degrees of tube deformation may have occurred. The regions are determined by the finite element analysis which, when combined with tube strain tests, yields tube hoop strains versus tube location and extent of plate deformation. Additional inspections are defined for certain areas, particularly the wedge and patch plate regions. The inspection programs in the wedge and patch plate regions are based on previous leaker history at the Turkey Point and Surry sites, as well as previous gauging results at the Surry and Turkey Point sites. The basic inspection program was submitted in our letters of December 11 and 20, 1978 (Serial Nos. 703 and 703A). Additional inspections have been made on the basis of the visual inspection performed at the beginning of the inspection program. A summary of all inspections is included in Figure 1, Table 1 and Figures 3, 4, and 5.

(SEE ALSO TABLE 1)

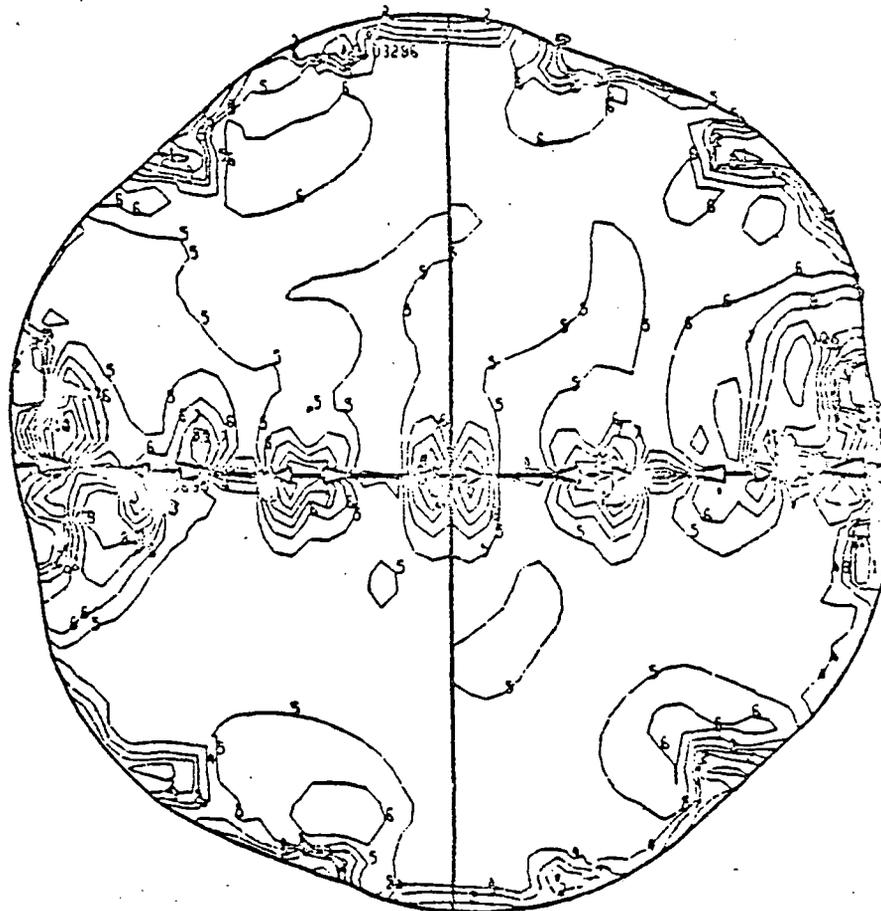
Figure 2 Tube Hoop Strain at 18 EFPM's  
Beyond Full Closure

- 1) The hot leg inspection boundary encompasses the 15% strain boundary as determined by finite element analysis. Since full closure was observed in Surry Unit 1 during the April 1977 inspection, Surry 1 is regarded as being beyond full closure by approximately 15 EFPM's. The tube hoop strain contours calculated for 15 EFPM's were utilized to determine the 15% boundary for this inspection. Figure 2, "Tube Hoop Strain at 18 EFPM's", conservatively represents the approximate current condition of Surry Unit No. 1 steam generators.

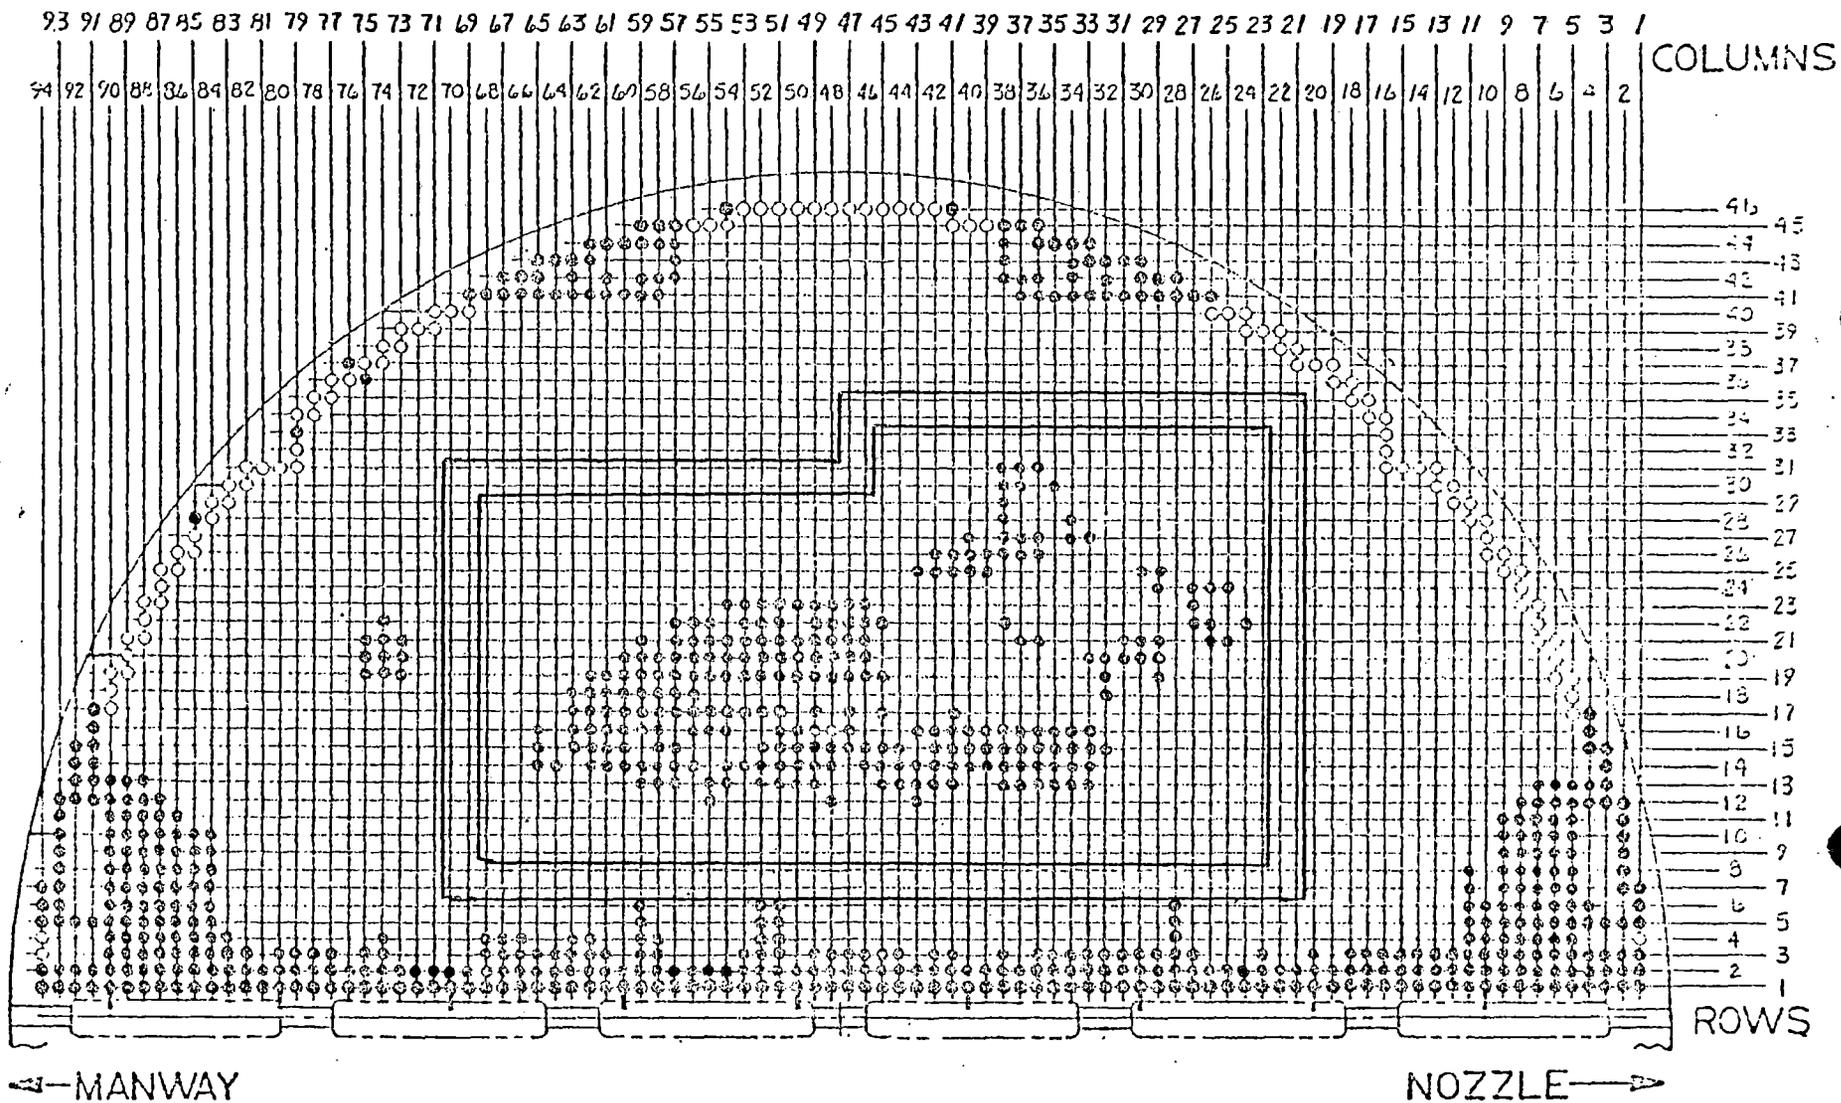
Recognizing that the above conclusions bring into question previous inspection results, extensive additional inspections were made in the wastage prone areas. Specifically, all tubes in all steam generators which indicated moderate (> 20%) wastage at the previous inspection were reinspected. Additionally 2 tubes in all directions beyond the boundary of the previous Regulatory Guide 1.83 inspection were inspected. This

was to detect any expansion in the area of significant wastage. The inspection areas are shown in Figures 3, 4, and 5. Note that on Figure 3 for steam generator "A", the inner enclosed area represents the boundary of the previous inspection. All tubes in the inner area which showed wastage of 20% or greater in the previous inspection were reinspected. This area is surrounded by a two tube boundary in which all tubes were inspected. The same applies to Figures 4 and 5 for steam generators "B" and "C". Additionally, in steam generator "C" a ten by ten area designated by the small square was completely inspected. This was the localized inspection in the area of the two suspected leaking tubes. The supplementary inspections for tube OD wastage included a total of 918 tubes. All tubes with either significant wastage or some wastage in proximity to a dent of sufficient size to mask the defect were plugged. This resulted in the plugging of a total of 63 tubes including all steam generators. While this is a large number of tubes, this indicates the application of an extremely conservative plugging approach more so than any increase in wastage activity. Almost all tubes plugged had indications of only minor wastage and were plugged due to masking. Only 16 tubes were judged as near or exceeding the 40% plugging limit, and in each case these were tubes which were close to the limit, i.e. 35-39% wastage, at the previous inspection. This indicates that there has been no rapid growth in wastage activity. The recognition of the masking effects of minor dents and the corrective action as implemented should ensure the integrity of the central bundle region during the next operating period.

STEAM GENERATOR 1A  
SUPPLEMENTARY INSPECTION AREAS

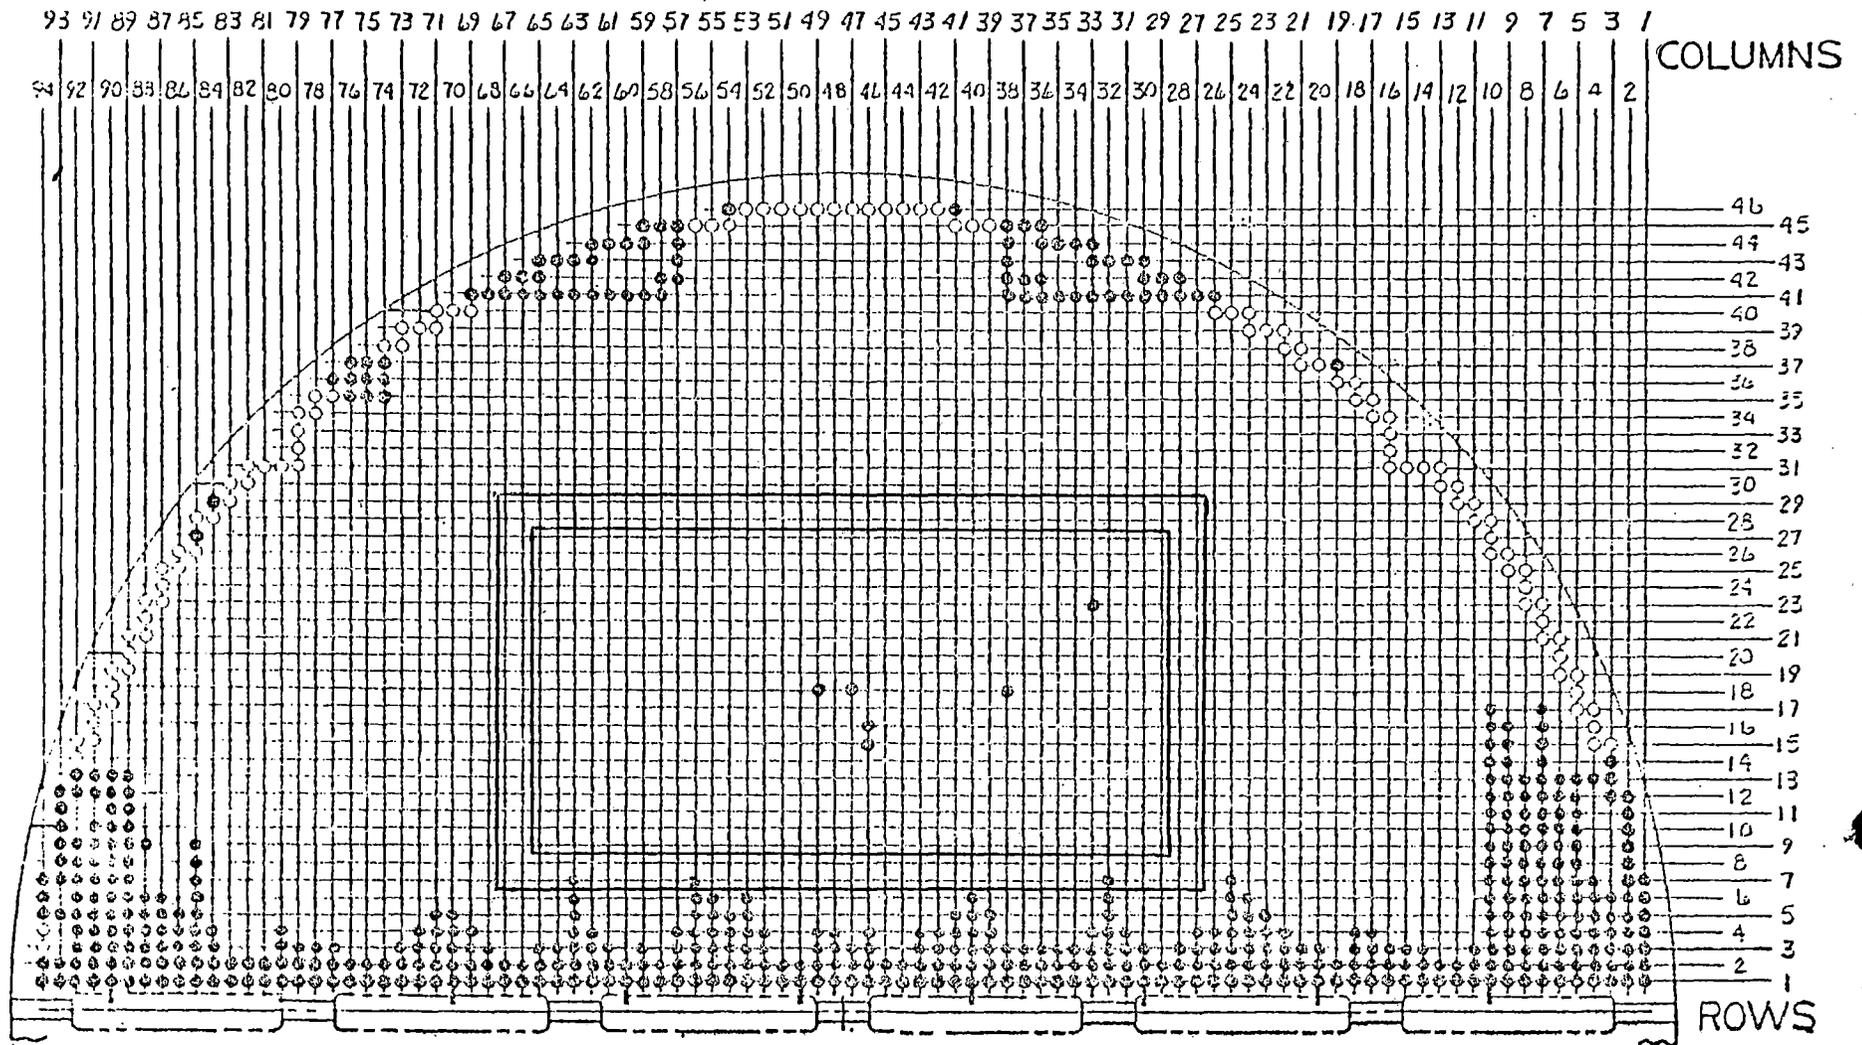
Figure 4

SUPPLEMENTARY INSPECTION AREAS

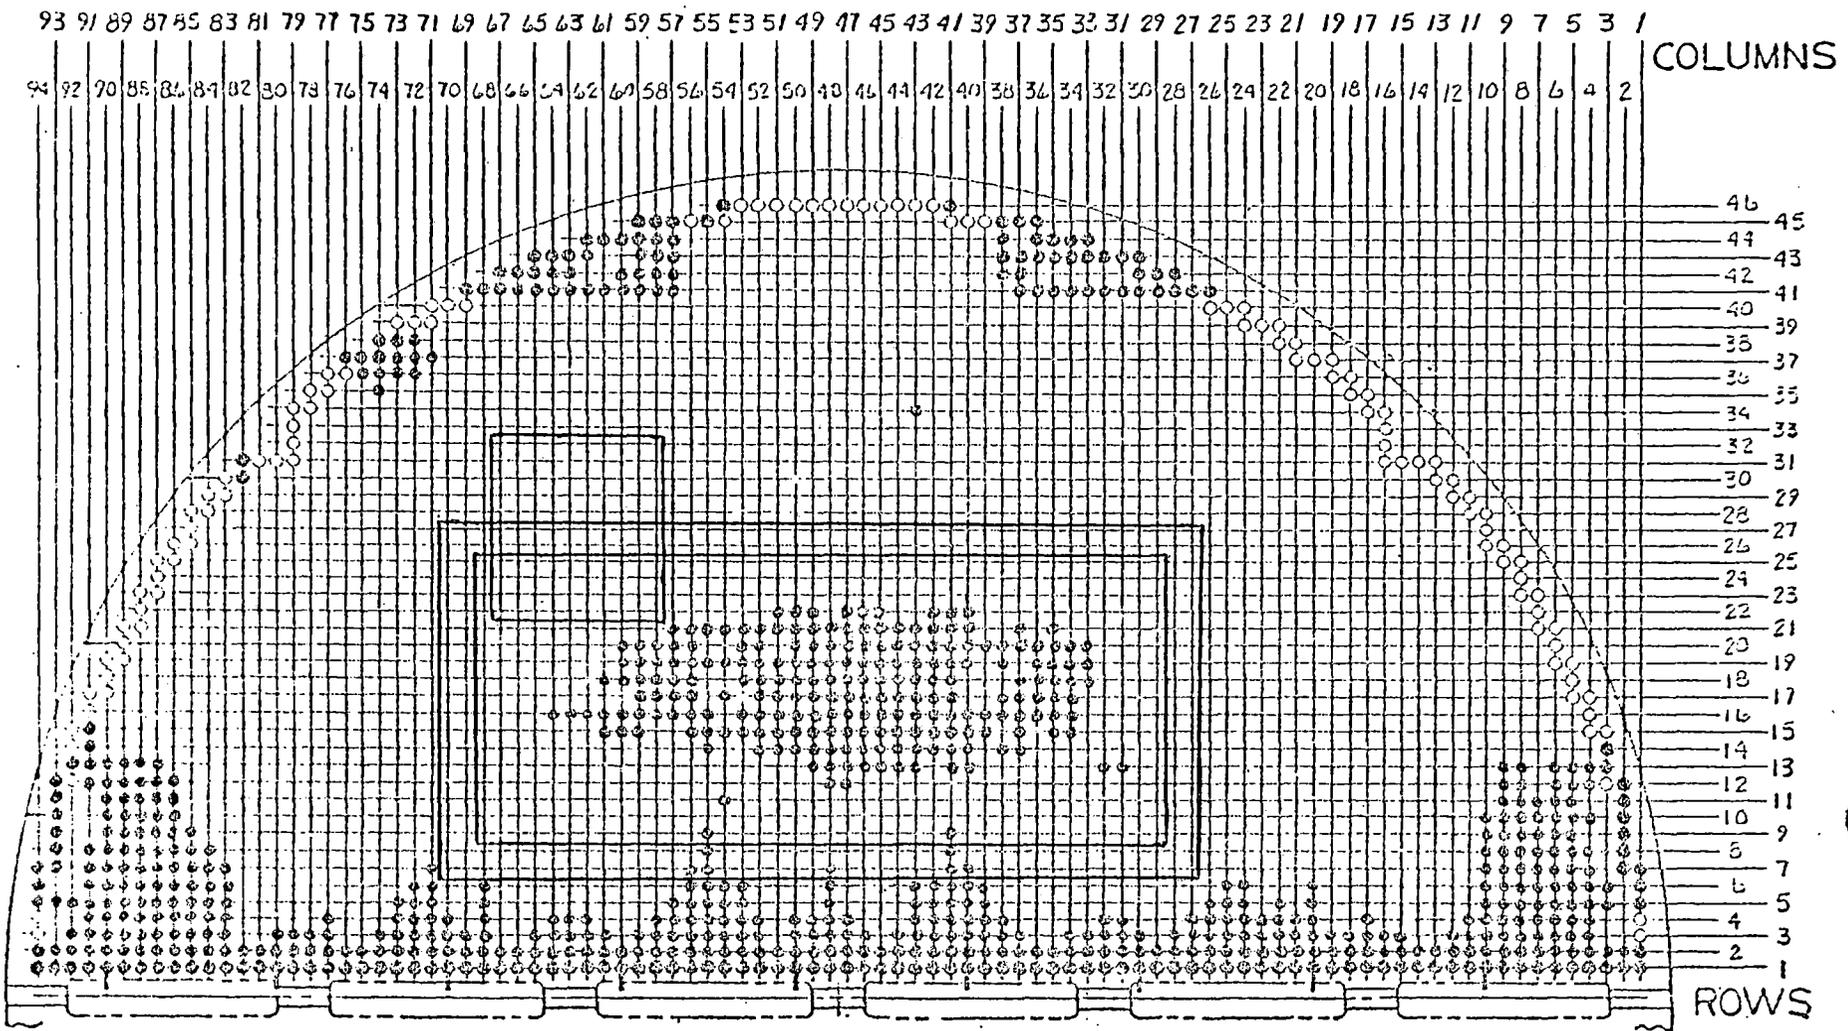
Figure 5

STEAM GENERATOR IC  
SUPPLEMENTARY INSPECTION AREAS

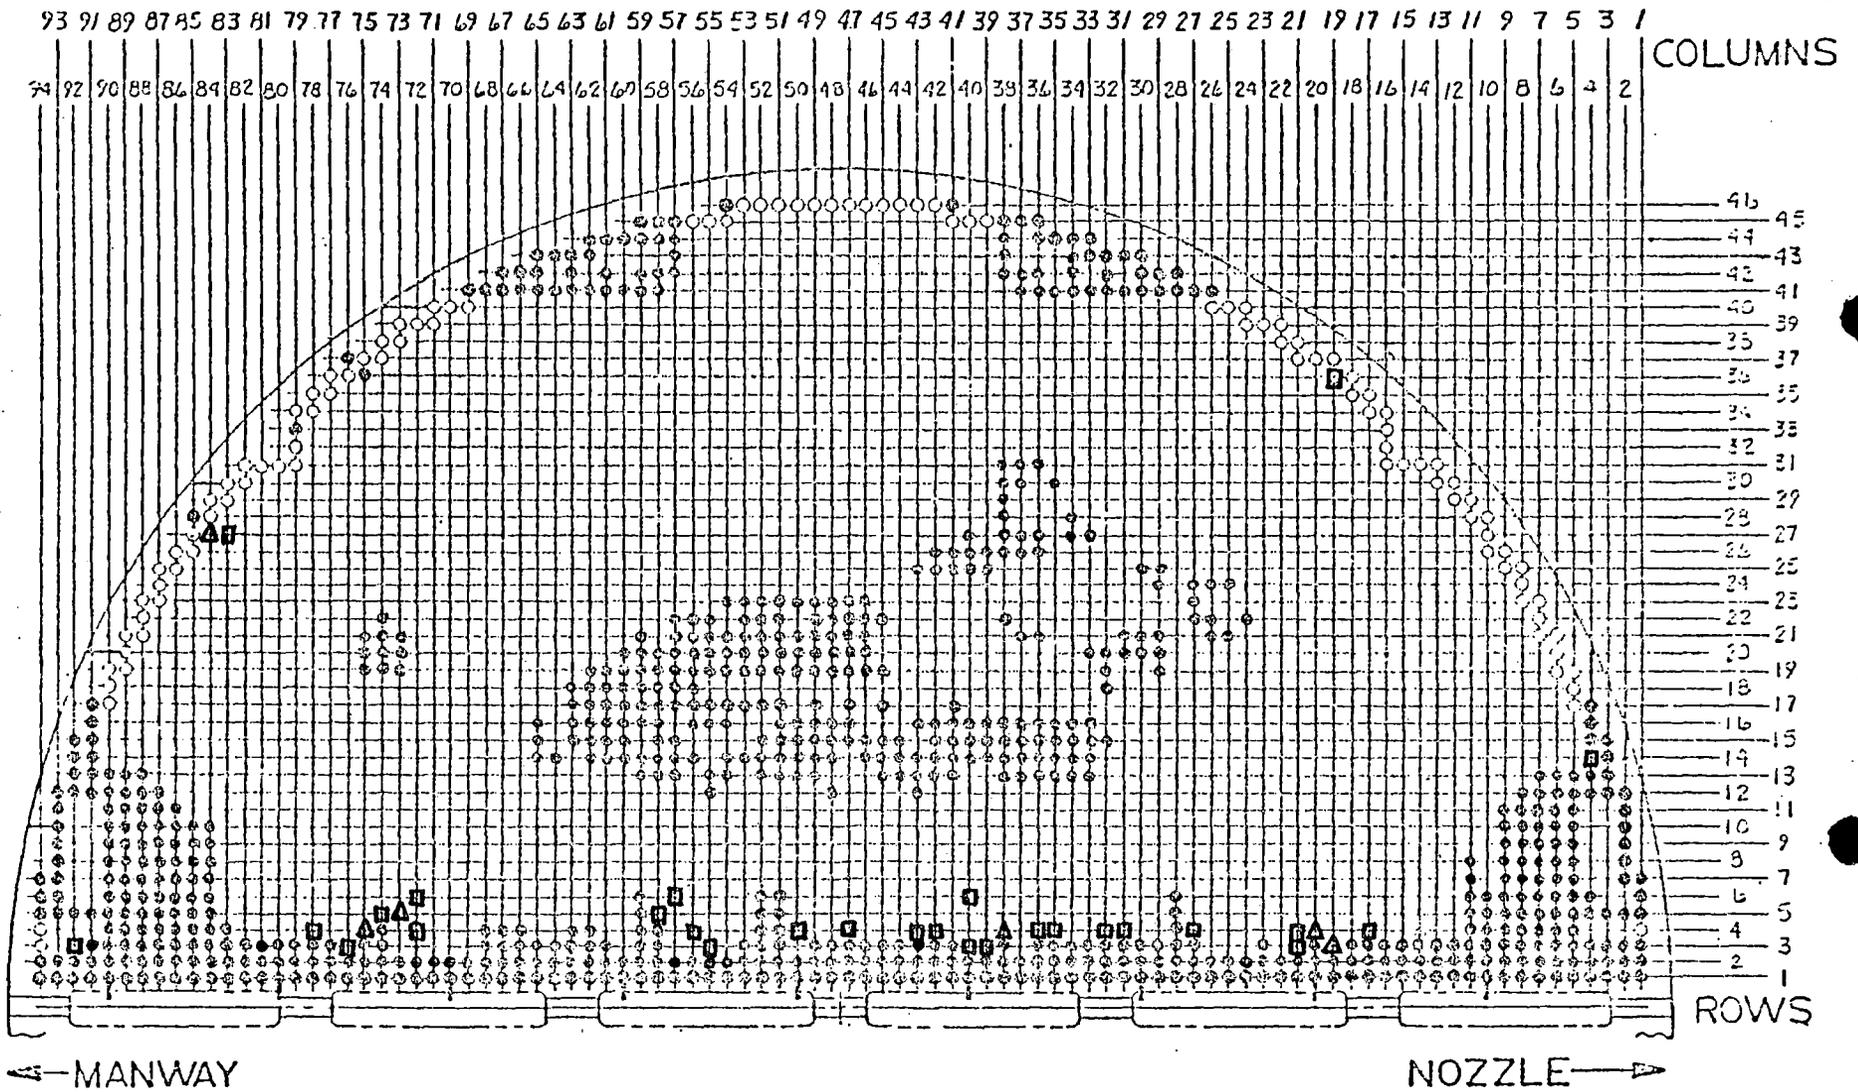
Figure 6.

The results of the inspection program are presented in Figures 6, 7, and 8. These results support the adequacy of the inspection program and the plugging criteria.

A. Tubes in the tubelance region that restrict the .650" probe lie within the 15% strain boundary. All tubes that restrict either the .610" or the .650" probe are adjacent to areas of previous activity.

B. There were no tubes in steam generators A, B, or C that restricted the .540" probe.

C. All activity appears to be moving in a stable manner, adjacent to previous activity.

GAUGING RESULTS

SURRY 1, S.G. "A"

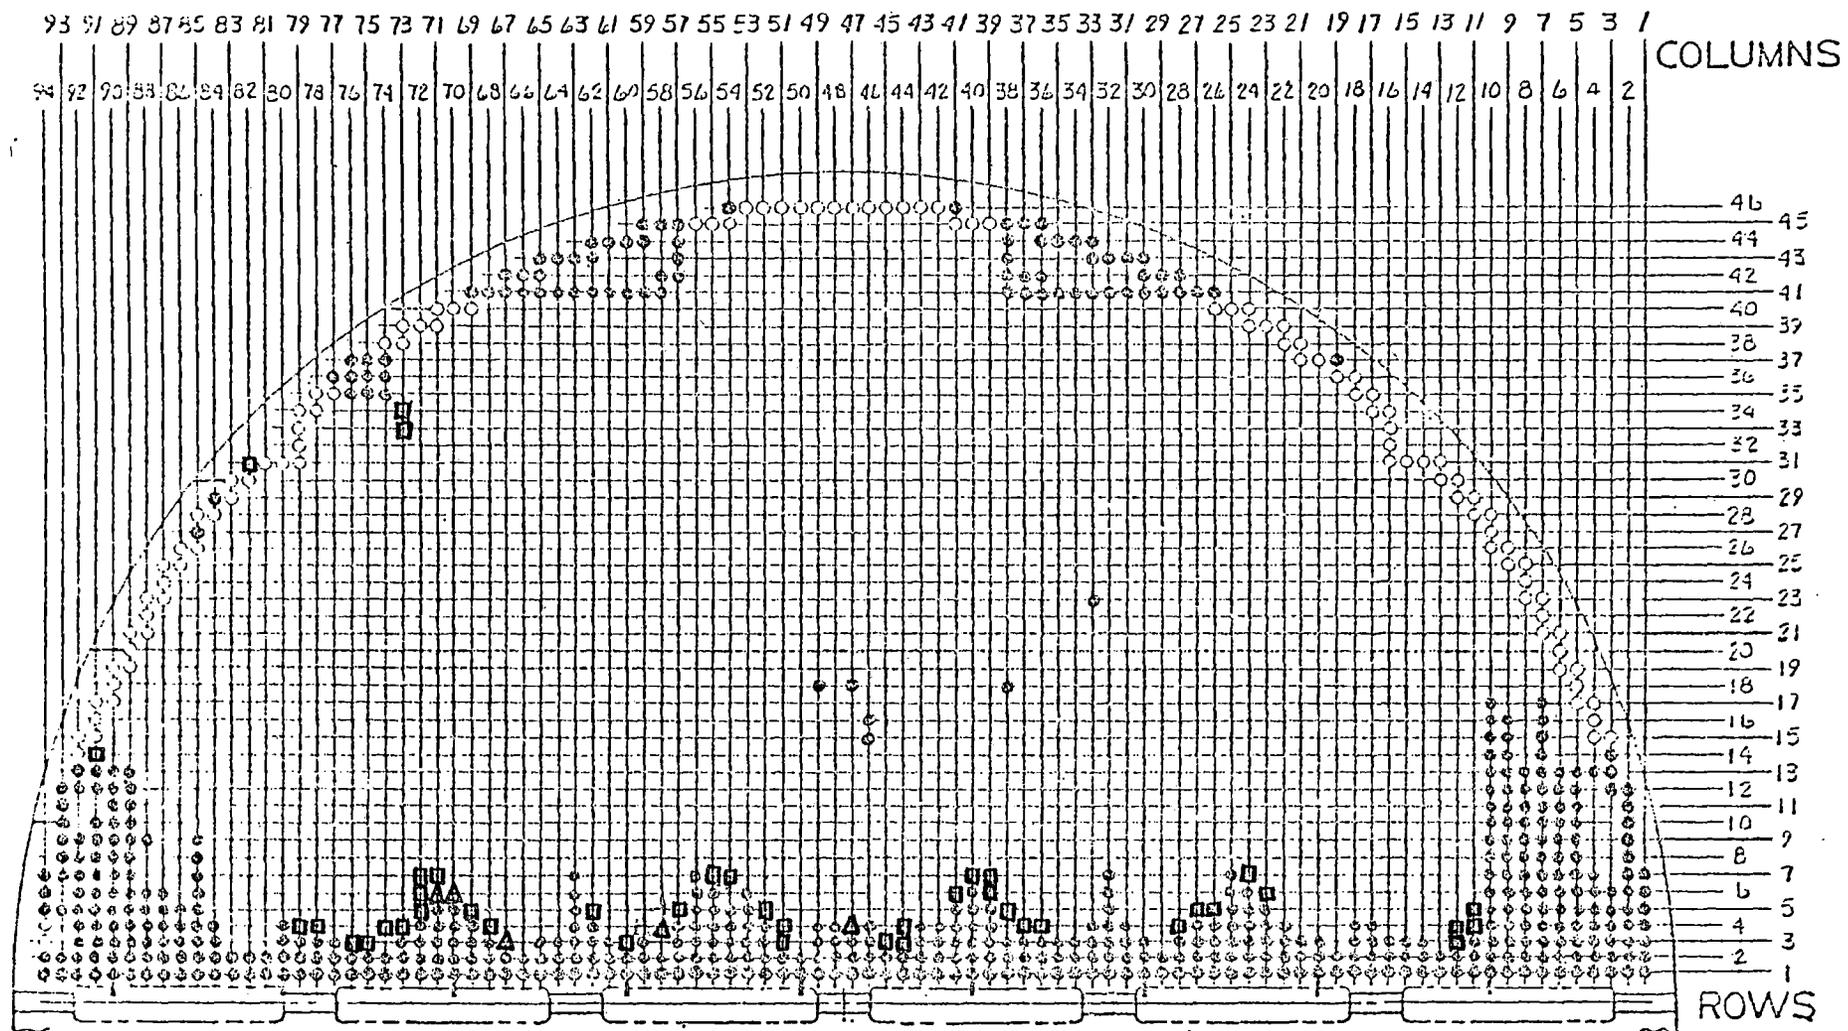
Figure 7

GAUGING RESULTS  
SURRY 1, S.G. "B"

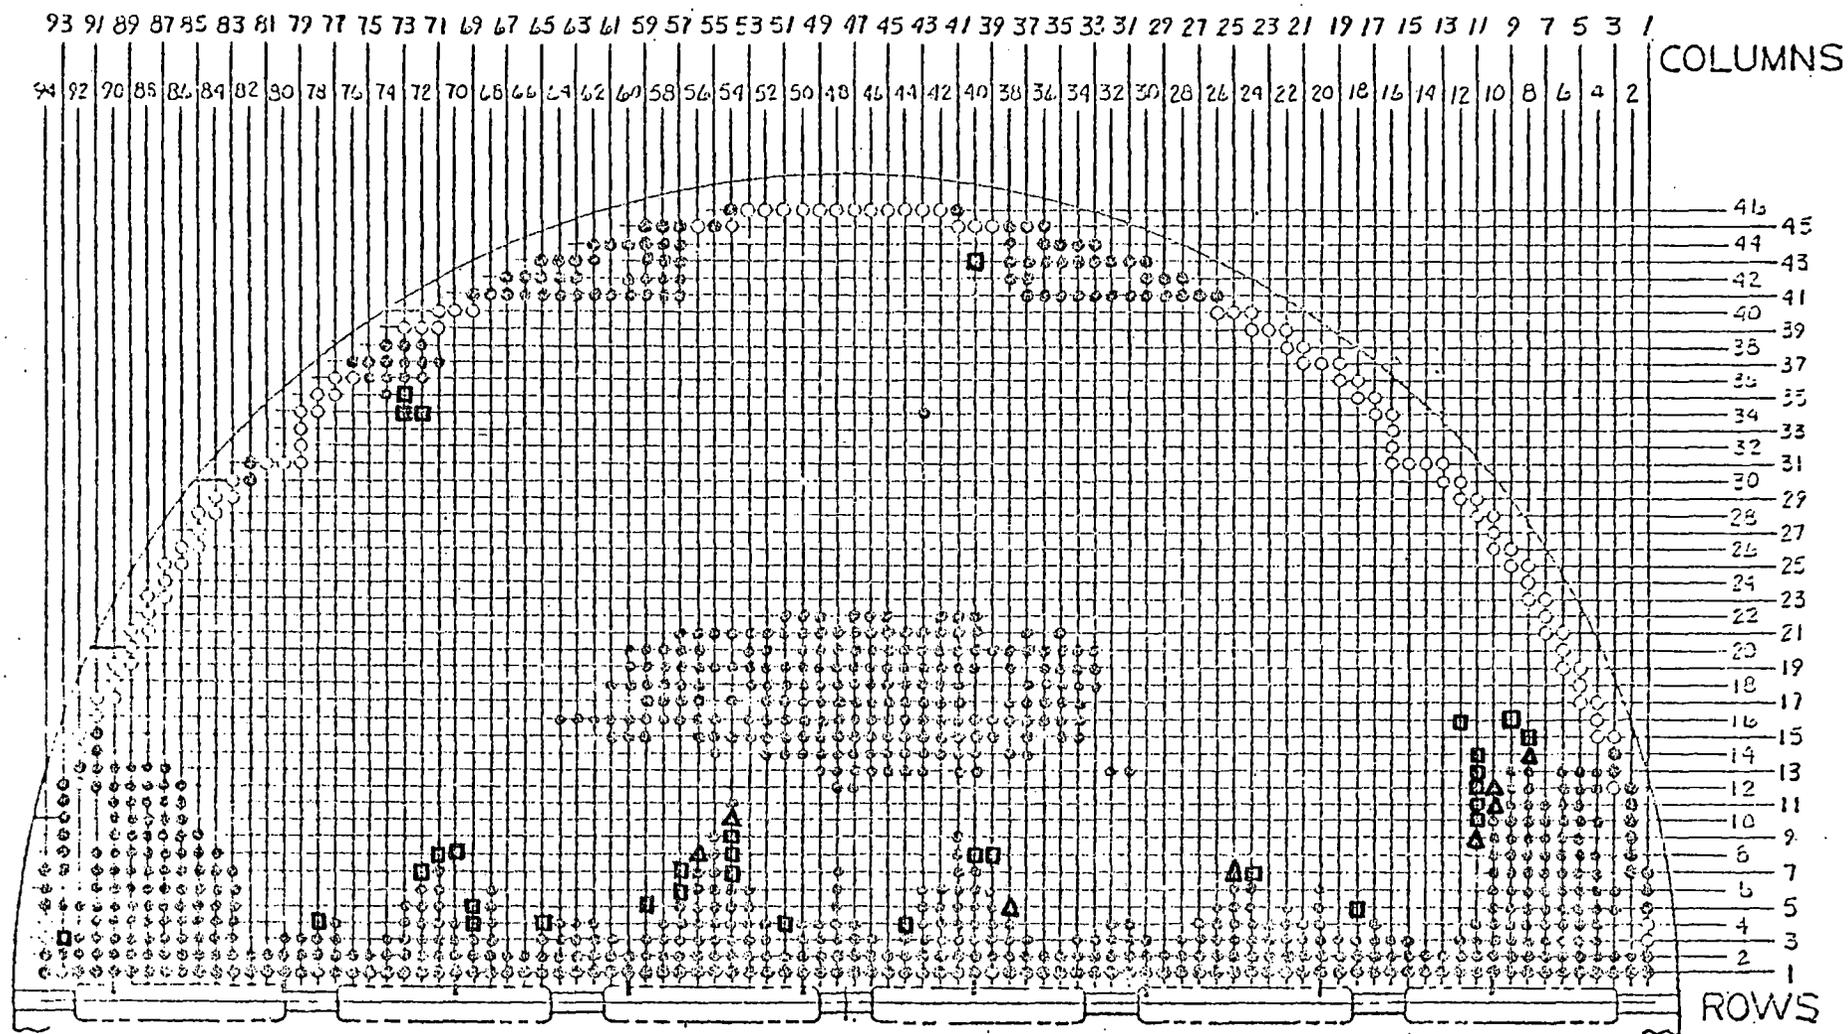
Figure 8

GAUGING RESULTS  
SURRY 1, S.G. "C"

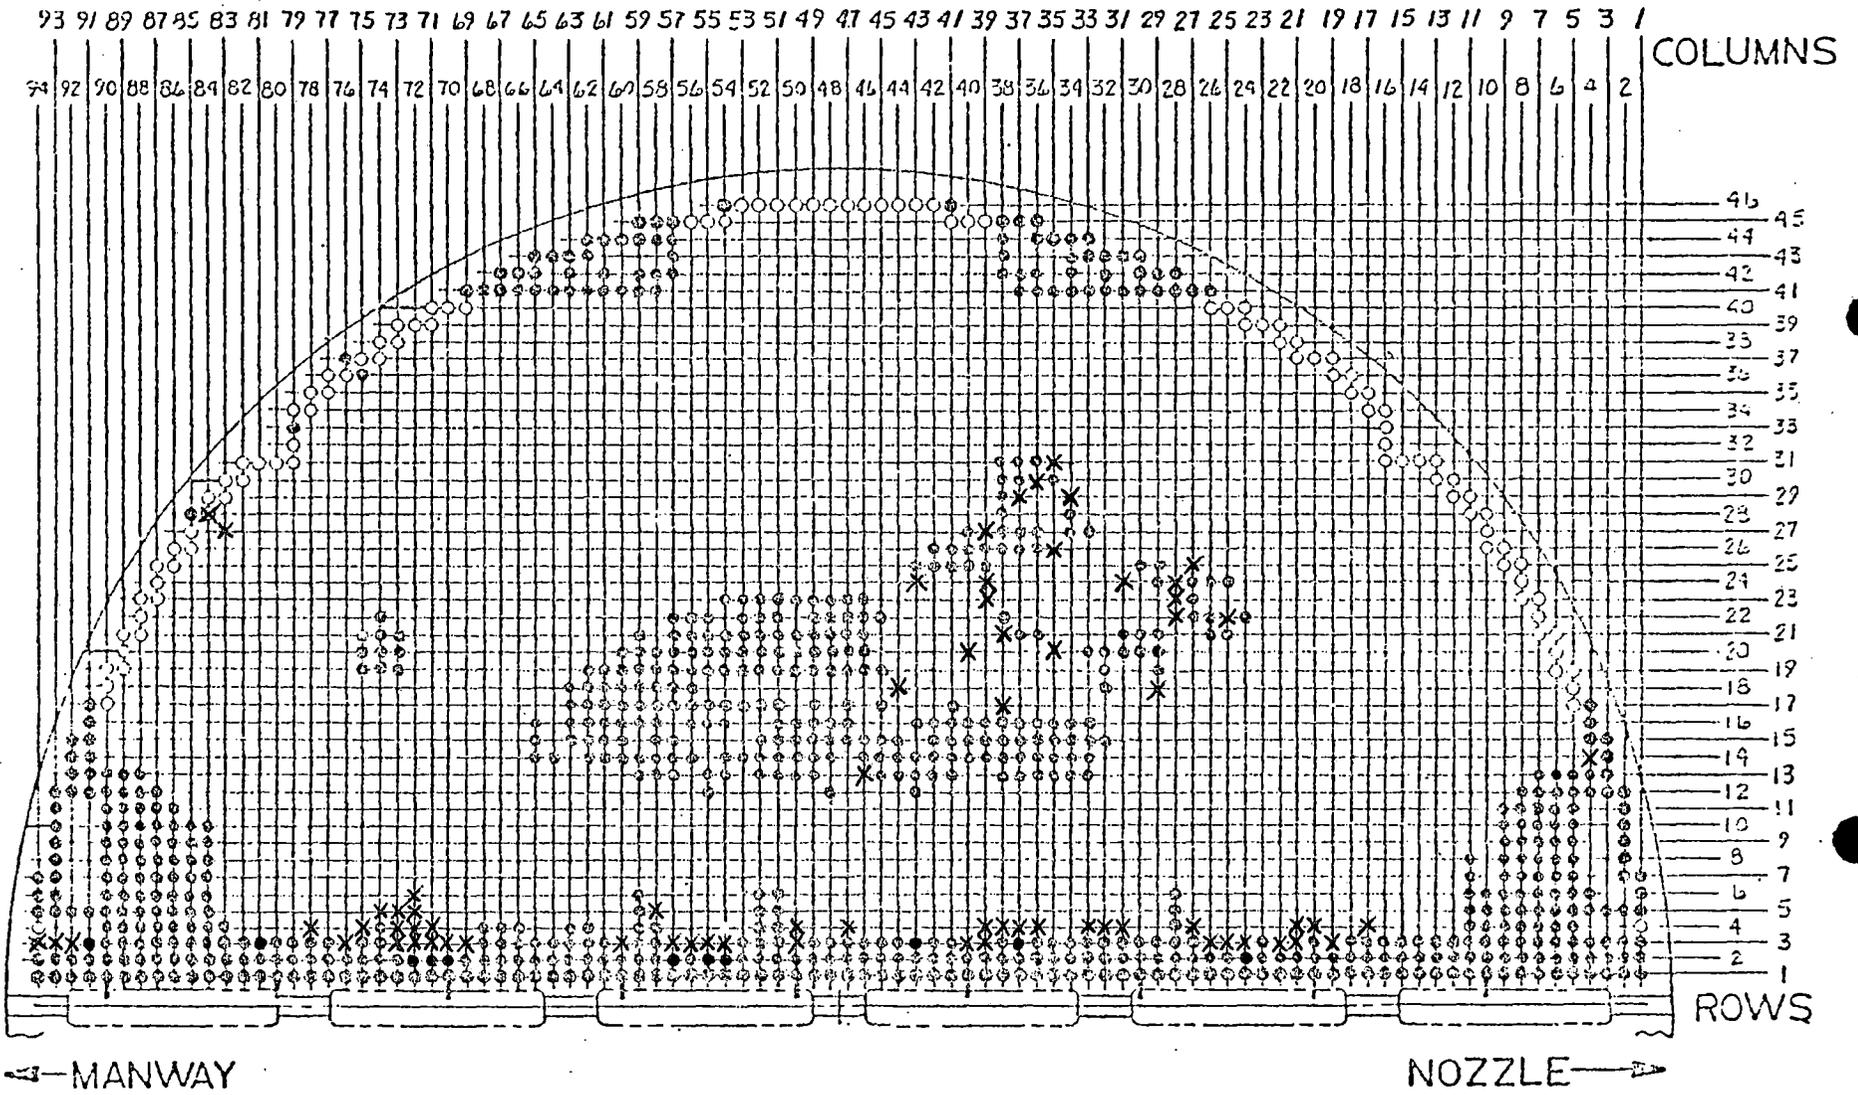
Figure 9

SURRY 1 STEAM GENERATOR A  
PREVENTIVE PLUGGING PATTERN

Figures 9, 10, and 11 indicate the plugging patterns for Surry 1 steam generators based on the plugging criteria described above.

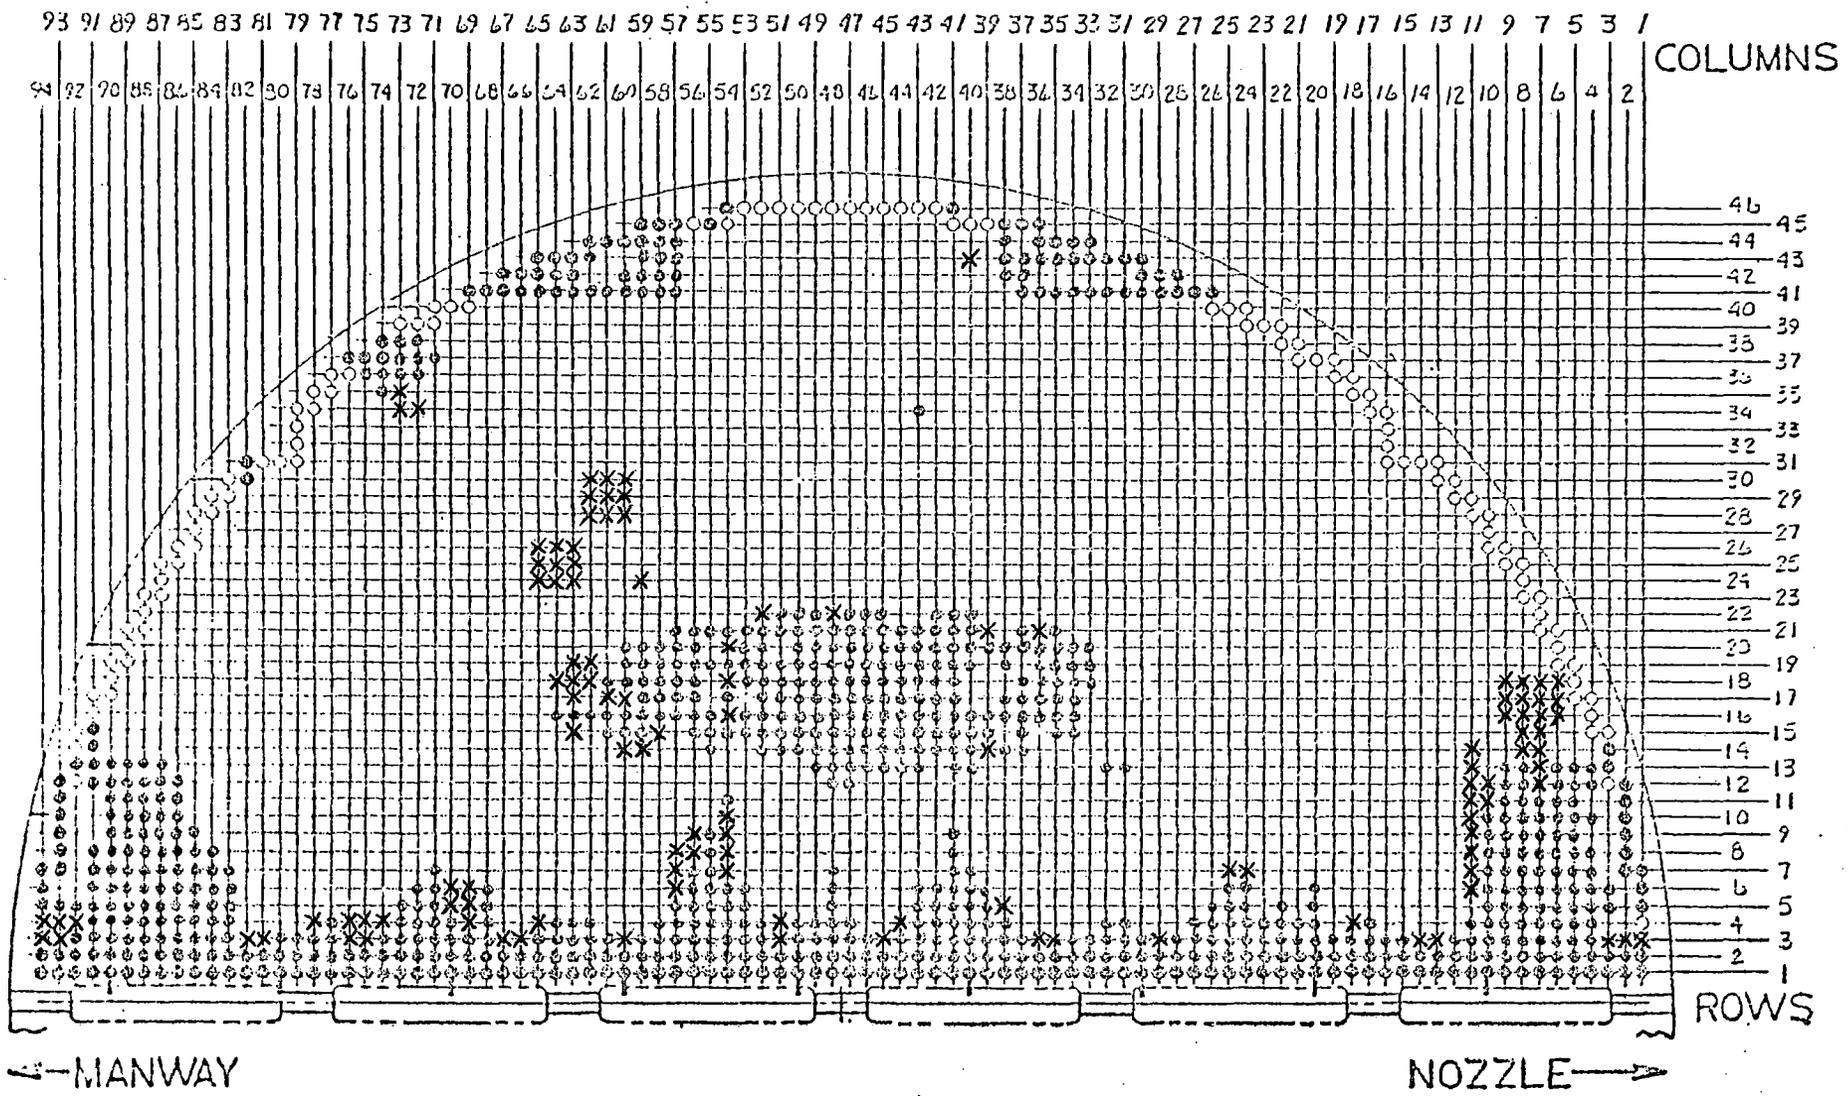
Figure 11

SURRY 1 STEAM GENERATOR C

PREVENTIVE PLUGGING PATTERN
