UNITED STATES
NUCLEAR REGULATORY COMMISSION
OFFICE OF INSPECTION AND ENFORCEMENT
WASHINGTON, D.C. 20555

October 16, 1979

IE Bulletin No. 79-13
Revision 2

CRACKING IN FEEDWATER SYSTEM PIPING

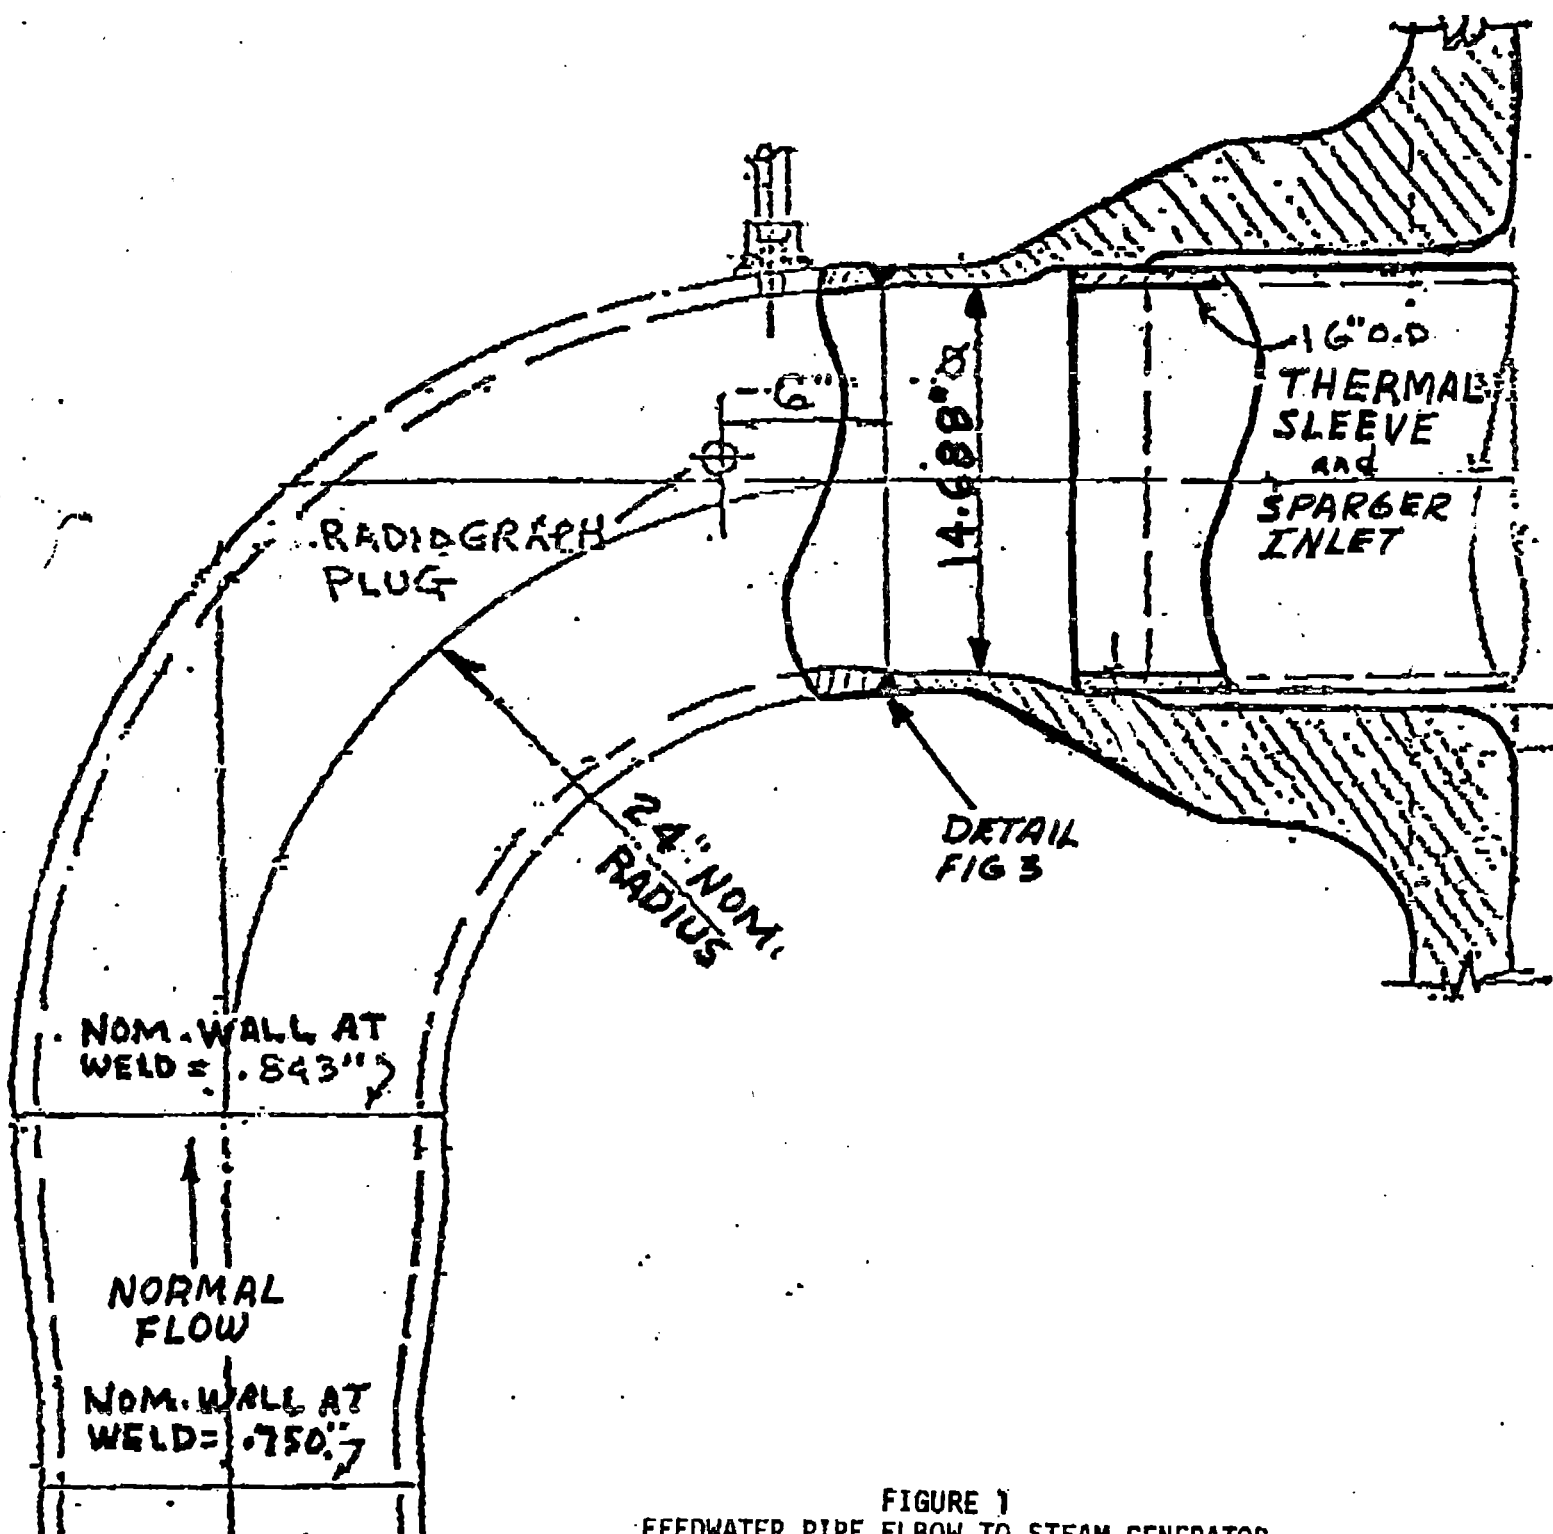
FIGURE 1
FEEDWATER PIPE ELBOW TO STEAM GENERATOR
NOZZLE INSTALLATION (DC COOK)

On May 20, 1979, Indiana and Michigan Power Company notified the NRC of cracking in two feedwater lines at their D. C. Cook Unit 2 facility. The cracking was discovered following a shutdown on May 19 to investigate leakage inside containment. Leaking circumferential cracks were identified in the 16-inch feedwater elbows adjacent to two steam generator nozzle elbow welds. Subsequent radiographic examination revealed crack indications in all eight steam generator feedwater lines at this location on both Units 1 and 2.

The feedwater nozzle-to-pipe configurations for D. C. Cook and for San Onofre are shown on the attached figures 1 and 2. A typical feedwater nozzle-to-pipe weld joint detail showing the principal crack locations for D. C. Cook and San Onofre are shown on the attached figure 3.

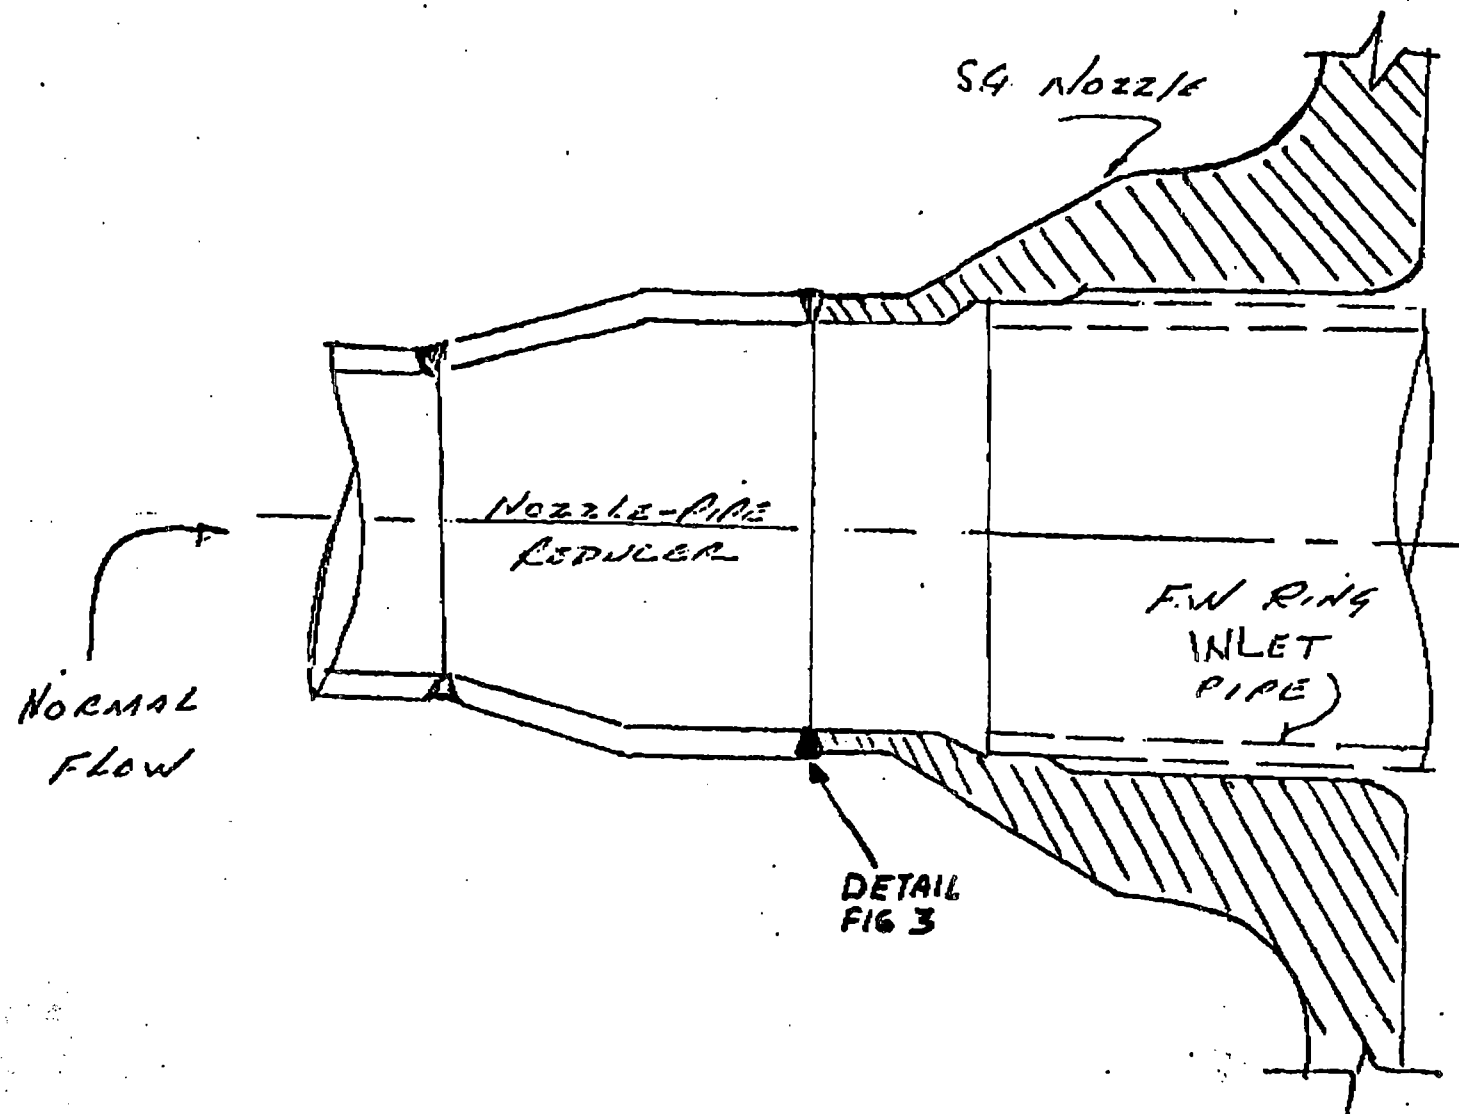
FIGURE 2
FEEDWATER PIPE REDUCER TO STEAM GENERATOR
NOZZLE INSTALLATION (SAN ONOFRE).

As a result of these actions, several other licensees with Westinghouse steam generators reported crack indications. Southern California Edison reported on June 5, 1979, that radiographic examination revealed indications of cracking in feedwater nozzle-to-pipe welds on two of three steam generators of San Onofre Unit 1. On June 15, 1979, Carolina Power and Light reported that radiography showed crack indications in similar locations at their H. B. Robinson Unit 2. Duquesne Power and Light confirmed on June 18, 1979, that radiography has shown cracking in their Beaver Valley Unit 1 feedwater piping-to-vessel nozzle weld. Public Service Electric and Gas Company reported on June 20, 1979 that Salem Unit 1 also has crack indications. Wisconsin Public Service company decided on June 20, 1979 to cut out a feedwater nozzle-to-pipe weld which contained questionable indication, for metallurgical examination. As of June 22, 1979 and since May 25, 1979 seven other PWR facilities have inspected the feedwater nozzle-to-pipe welds without finding cracking indications.

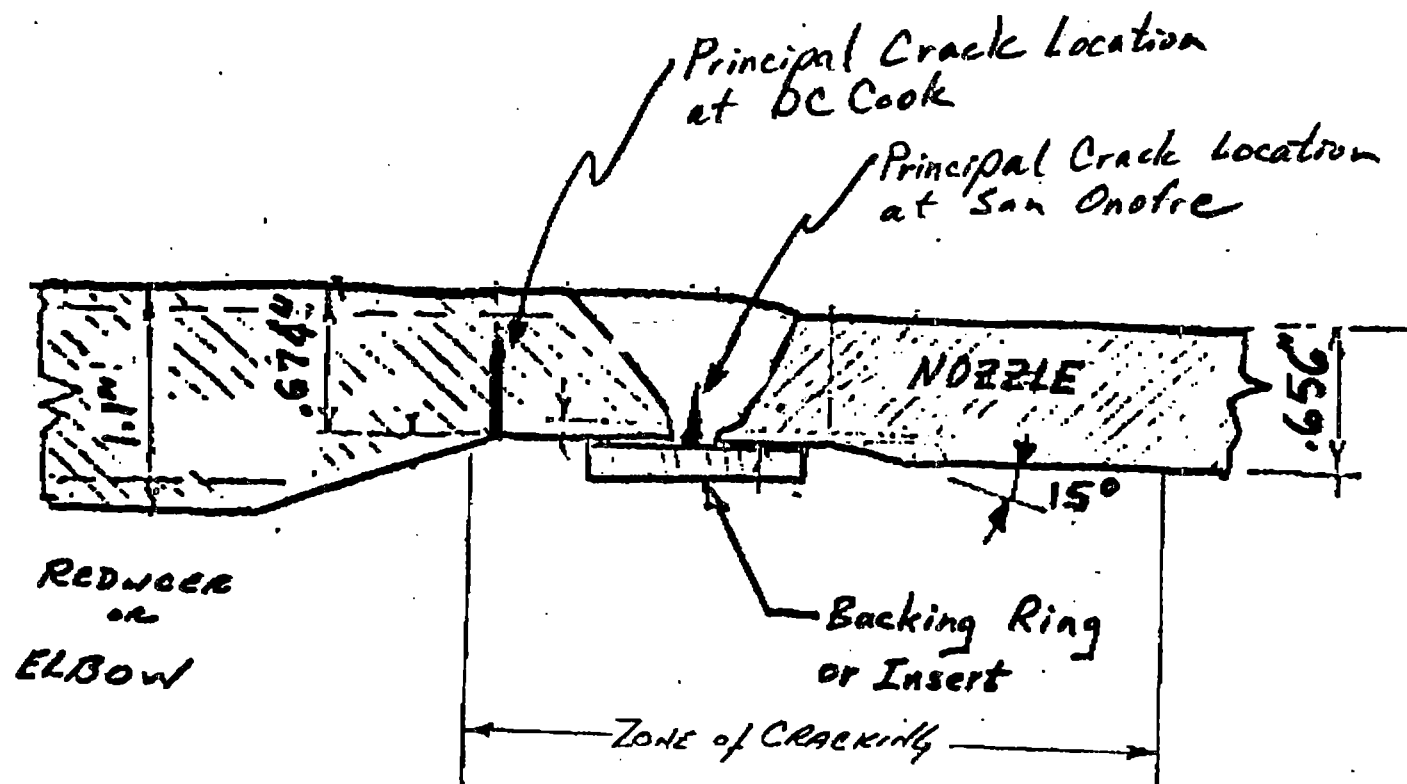
FIGURE 3
TYPICAL FEEDWATER PIPE TO NOZZLE
WELD JOINT DETAIL
(W . CE)

An extensive metallurgical investigation has been conducted by Westinghouse on a substantial number of cracked weldments removed from the above plants. Results of the metallurgical analysis lead to the conclusion that a corrosion fatigue phenomenon is the probable failure mechanism, except for the San Onofre piping which has been characterized as stress assisted corrosion.

- a. Perform radiographic examination, supplemented by ultrasonic examination as necessary to evaluate indications, of all feedwater nozzle-to-pipe welds and of adjacent pipe and nozzle areas (a distance equal to at least two wall thicknesses). Evaluation shall be in accordance with ASME Section III, Subsection NC, Article NC-5000. Radiography shall be performed to the 2T penetrameter sensitivity level, in lieu of Table NC-5111-1, with systems void of water.
