WCAP-9638

METALLURGICAL INVESTIGATION OF  
CRACKS IN THE STEAM GENERATOR  
FEEDWATER LINES OF SURRY STATION NO. 1

L. Albertin  
G. V. Rao  
T. R. Mager

December 1979

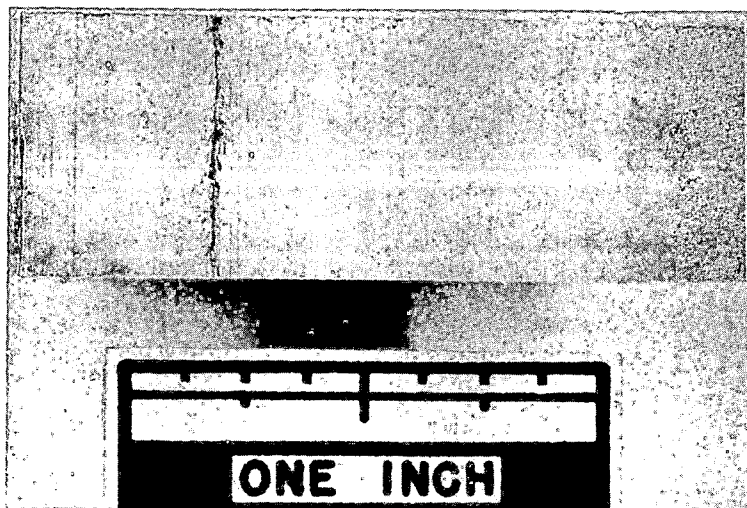
Figure 2-1. Cross Section and Inside Diameter Surface Appearance of Reducer B Near the Nozzle-to-Pipe Joint at 121°. Note machining grooves and heavy pitting at crack.

Visual and microscopic examination of the inside surfaces of Reducer B and C sections near the nozzle-to-pipe joint revealed several cracks and pits (figures 2-1 to 2-5). The cracks tended to initiate from machining grooves or grinding marks below the "knee" of a reduced section. A piece containing the largest crack in Reducer B (figure 2-1) showed severe, continuous pitting along the crack. This crack, when opened, measured 0.080 inches and was located 121° away from the top (0°) position. The deepest crack in Reducer C measured 0.070 inches and was located at 108°. Smaller cracks were found at other locations in the reduced sections of both pipes. The cracks ran along the circumference of the pipes and grew in a relatively straight manner from the ID surface towards the OD surface (figures 2-6 to 2-11) with very little branching. The cracks were transgranular in nature and were not influenced by the banded microstructure. The walls of the cracks were severely oxidized. Bulging and narrowing of the oxide along the crack path (figures 2-5 and 2-9) suggest a crack-arrest and growth mechanism. A few beach marks, seen in figure 2-16, further point to an intermittent growth mechanism. Some of the oxidation was in the form of intrusions rather than cracks (figures 2-8 and 2-12). The relatively straight nature of cracking in the radial direction suggests that aqueous corrosion was assisted by stress. Opened cracks showed a dark corrosion product on the surface. Higher magnification fractographs showed the product to be mostly crystalline (figure 2-21), presumably  $Fe_3O_4$ . This oxide is more voluminous than the parent metal and could exert an additional stress for crack propagation. The cracking process appears to be relatively slow and perhaps self-limiting.

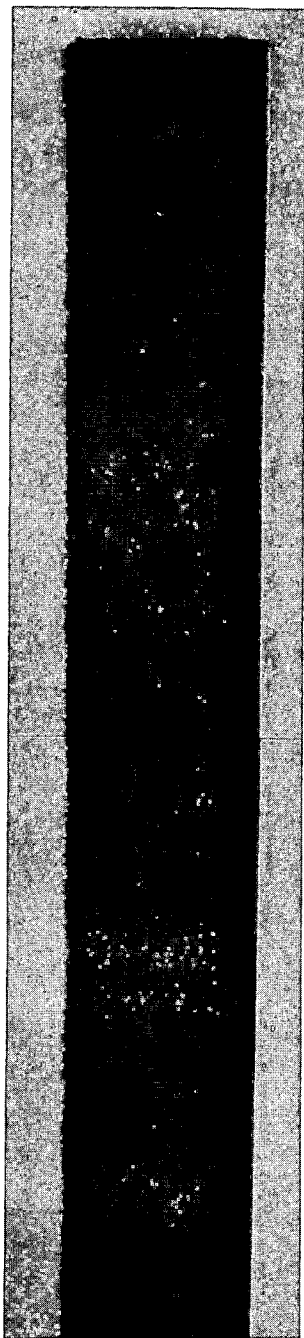
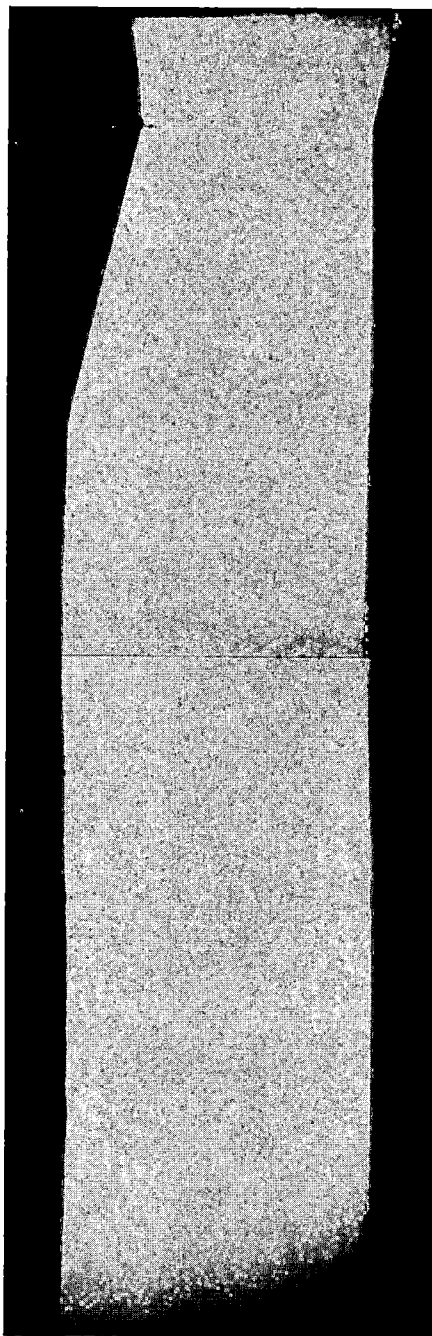
Figure 2-2. Inside Diameter Surface and Cross Section of Reducer B Near Crack Location 64 Degrees

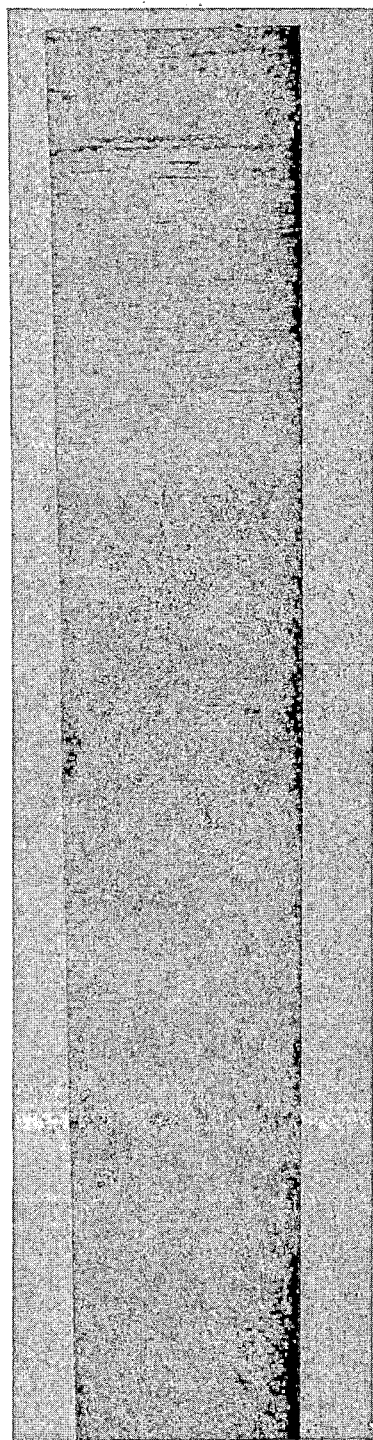
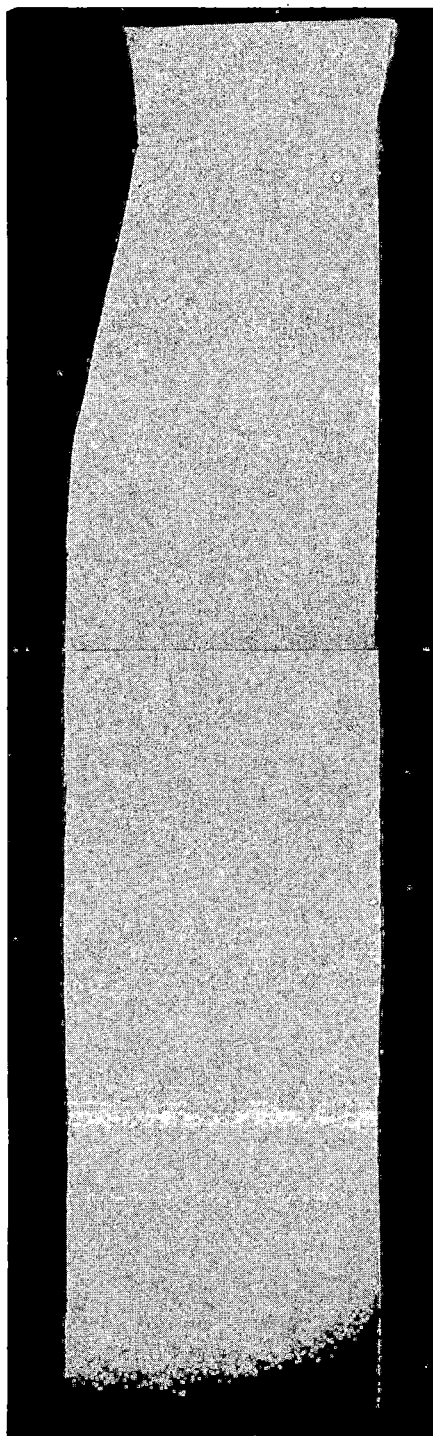
Figure 2-3. Inside Diameter Surface and Cross Section of Reducer B at 227°

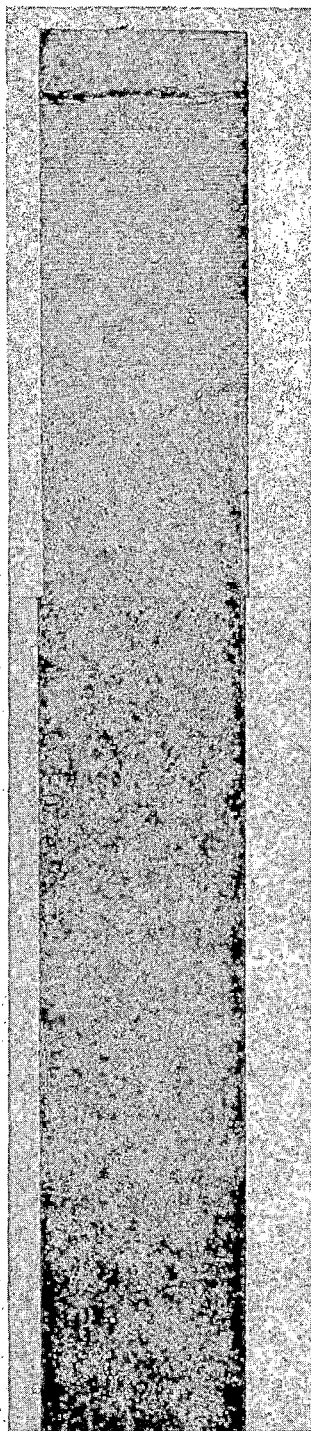
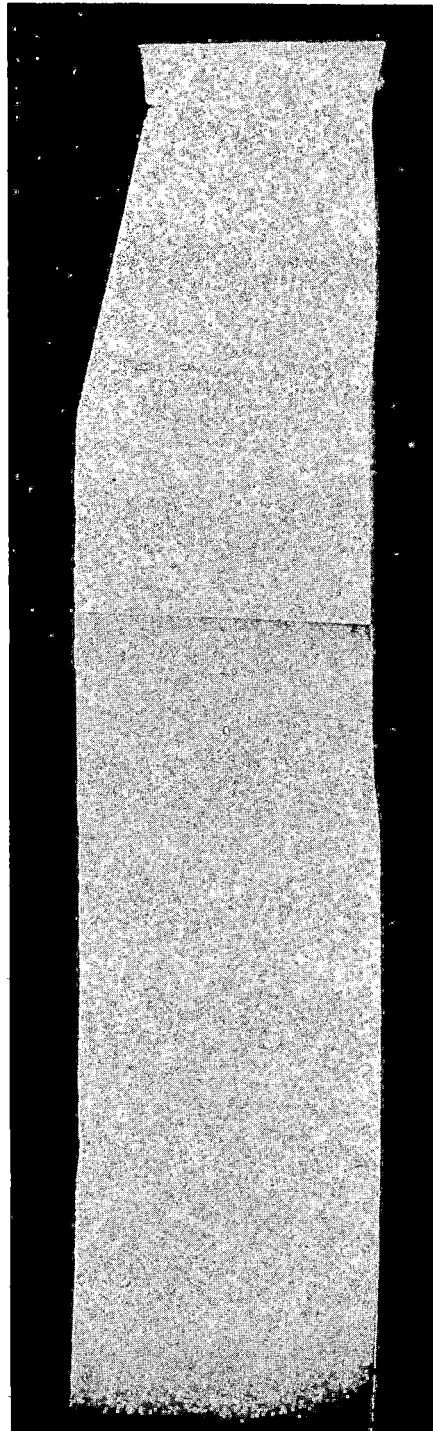
Figure 2-4. Inside Diameter Surface Appearance and Cross Section of Reducer B at 294°

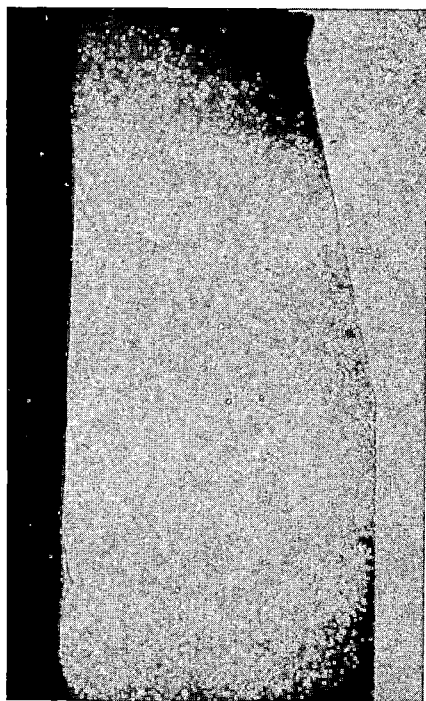
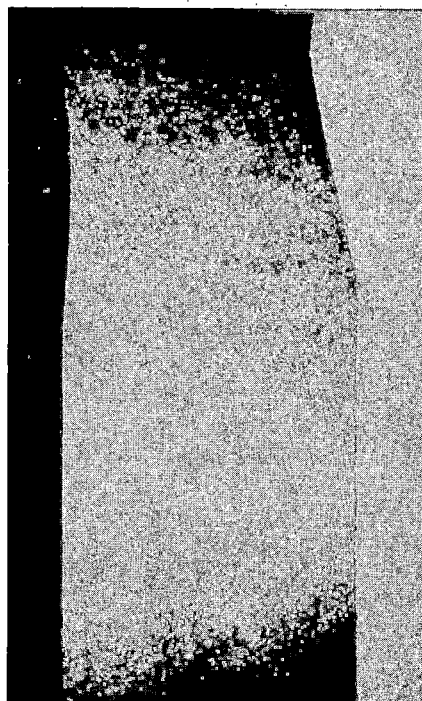
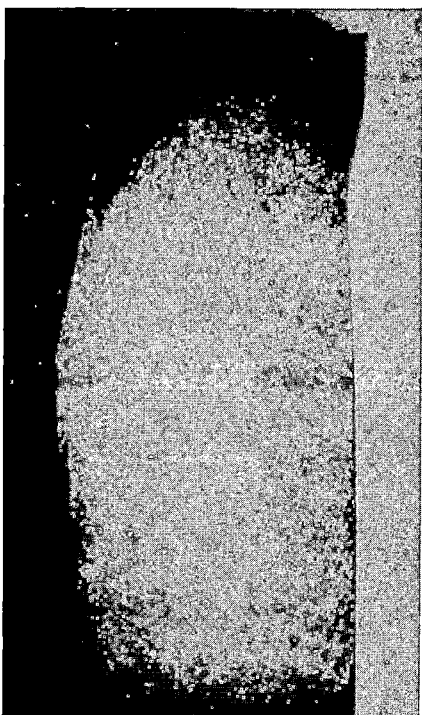
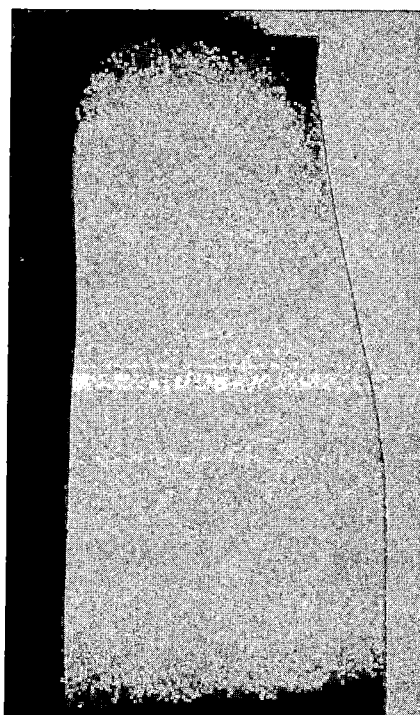
Figure 2-5. Location and Shape of Cracks at Various Locations in Reducer C (Mag. 2x)

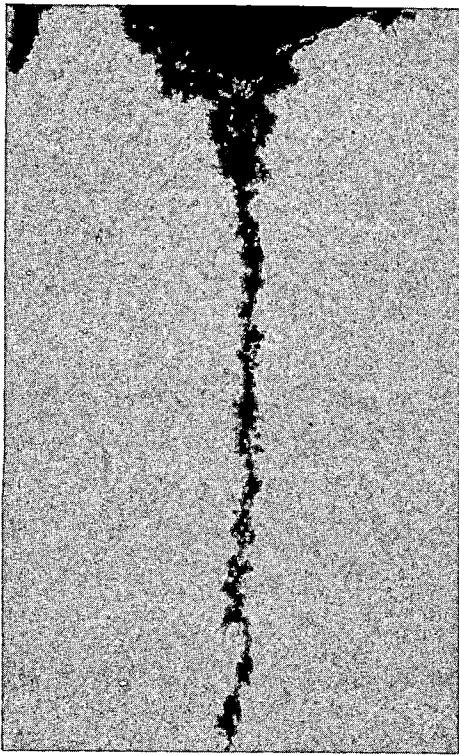
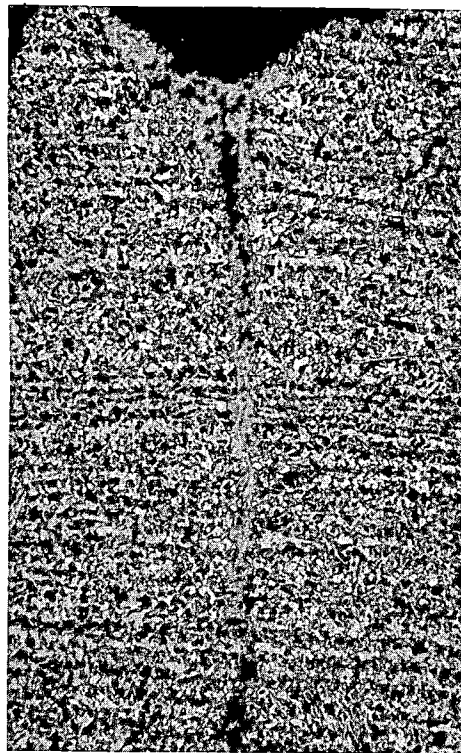
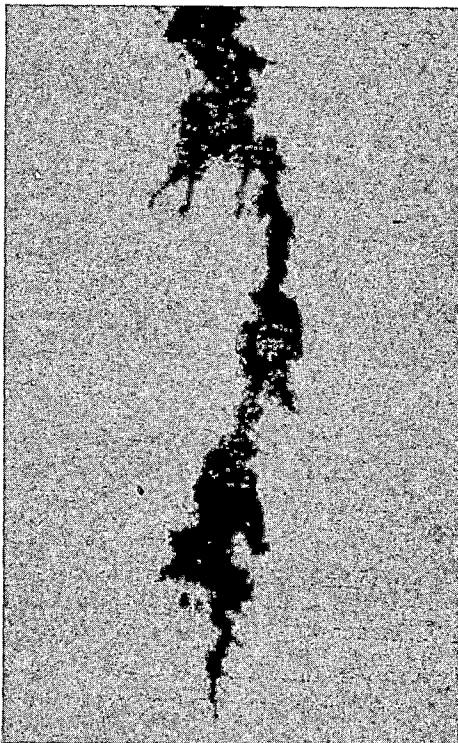
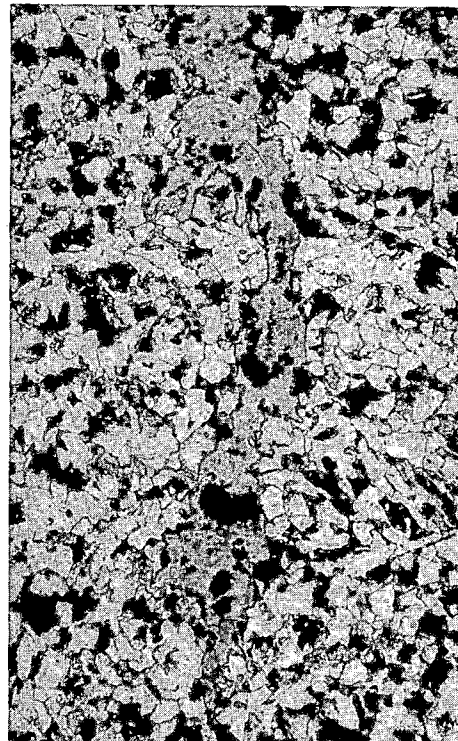
Samples containing the largest cracks in Reducers B and C were further evaluated by metallography. Details of these cracks are shown in figures 2-6 to 2-12. Most cracks tend to initiate at stress concentrations such as machining grooves.

Figure 2-6. Metallographic Section Containing the Longest Crack at 121° in Reducer B. Lower photographs are details of the crack tip.

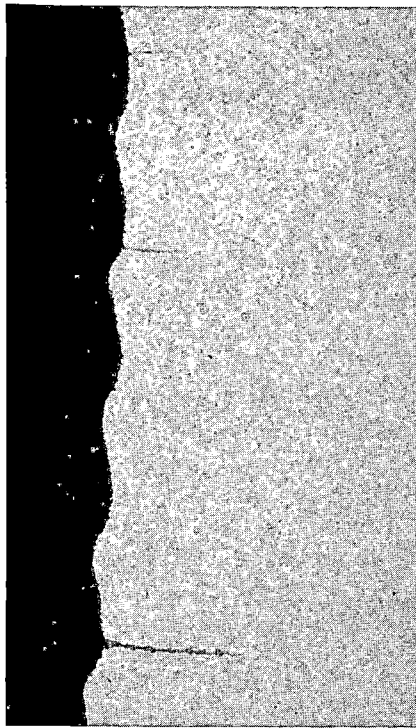
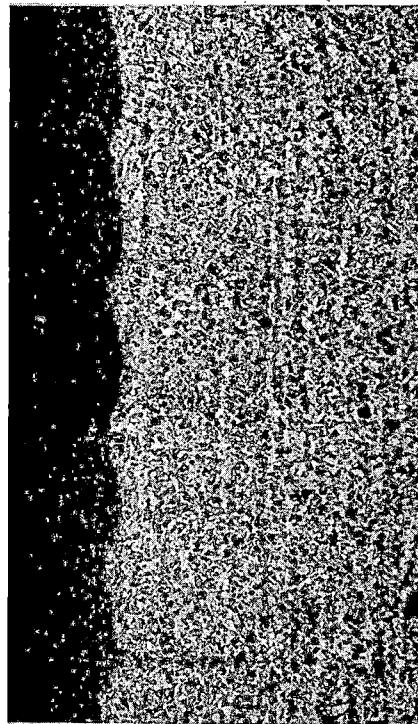
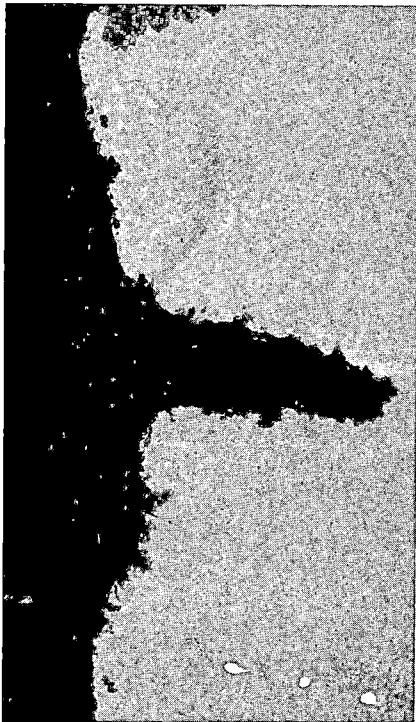
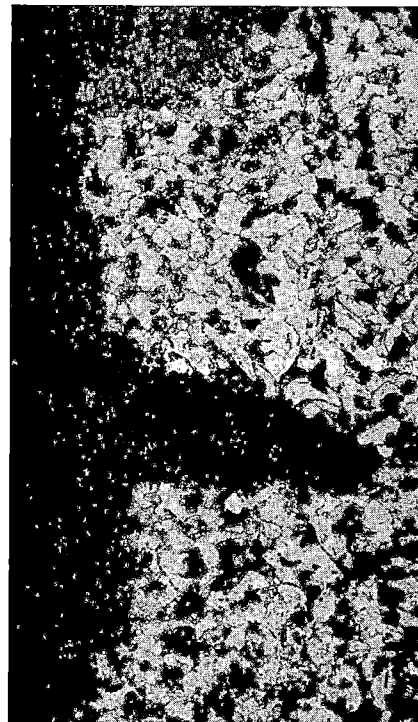
Figure 2-7. Section at 121° Showing Location and Shape of Smaller Cracks Near Weld in Reducer B

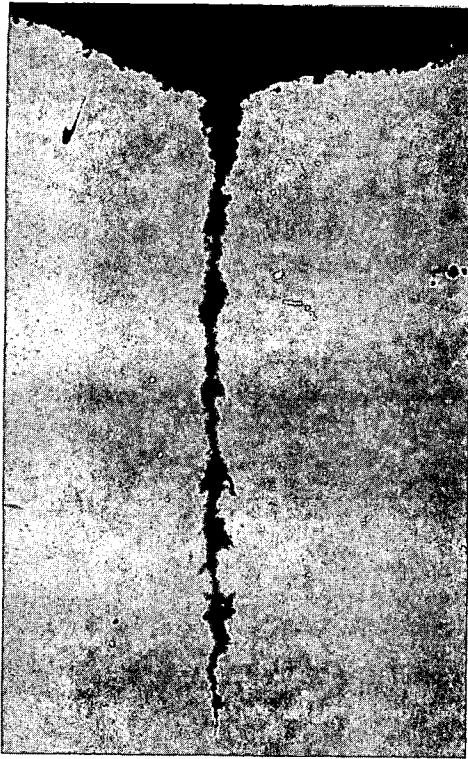
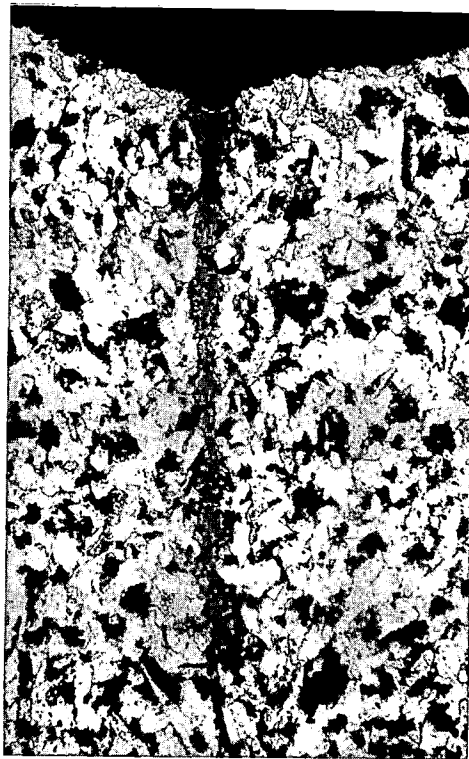
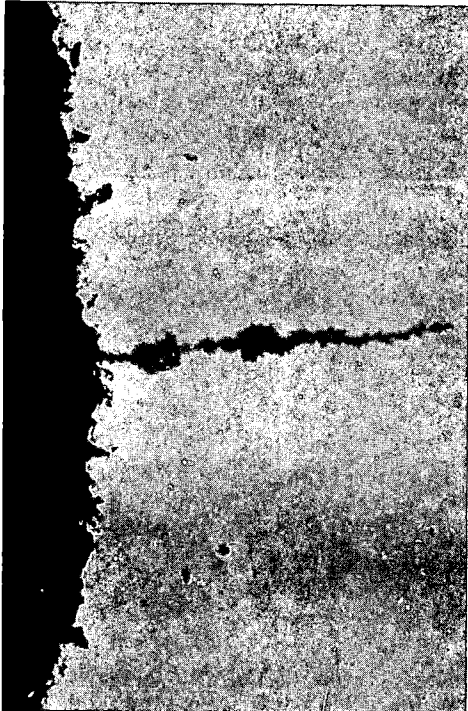
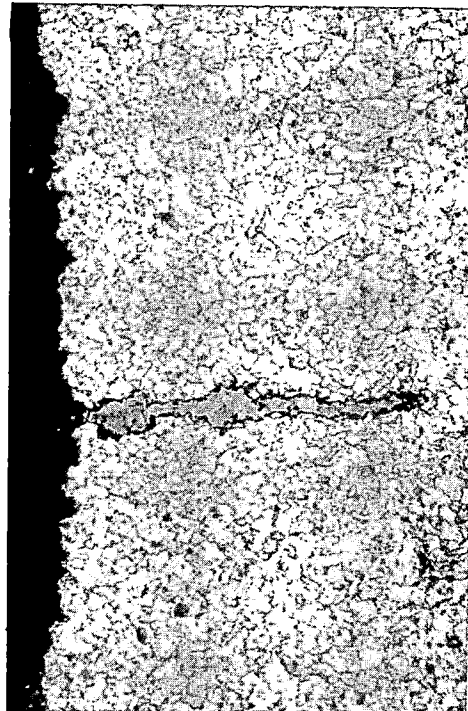
Figure 2-8. Section at 121° Showing Details of Smaller Cracks in Reducer B Near the Nozzle-to-Weld Joint

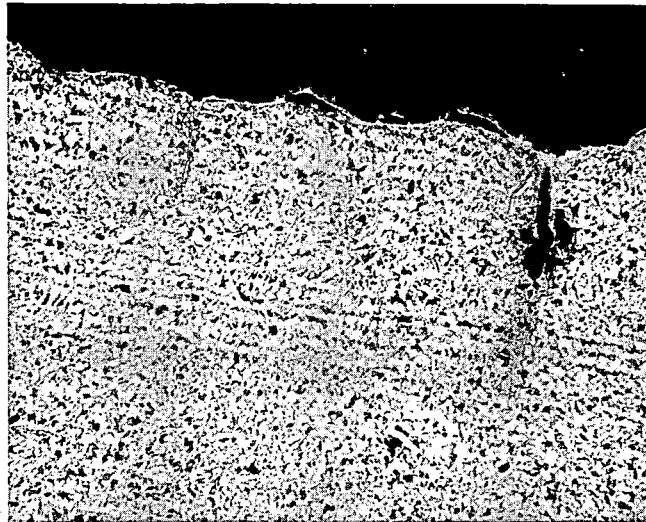
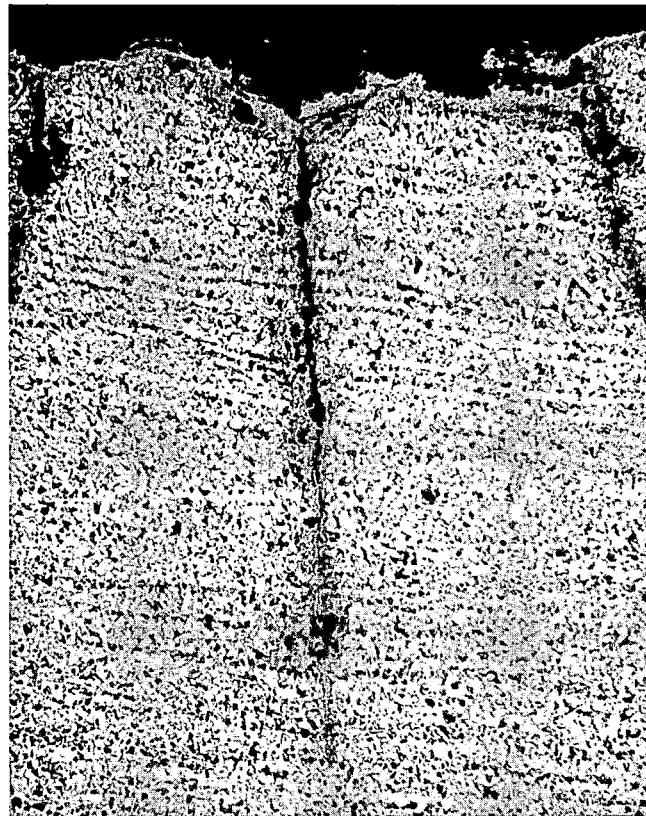
**Figure 2-9.** Metallographic Cross Section of Reducer C Showing Several Small Cracks and the Deepest Crack (at 108°)

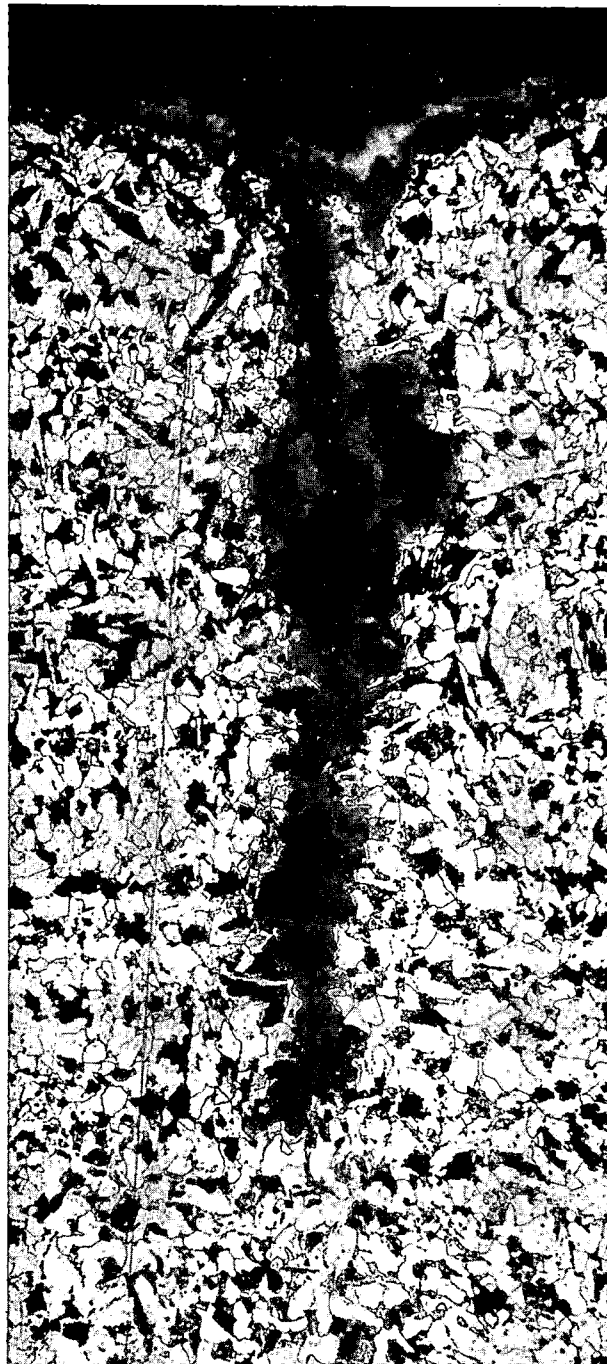
Figure 2-10. Details of One of the Cracks Shown in Figure 2-9

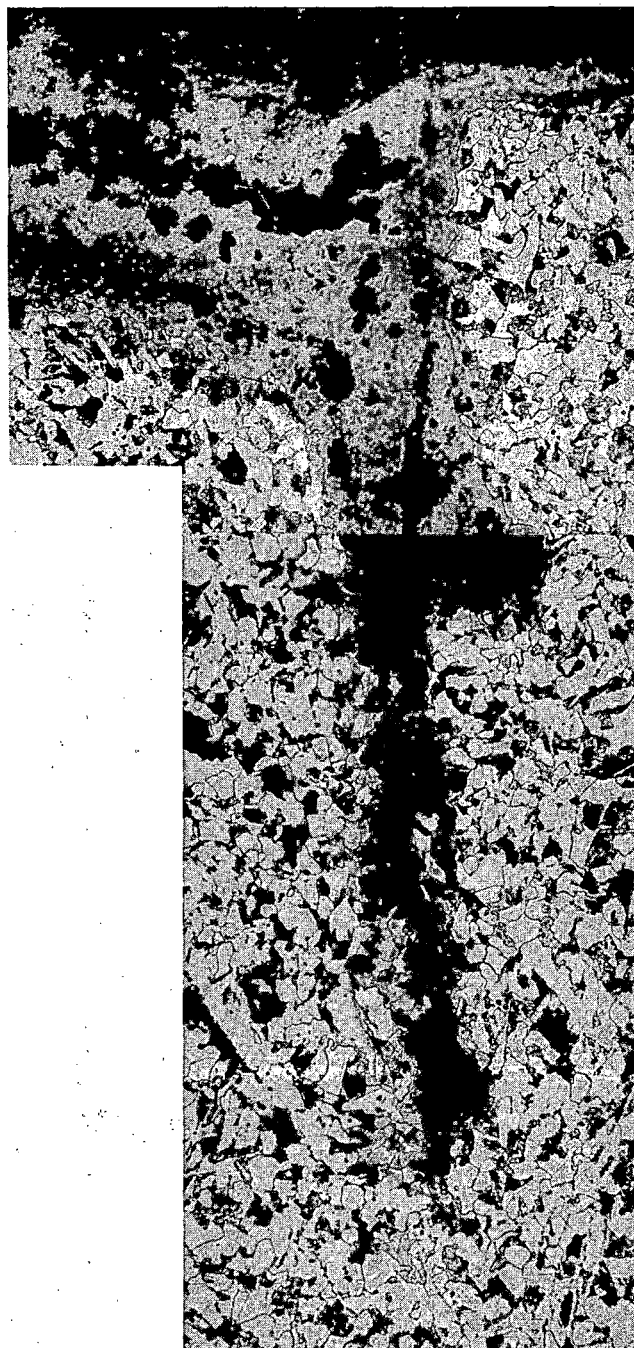
**Figure 2-11. Further Detail of a Second Crack Shown in Figure 2-9**

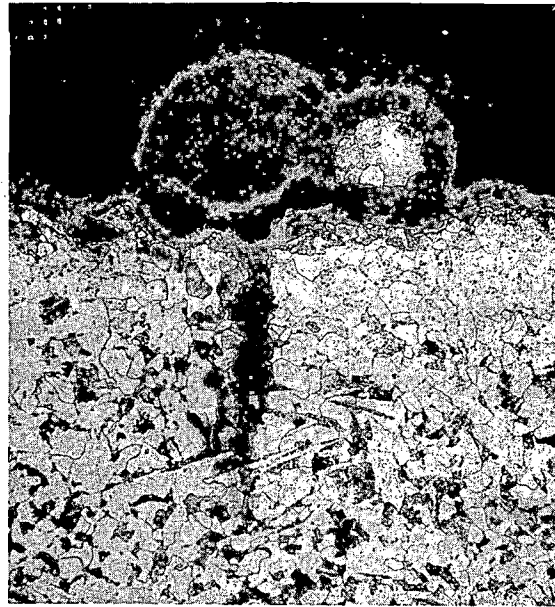
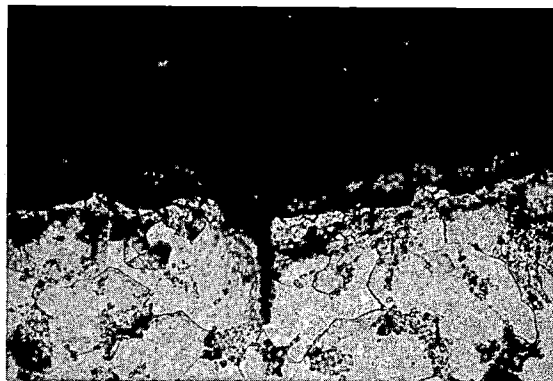
**Figure 2-12. Surface Oxidation and Small Oxide Protrusions Found in Reducer B, Section 108 Degrees**

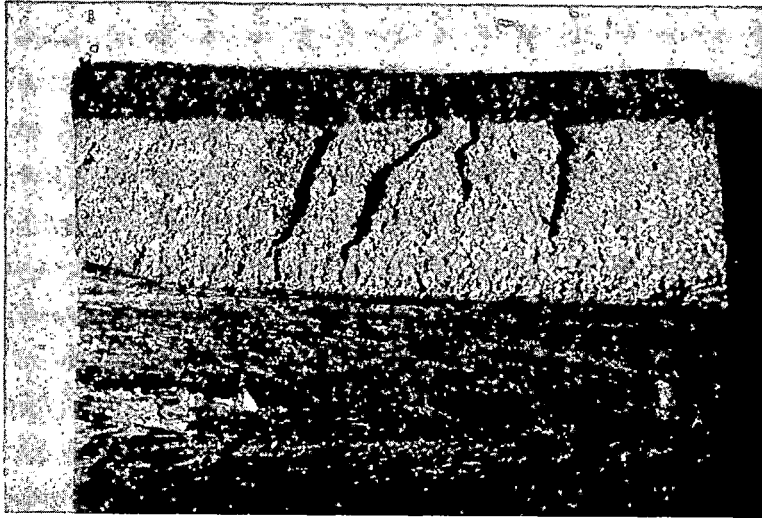
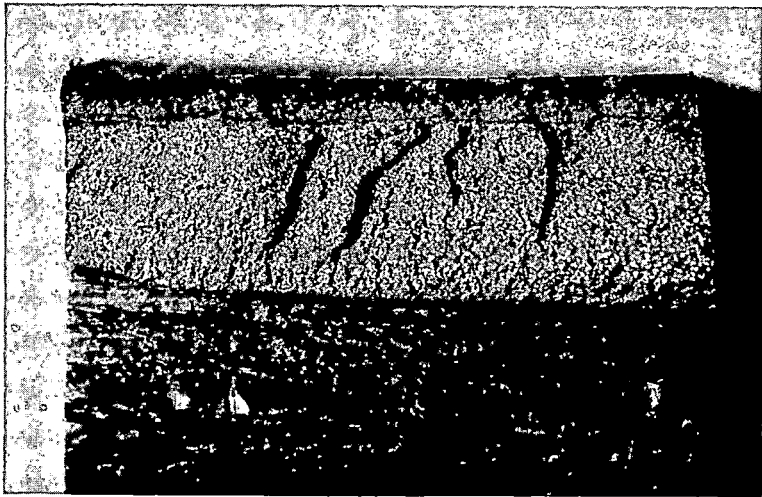
Figure 2-16. Appearance of Crack Surface at 64° in Reducer B Before and After Cleaning

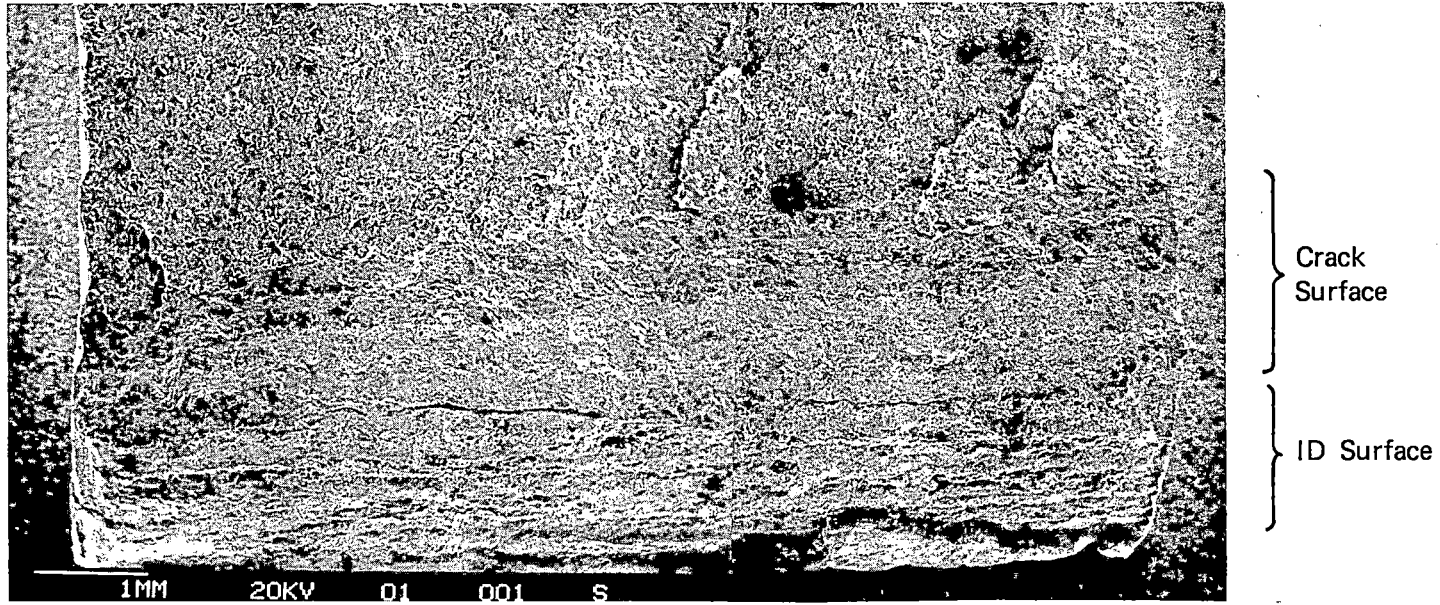
Figure 2-17. Appearance of Crack Surface at 108° in Reducer C Before Cleaning

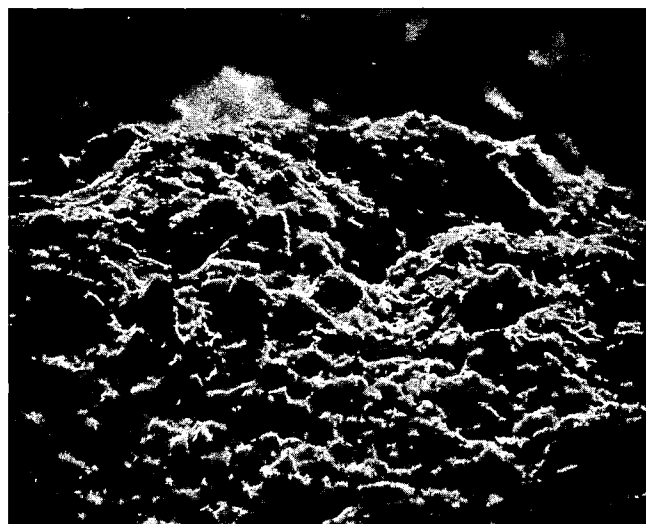
**Figure 2-19.** Fractographs Showing the Oxidized and Corroded Surface of Crack at 64 Degrees in Reducer B

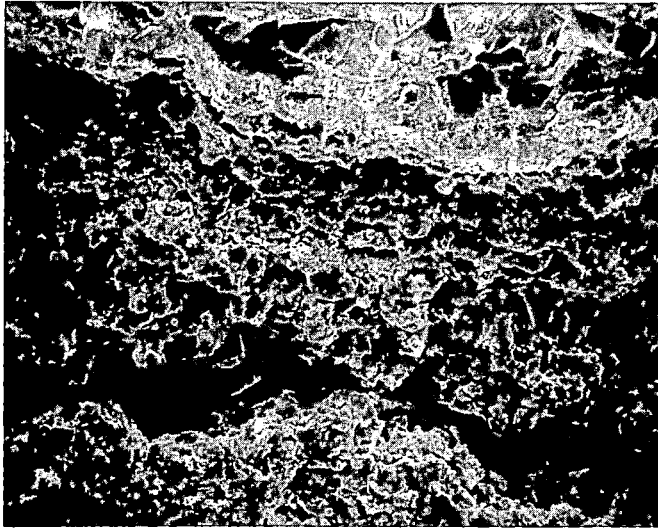
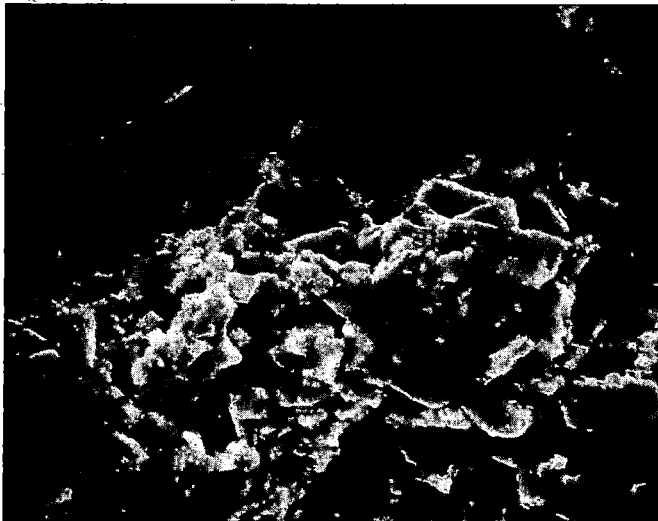
**Figure 2-20.** Fractographic Features of Opened Crack at 64 Degrees Near Crack Tip in Reducer B. Upper photograph shows cleavage fracture produced in laboratory when the crack was opened. Note the crystalline nature of oxide.

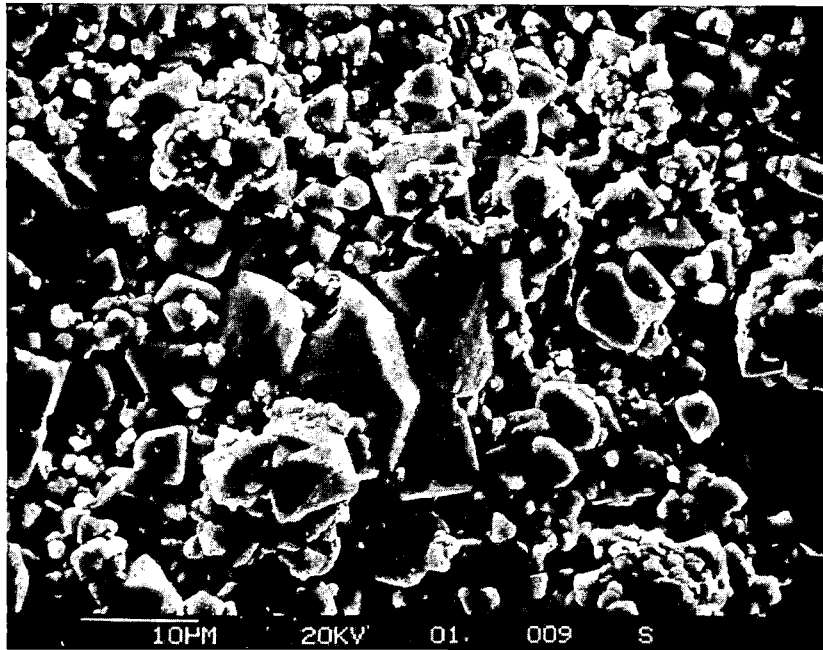
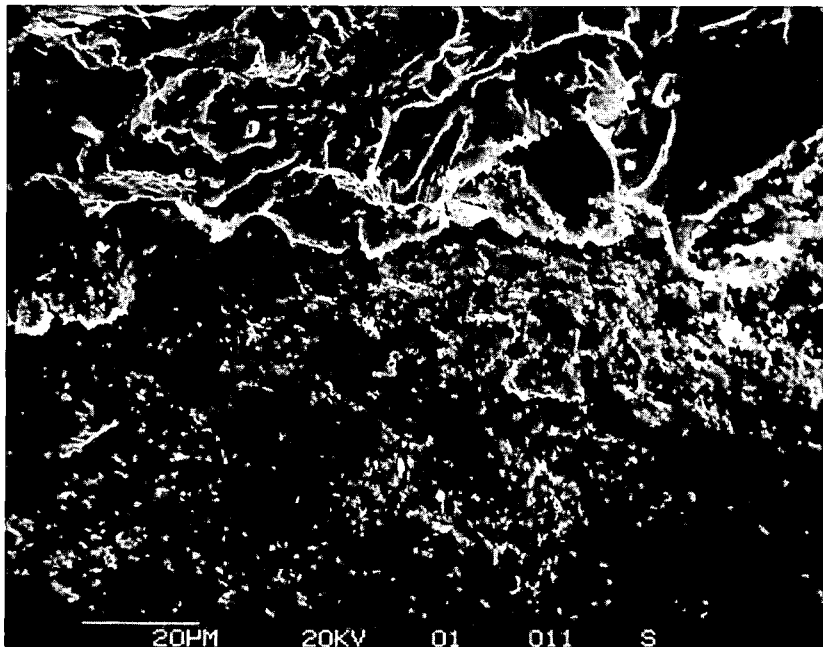
Figure 2-21. Fractographs Showing the Oxidized and Corroded Surface of Crack at 108 Degrees in Reducer C

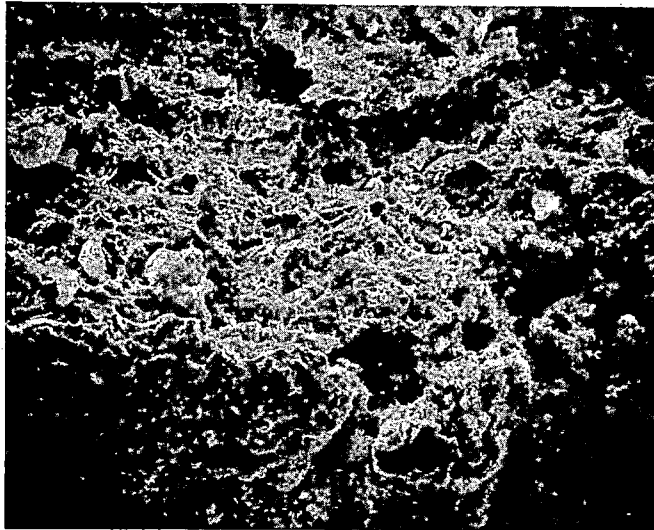
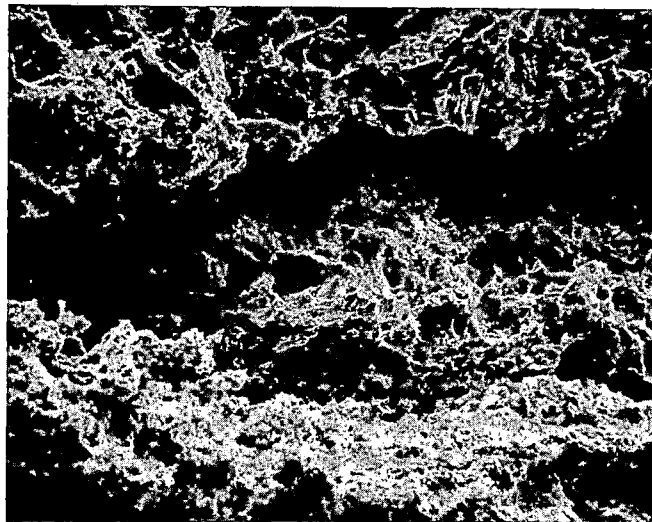
**Figure 2-22.** Fractographic Features of Cleaned Crack Surface at 64 Degrees for Reducer B

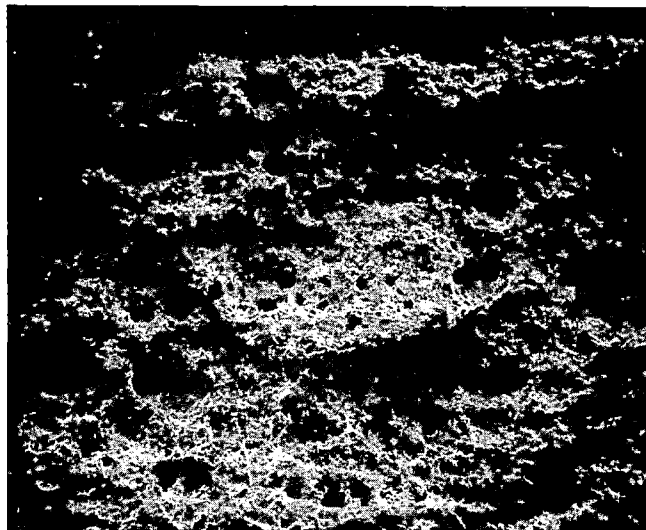
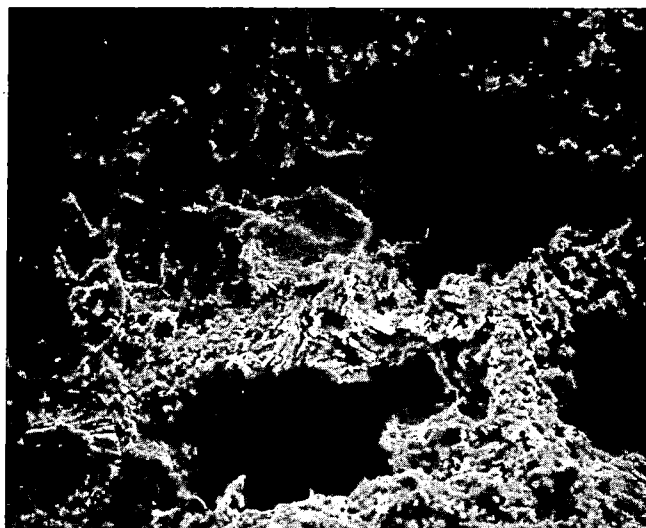
Figure 2-23. Topographic Features of Crack Surface at 64 Degrees, Reducer B, Showing Clusters of Holes Caused by Corrosion Deoxidized by Electrolytic Cleaning

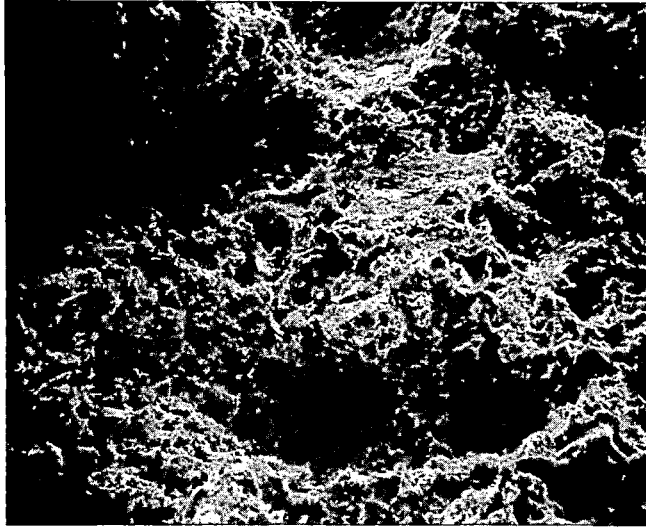
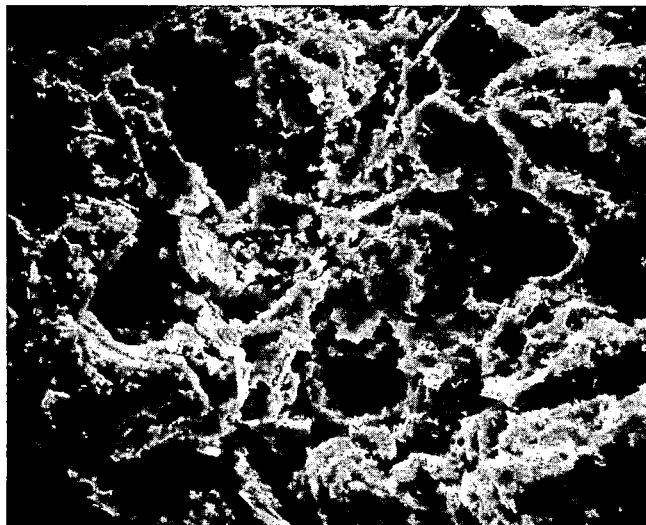
**Figure 2-24. Fractographs Showing the Corroded Nature of the Fracture Surface at 64 Degrees, Reducer B, Surface Deoxidized by Cleaning**

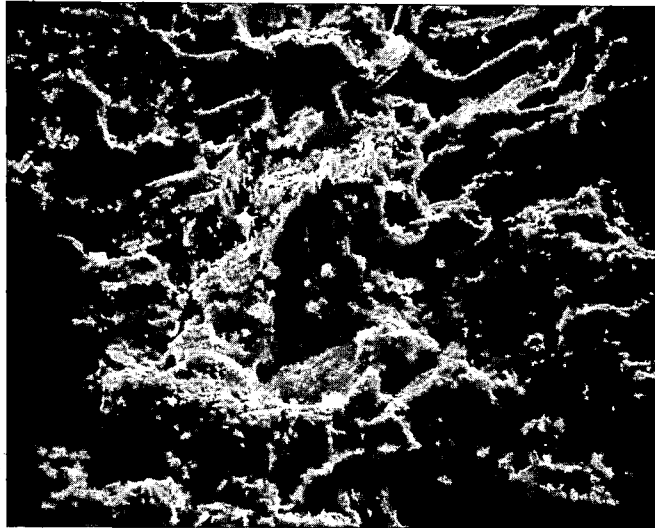
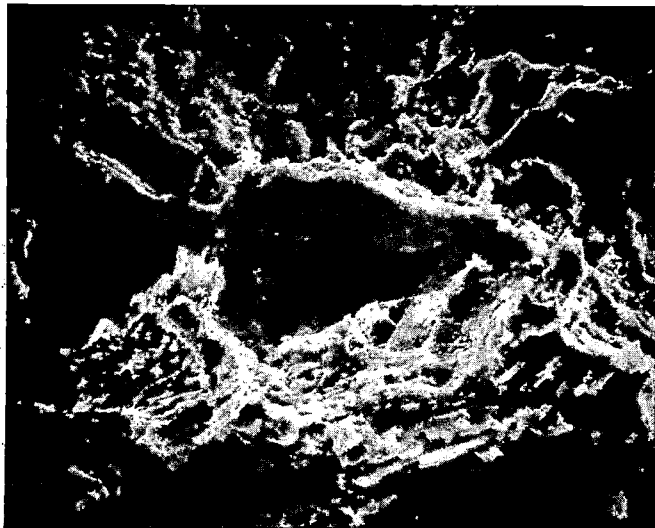
**Figure 2-25. Fractographs of Reducer B Crack at 64 Degrees Showing a Partially Intergranular Nature of the Fracture; Deoxidized Surface**

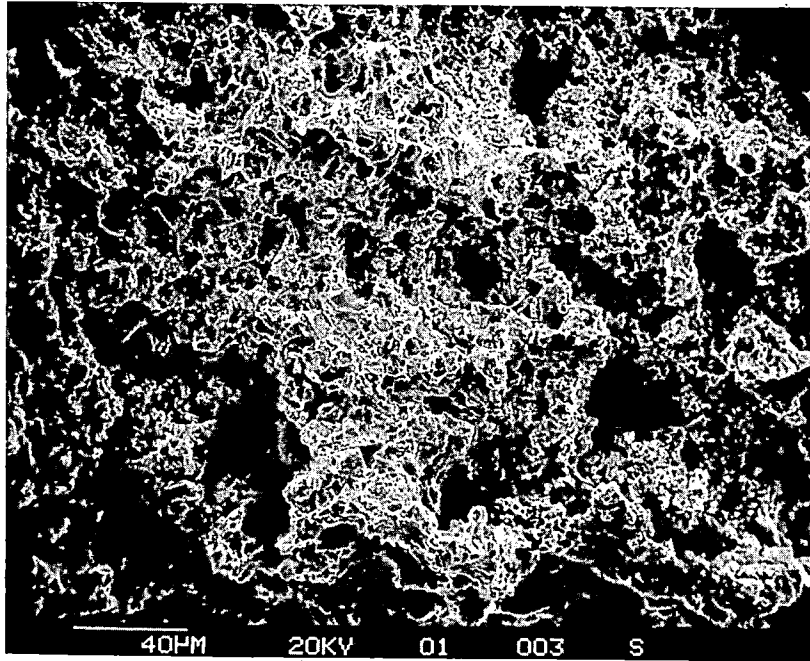
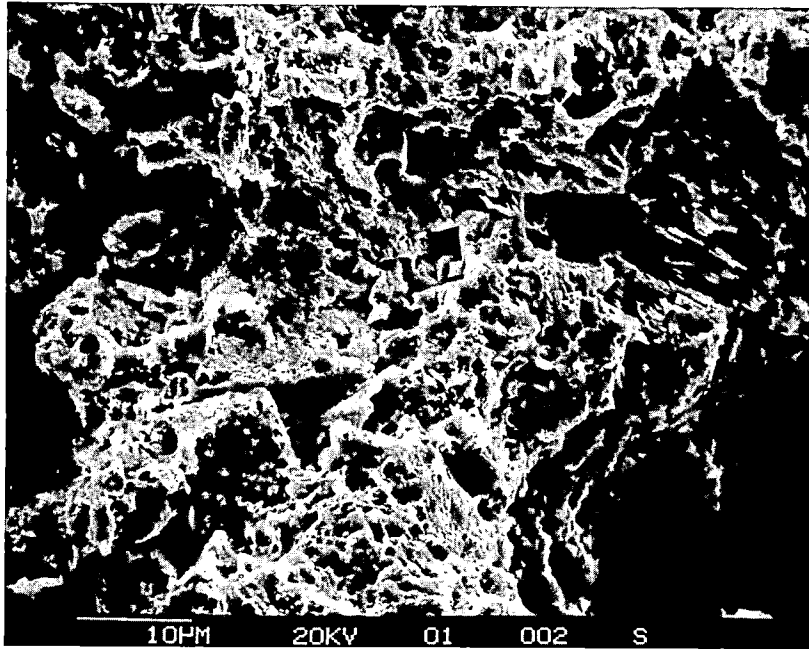
Figure 2-26. Fractographs Showing the Corroded Nature of the Crack Surface at 108 Degrees for Reducer C

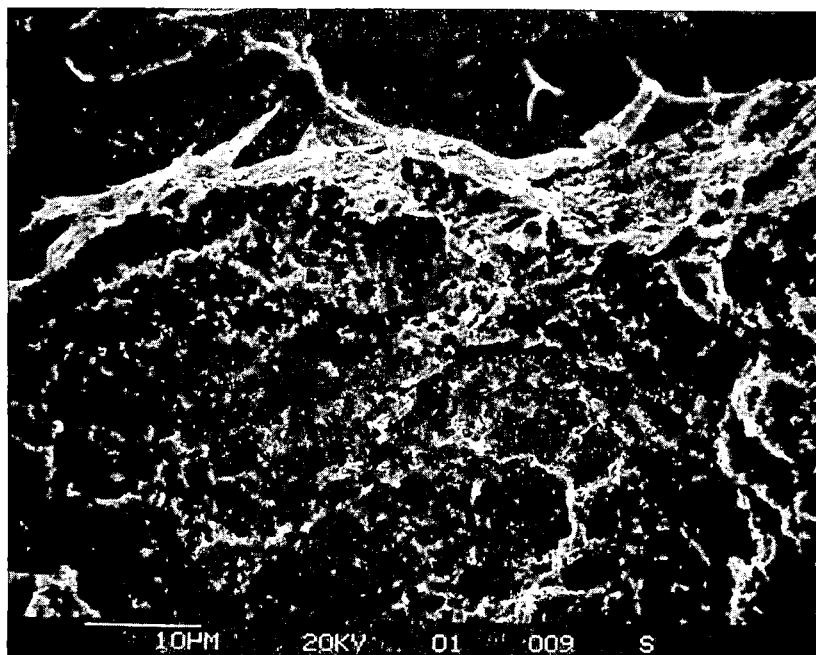
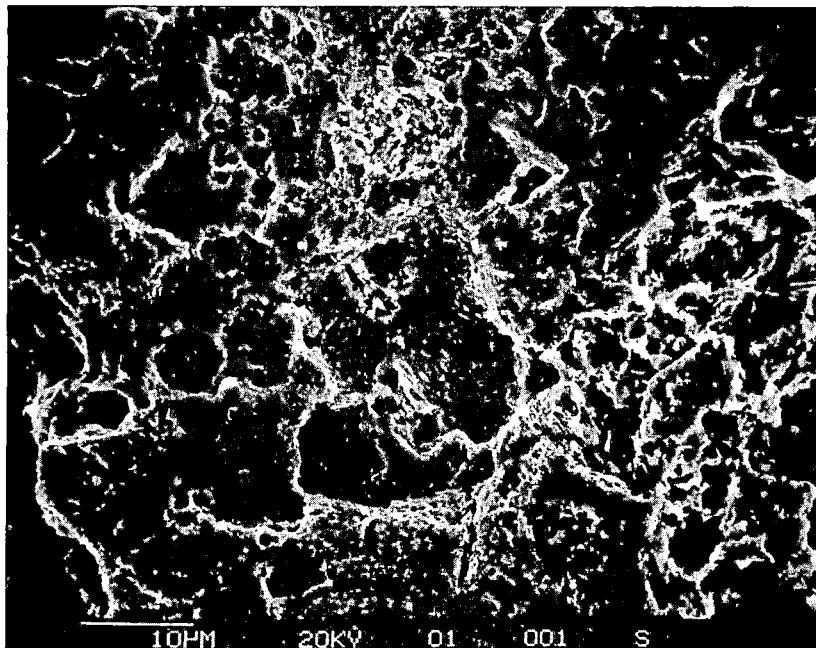
Figure 2-27. Additional Fractographic Features Seen on Crack Surface at 108 Degrees in Reducer C

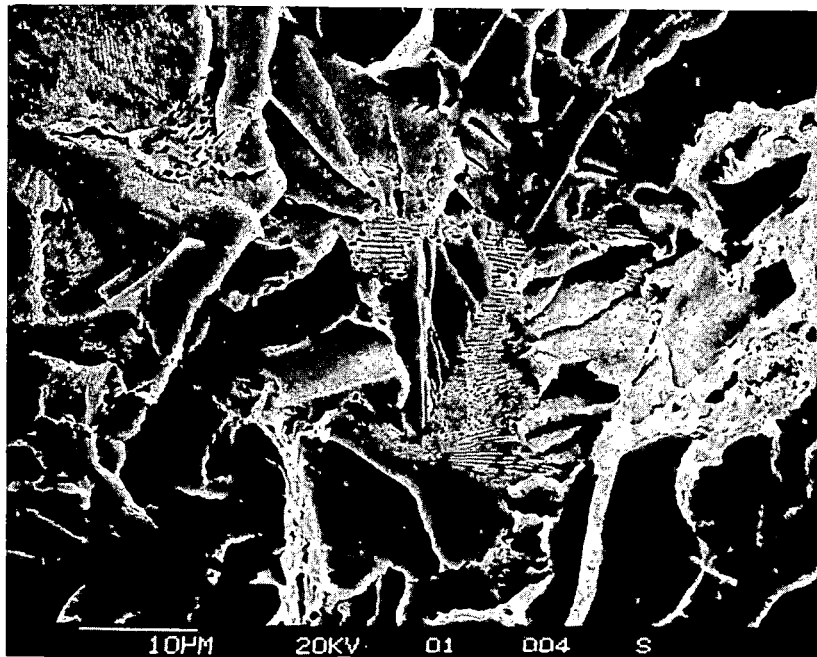
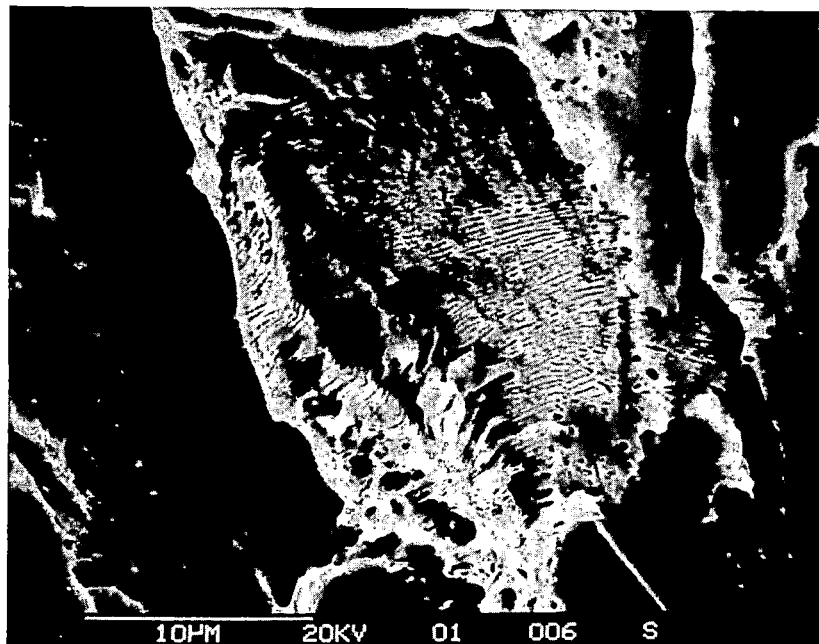
Figure 2-28. Fractographic Features Seen at the Crack-Overload Area Transition. Fracture of pearlite islands is clearly visible.
