WCAP-9638

METALLURGICAL INVESTIGATION OF  
CRACKS IN THE STEAM GENERATOR  
FEEDWATER LINES OF SURRY STATION NO. 1

L. Albertin  
G. V. Rao  
T. R. Mager

December 1979

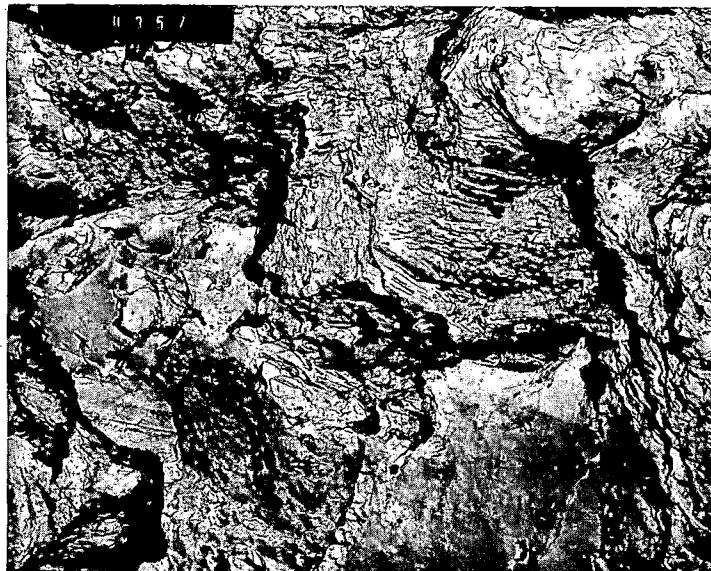
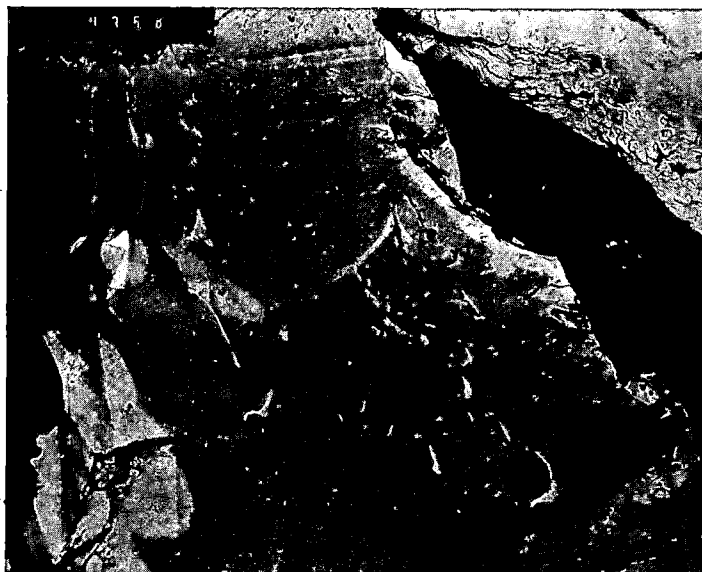
**Figure 2-29.** TEM Fractographs Showing Topographic Features of Crack (a) and Overload (b) Fracture Surfaces in Reducer B at 64 Degrees. Fractograph a) depicts the corroded surface of the crack with markings produced by the fracture of pearlite colonies, while b) shows a typical brittle cleavage fracture produced at low temperature in the laboratories during opening of the crack

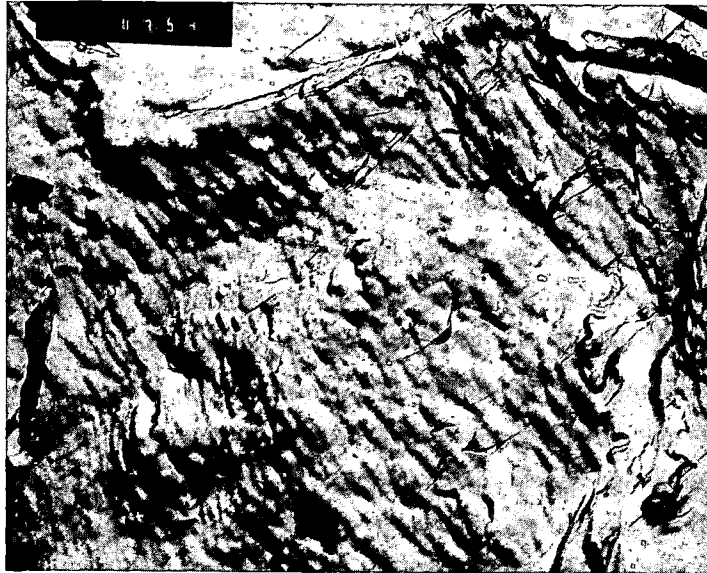
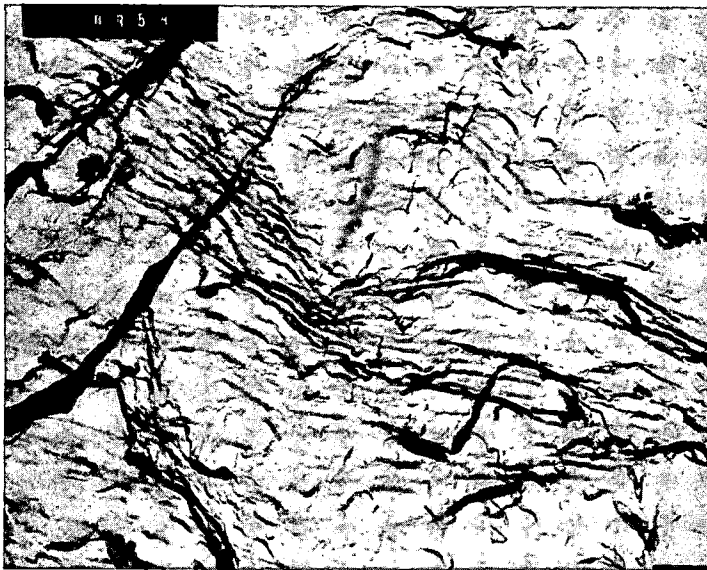
Figure 2-30. Fractographic Features on Reducer B Crack Surface Resembling Fatigue Striations.

Although electron replica fractography indicated some regions of fracture surface resembling fatigue striations, it could not be conclusively shown that these were not the result of fracture of pearlite colonies and hence are not structure related. It is also recognized however, that any substantial evidence of fatigue striations could have been lost by the presence of

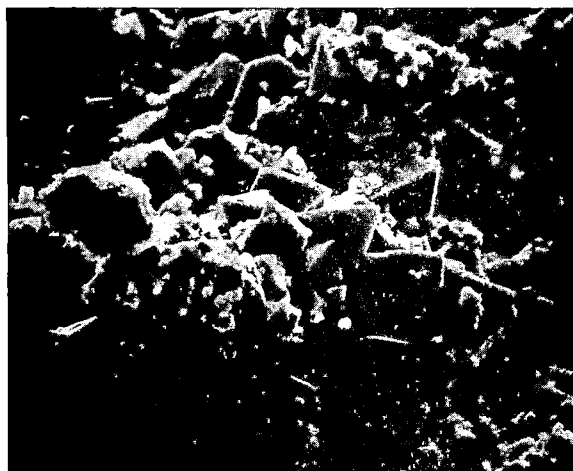
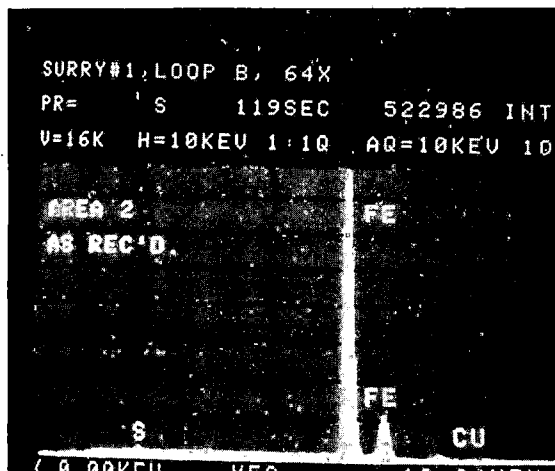
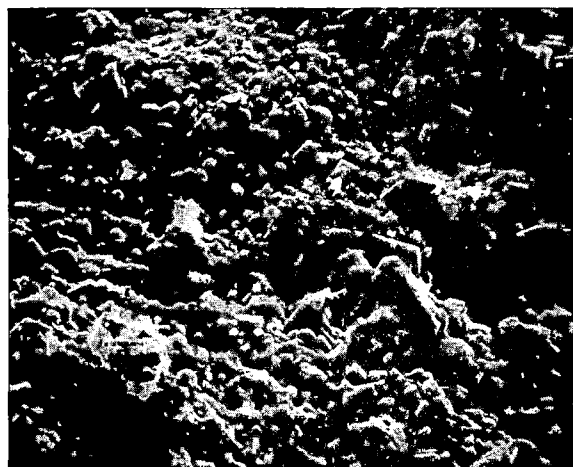
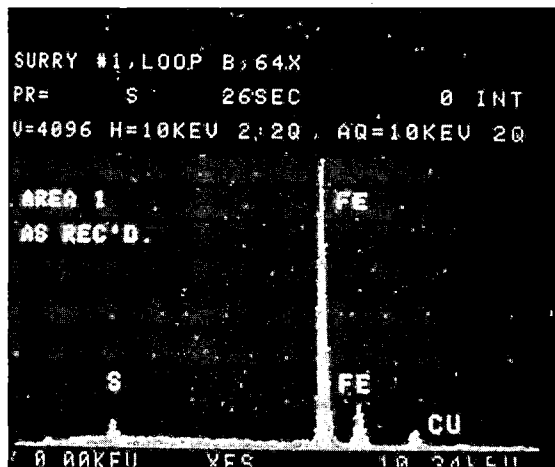
The corrosion deposits shown in figure 2-31 were analyzed using energy dispersive x-rays. The output of the semiquantitative analysis also shown in this figure indicates that, beside iron oxide, the deposits contained measurable quantities of sulfur and copper.

Figure 2-31. Crack Deposits Analyzed, and Output Charts of Energy Dispersive X-rays
