VIRGINIA ELECTRIC AND POWER COMPANY  
RICHMOND, VIRGINIA 23261

SURRY POWER STATION UNIT NO. 1  
STEAM GENERATOR INSPECTION AND PLUGGING

SURRY POWER STATION UNIT 1  
STEAM GENERATOR INSPECTION AND PLUGGING  
AUGUST 5, 1980

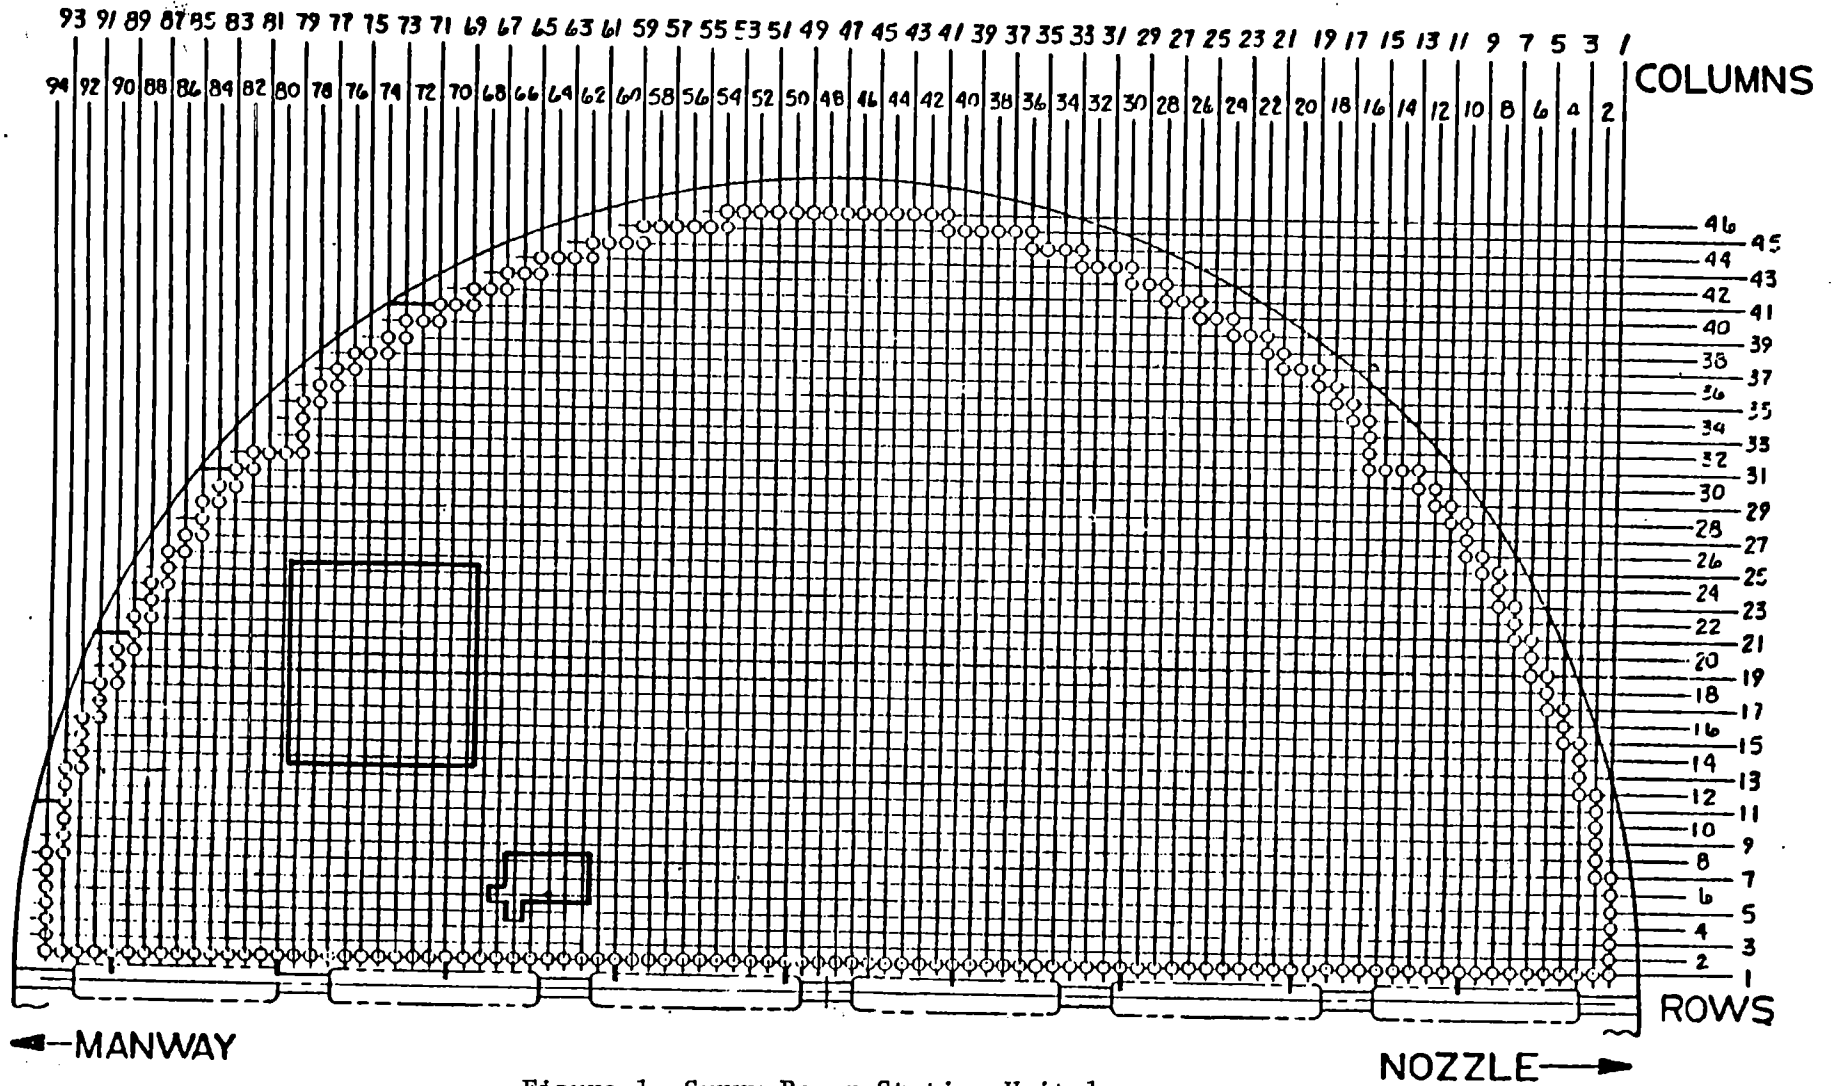
Figure 1 Surry Power Station Unit 1  
 C Steam Generator  
 Gauging Program

Eddy current inspections were performed on tubes surrounding the leakers as indicated on Figure 1, Unit 1 "C" Steam Generator, Inspection Boundary. This inspection boundary was determined to surround the leaking tubes and other tubes in the same vicinity which may exhibit significant tube denting or wastage activity. The larger area near the center of the tube sheet was inspected for wastage using a .650" probe. This area included Columns 69 through 79 and Rows 13 through 24 and covered 132 tubes. The smaller area located adjacent to the plugged tubes along the tube lane included 17 tubes. These 17 tubes were inspected for indications of denting.

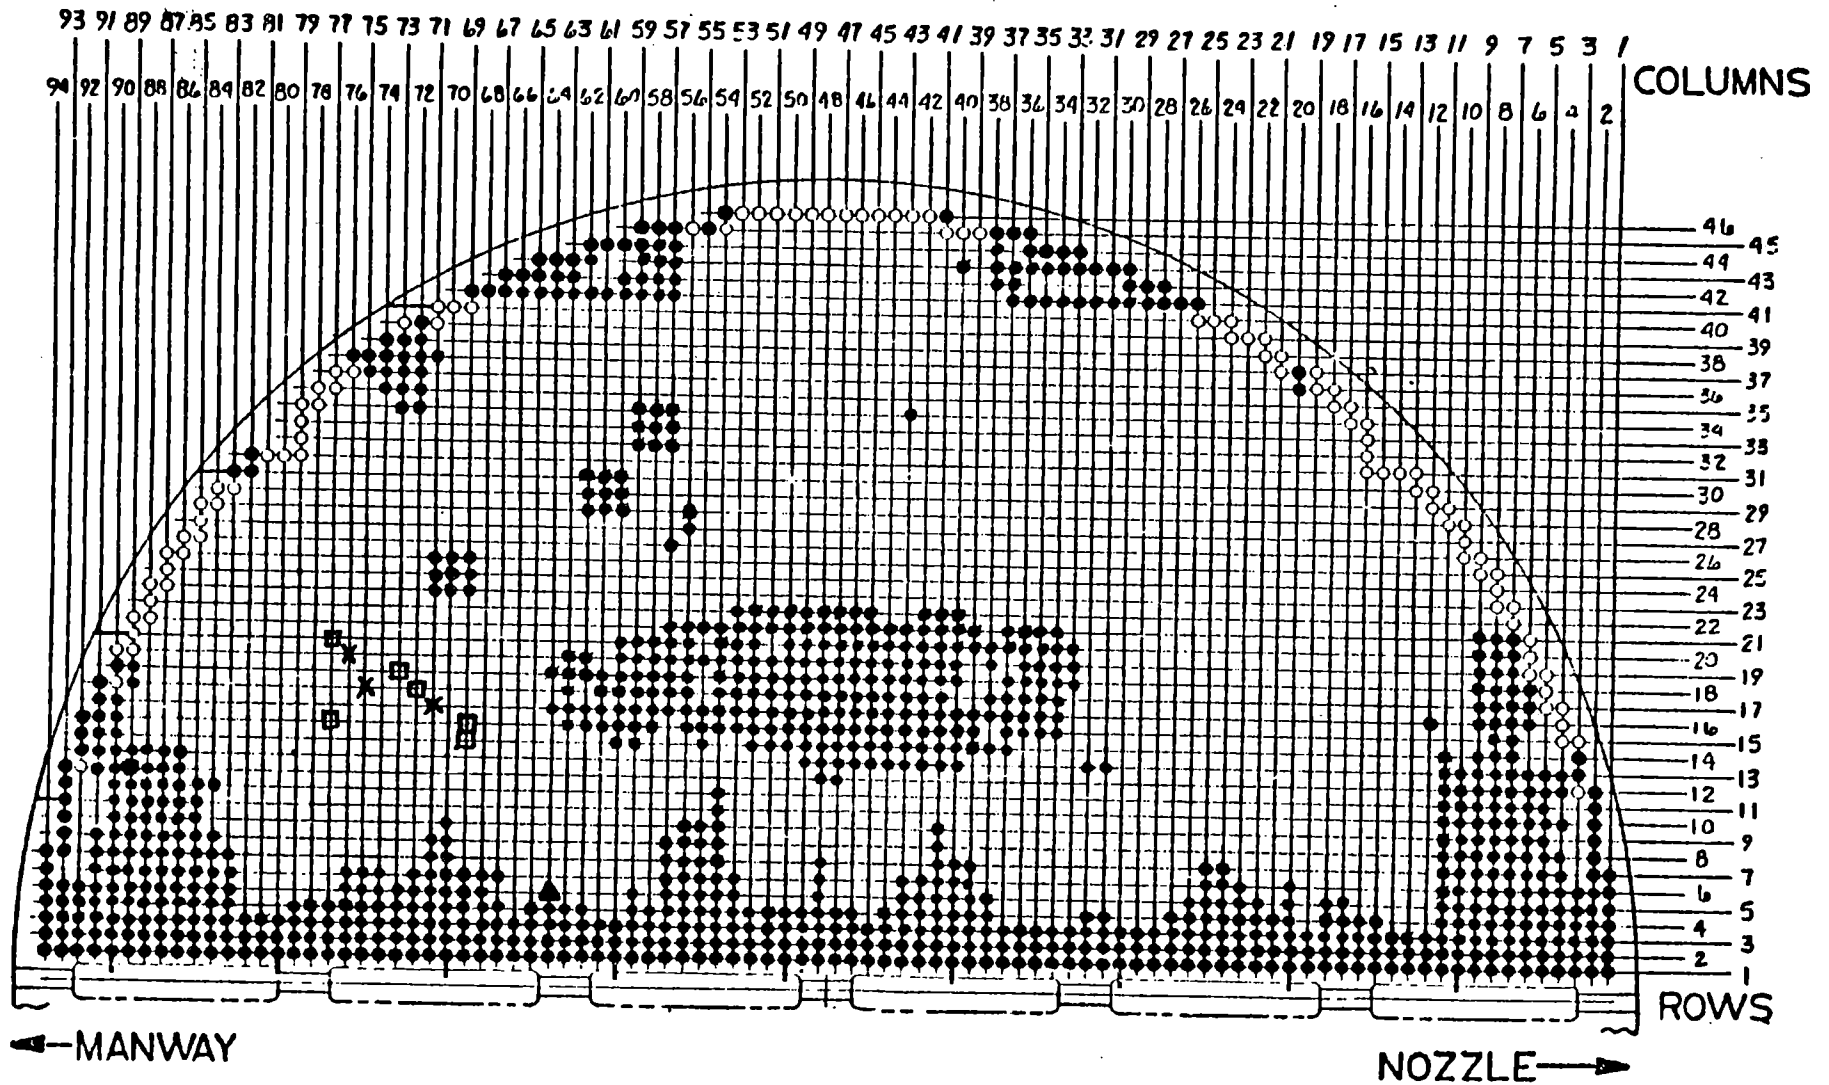
Figure 2 Surry Power Station Unit 1  
 C Steam Generator  
 Gauging Results

The results of the inspection program are shown in Figure 2. These results support the adequacy of the inspection program and the plugging criteria.

- 1) Three leaking tubes exhibited 100% wastage defect signals about one-half inch above the tube sheet. The wastage signals were detected over an area of zero to one-half inch above the tube sheet and are similar in character to wastage signals detected during previous inspections and are indicative of a large volume defect.

- 2) Six additional tubes within this wastage inspection boundary (see figure 2) were determined to exhibit wastage of about 40%, although the signals were somewhat distorted. One of these six tubes (Row 15, Column 69) had been previously inspected in March, 1980, and at that time exhibited wastage of about 20%. Two of the six tubes are next to a leaker and would have been plugged for that reason. No other previously inspected tubes showed any significant increase in wastage since the March, 1980, inspection. Only one other tube exhibited wastage in excess of 30%, the remainder were less than 30%.

- 1) The one leaking tube (Row 5, Column 64) passed the .610" probe to past the seventh support plate. A .650" probe was stopped at the third support plate indicating the location of the dent.
- 2) Sixteen other tubes surrounding the leaking tube were inspected with the .650" probe, which passed all tubes to past the seventh support plate. None of these tubes, then, exhibited significant denting activity.

- A. All tubes surrounding any known leakers including the diagonally next tube were plugged.
- B. All tubes with significant wastage ( $\geq 40\%$ ) and all tubes where wastage measurement could not be considered accurate due to masking effects were plugged.

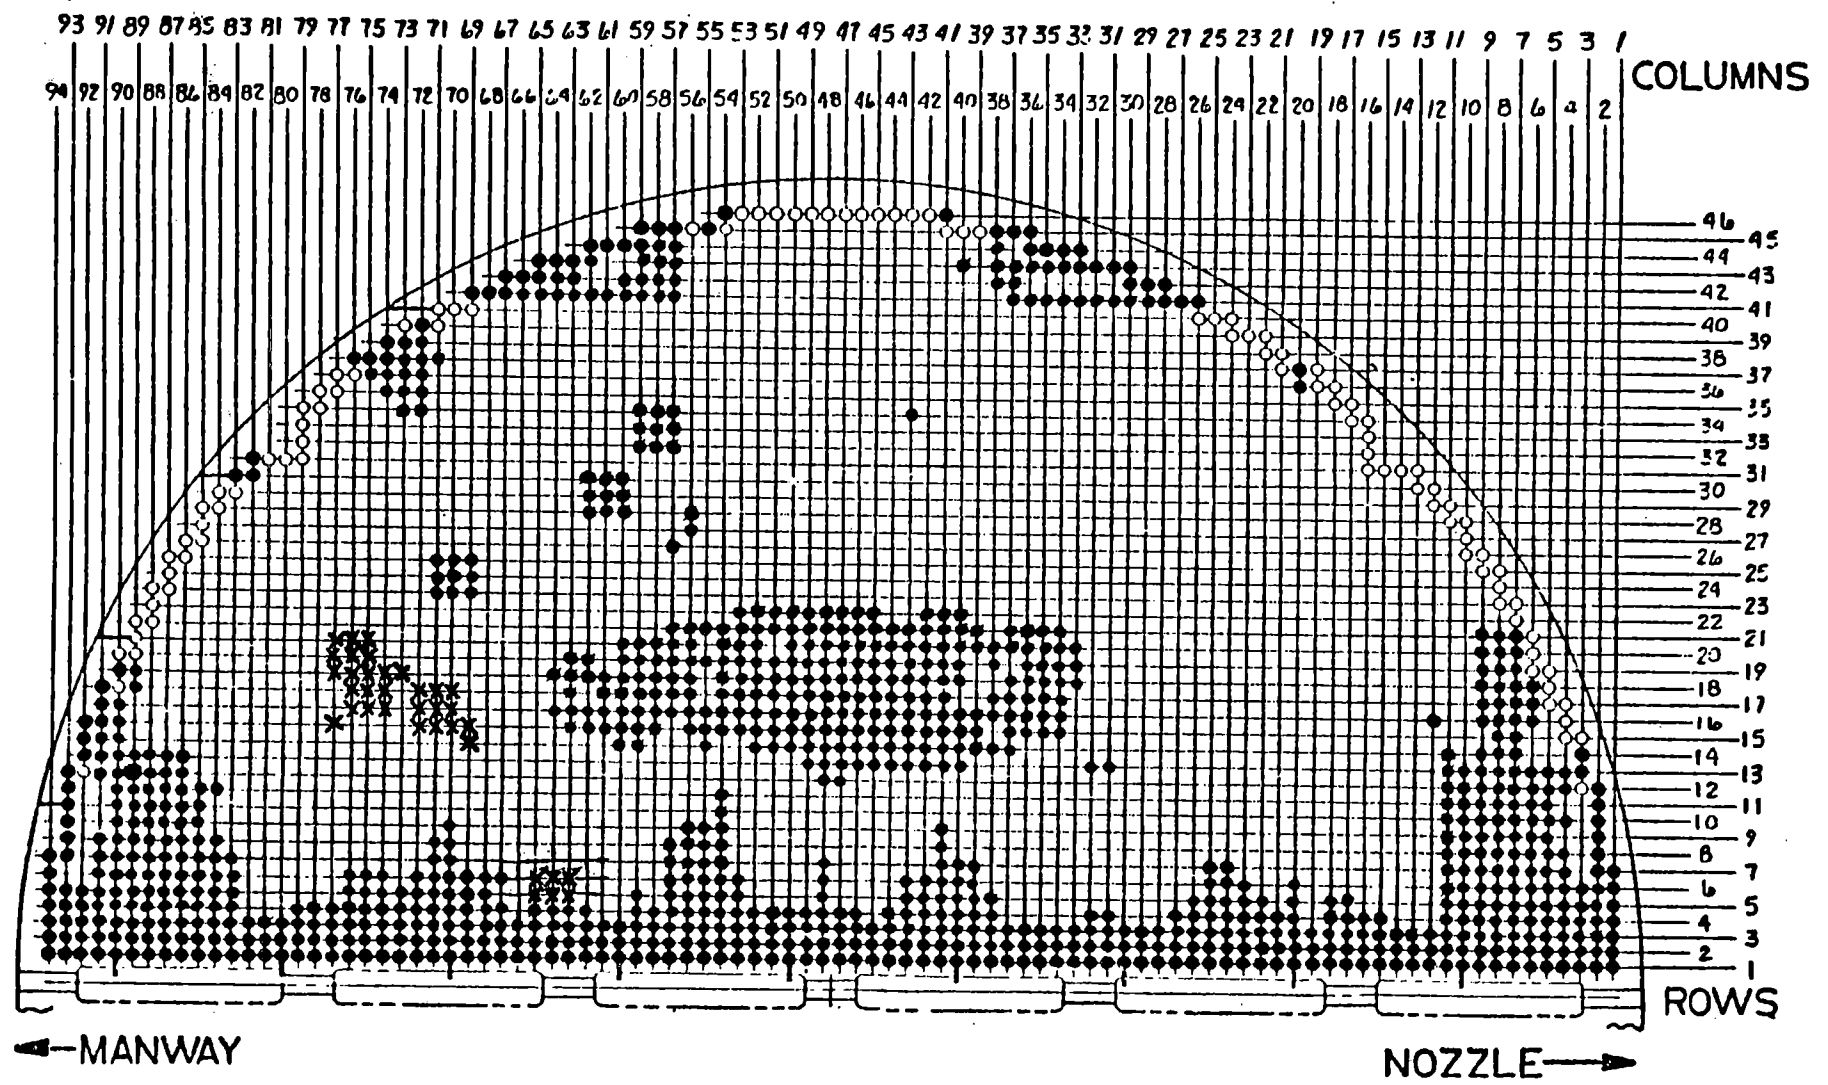
Figure 3 Surry Power Station Unit 1  
C Steam Generator  
Plugging Pattern

Figure 3 indicates the plugging pattern for Surry 1 "C" steam generator based on the plugging criteria described above. During this outage, 35 tubes were plugged, bringing the total tubes plugged in "C" steam generator to 1064. Steam Generators "A" and "B" have 885 and 662 tubes plugged, respectively.
