July 31, 1980

IE Bulletin No. 80-20

FAILURES OF WESTINGHOUSE TYPE W-2 SPRING RETURN TO NEUTRAL CONTROL SWITCHES

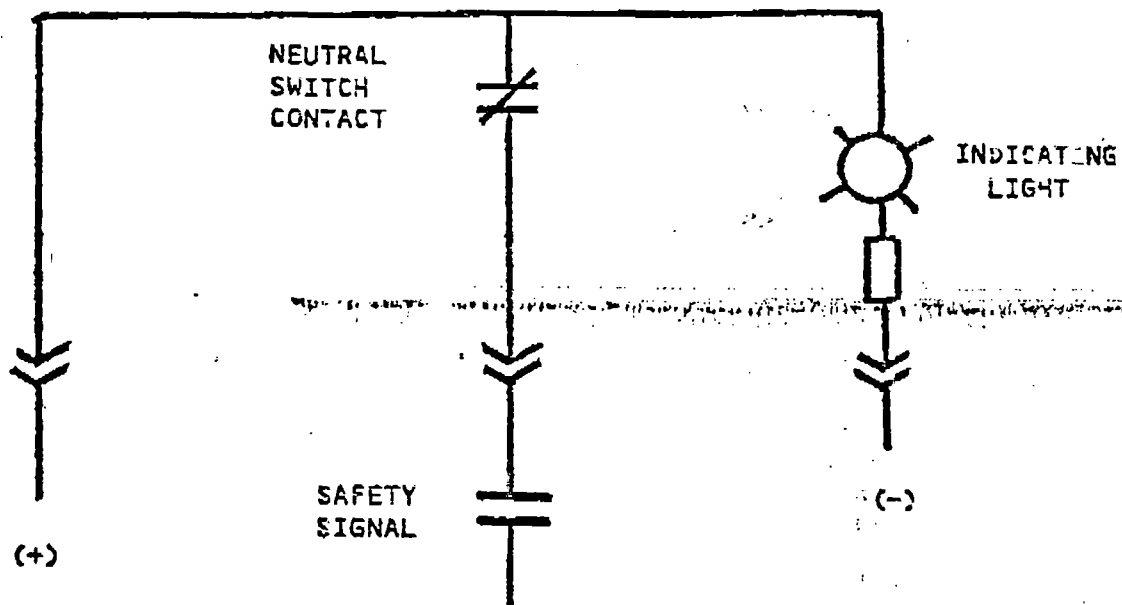
# EXISTING INDICATING LIGHT CIRCUIT (TYPICAL)

Depending on how the indicating light circuit is wired, loss of continuity thru the neutral position contact of a W-2 switch could remain undetected until the equipment associated with the switch were called upon to operate. Since such a failure would be equivalent to by-passing the system associated with the switch, consideration should be given to rewiring the switches used in safety-related applications as shown in Figure 1. Such rewiring would provide an acceptable means for detecting contact failure, provided the indicating light is in the control room and readily visible by the operator. If the indicating light is not so located, consideration should be given to annunciating the neutral position contact failures at the control room to alert the operator of the inoperable status of a safety-related system. In addition, consideration should be given to adding redundant contacts to the W-2 switches or to replacing the W-2 switches with others having a more positive contact wiping action.

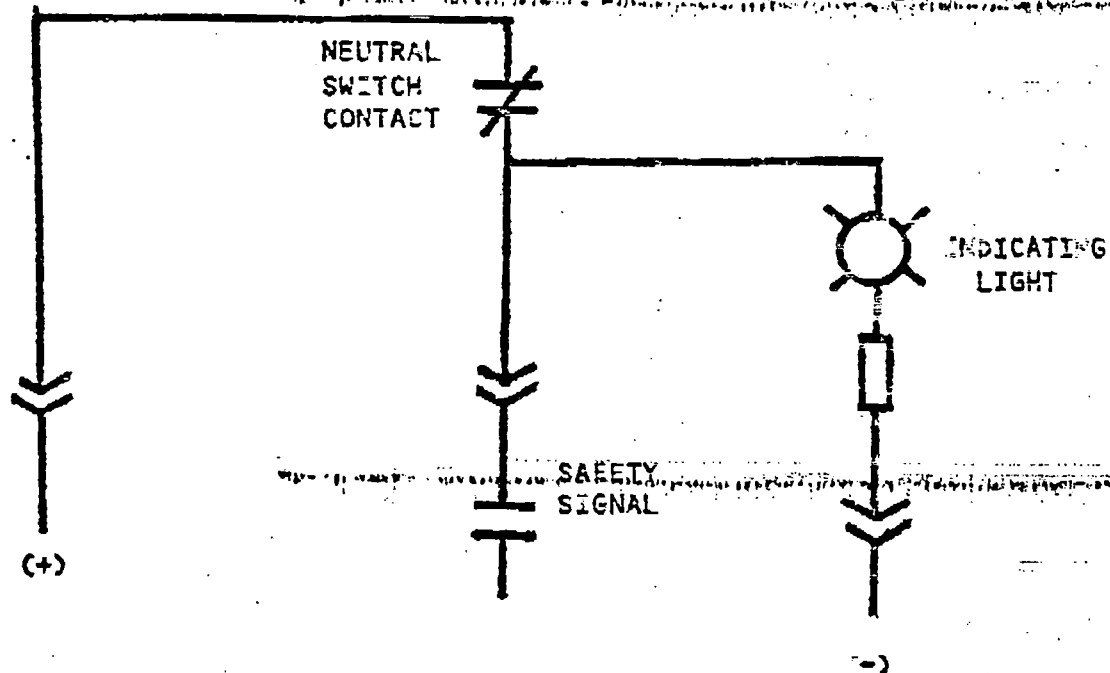
# PROPOSED REWIRING OF INDICATING LIGHT CIRCUIT (TYPICAL)

REWIRING OF INDICATING LIGHT CIRCUIT OF W-2 SWITCHES  
AS RECOMMENDED BY WESTINGHOUSE TECHNICAL BULLETIN NSD-TB-80-9

A review of this matter by Westinghouse led to the issuance of NSD Technical Bulletin No. NSD-TB-80-9 to the utility owners of all Westinghouse operating plants. The recommendations contained in the Westinghouse technical bulletin include: (i) testing the neutral position contacts of the subject W-2 switches for continuity, and (ii) rewiring of the indicating light circuit to permit the early detection of a neutral contact failure as shown in Figure 1.

3. Licensees of operating plants and holders of construction permits shall describe the longer term corrective measures planned and the date by which such measures will be implemented by actual installation or by design change, as appropriate. As a minimum, the longer term corrective measures should include rewiring the indicating light as shown in Figure 1 provided the light is readily visible to the control room operator. If not, failures of the neutral position contacts should be annunciated in the control room.
