Subject: Reportable Occurrence 77-03 (14-day report), Abnormal
degradation of steam generator tubes
R. E. Ginna Nuclear Power Plant, Unit No. 1
Docket No. 50-244

LER 77-03/1T
LICENSEE EVENT REPORT

Ginna Station
Steam Generator Inspection
Final Report
 May 11, 1977

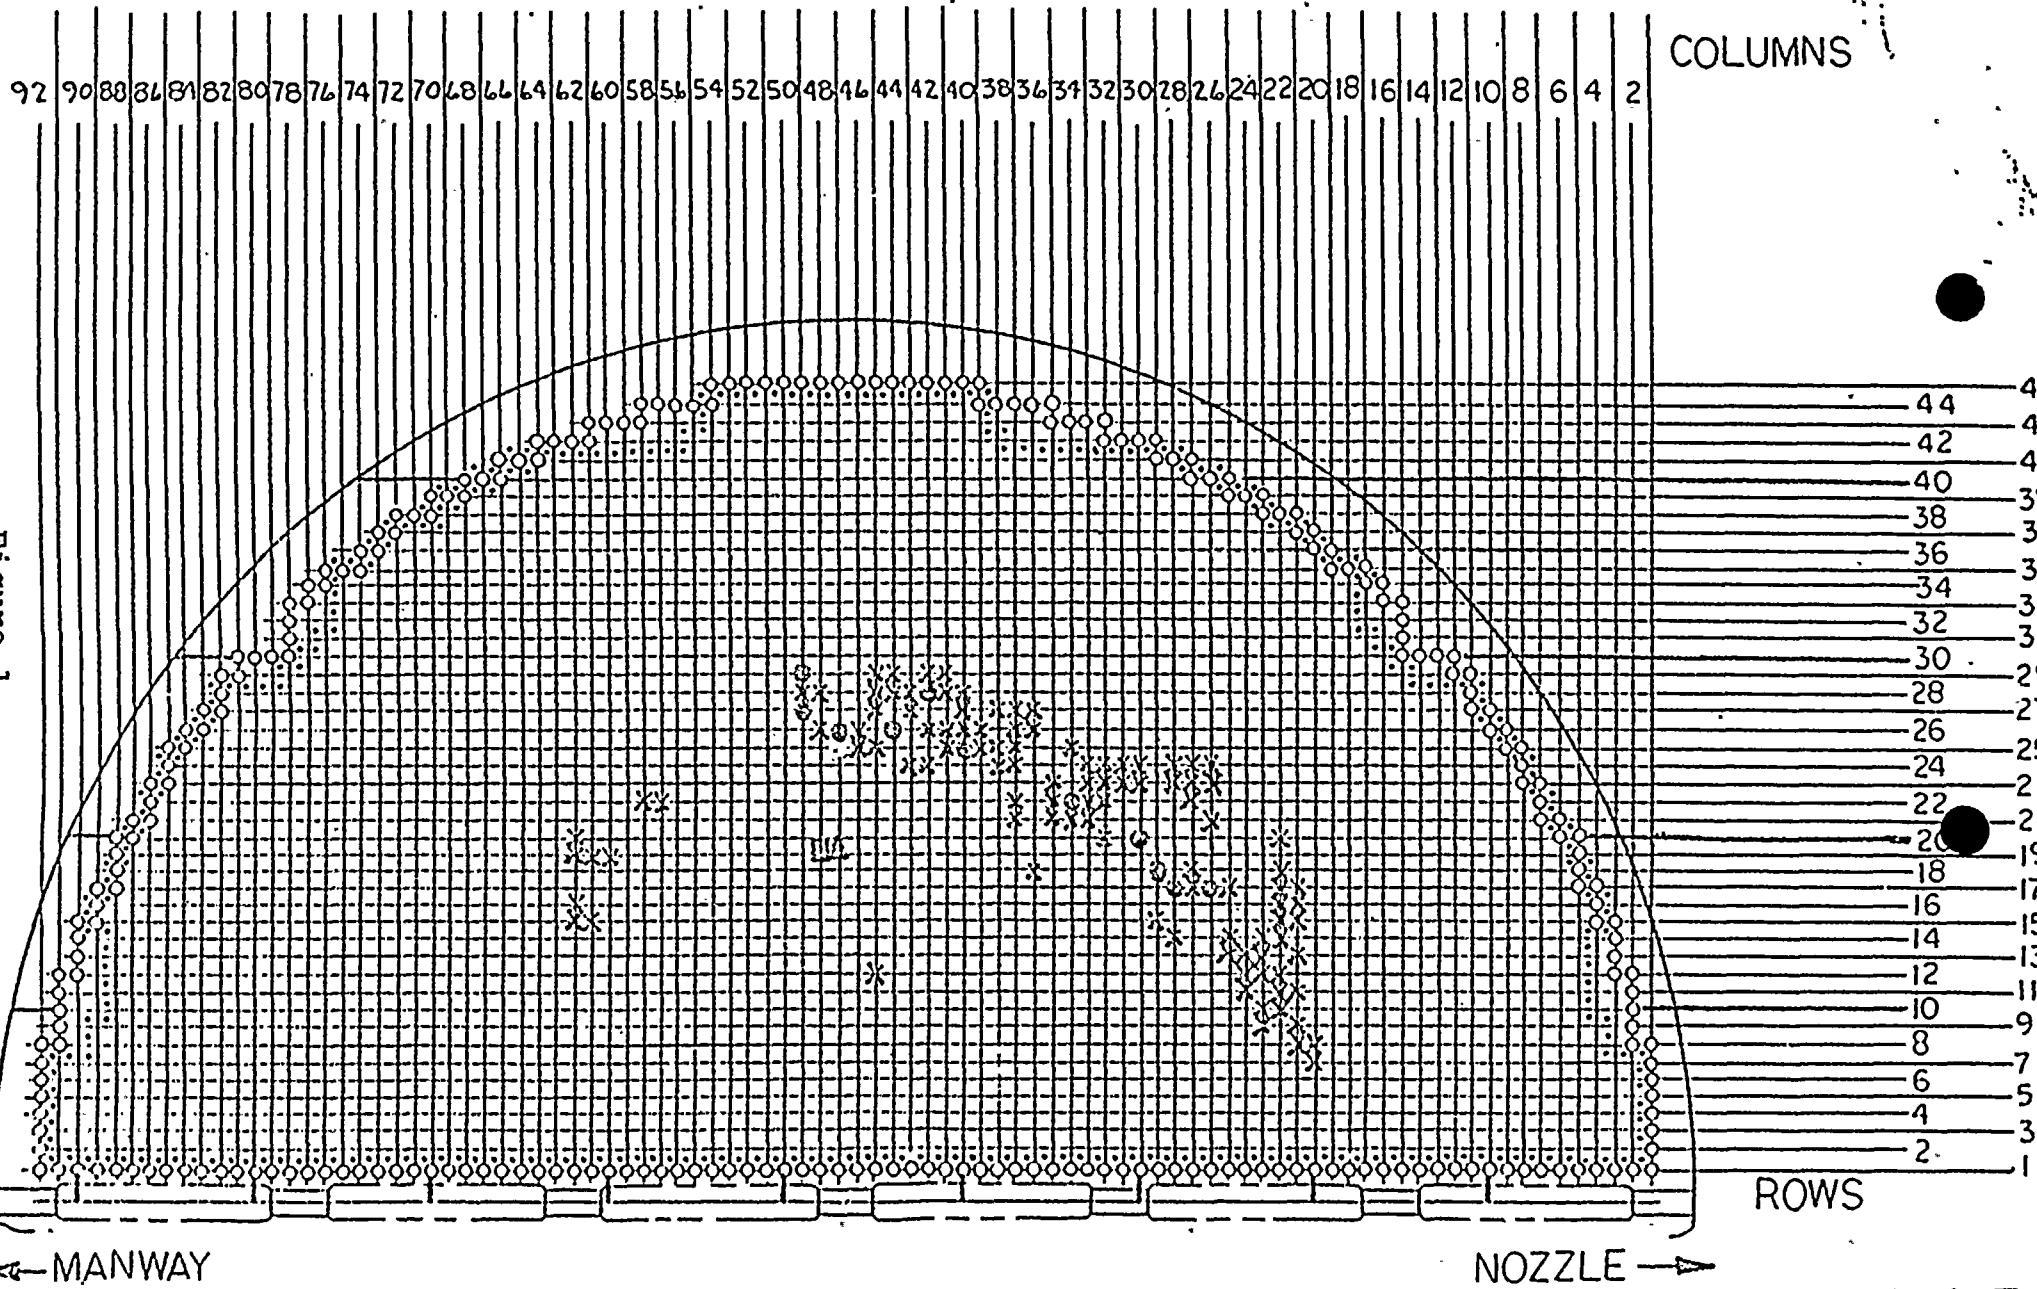
Figure 1

All of the eddy current indications were within the first few inches of tubing directly above the tube sheet with the exception of one in the U-bend area of the "B" steam generator. This indication in the "B" steam generator U-bend area was on a periphery tube and appears to be a one-of-a-kind construction-type defect of very small volume, 95% through the tube wall. The other indications with the exception of two, are postulated to be due to wastage, based on growth rates. The excepted two

tubes, in the "A" inlet, due to their large growth rate compared to the mean, may have been caused by concentrations of caustics. Confirmation of this is not possible since the eddy current examination method cannot differentiate between indications resulting from either wastage or stress corrosion cracking, but can accurately measure the maximum defect penetration to within normal statistical variation. The indications are seen only in those areas where indications have been previously noted, with the exception of the indication in the "B" steam generator U-bend area. There has been no expansion of the indication region to other areas of the steam generators. This inspection verified that there are not any other tubes with ID Indication in the periphery tubes associated with the wedge areas where there had been a leak in April 1976 (see Licensee Event Report 76-15).

The small number of tubes in the "A" inlet which have experienced deterioration, inconsistent with the average, are believed to have deteriorated from the concentration of residual phosphates in the secondary side sludge deposits. These concentrations of phosphates are caused by the remaining traces of sludge deposits formed during the period of phosphate control of the secondary system water chemistry before the conversion to AVT chemistry control in November 1974.

"A" INLET EDDY CURRENT INDICATIONS

- a. All tubes with eddy current indications of wall penetration greater than or equal to 40% were plugged.
- b. A thorough lancing of the secondary side of the tube sheets was performed in both steam generators to remove as much as possible any remaining phosphates and/or caustics contained within the sludge. Sludge lancing of both steam generators will be continued in an effort to keep sludge content to a minimum. The lancing, coupled with blowdown during startup and normal operation, should considerably reduce the probability of significant tube degradation during the plants' subsequent operation.

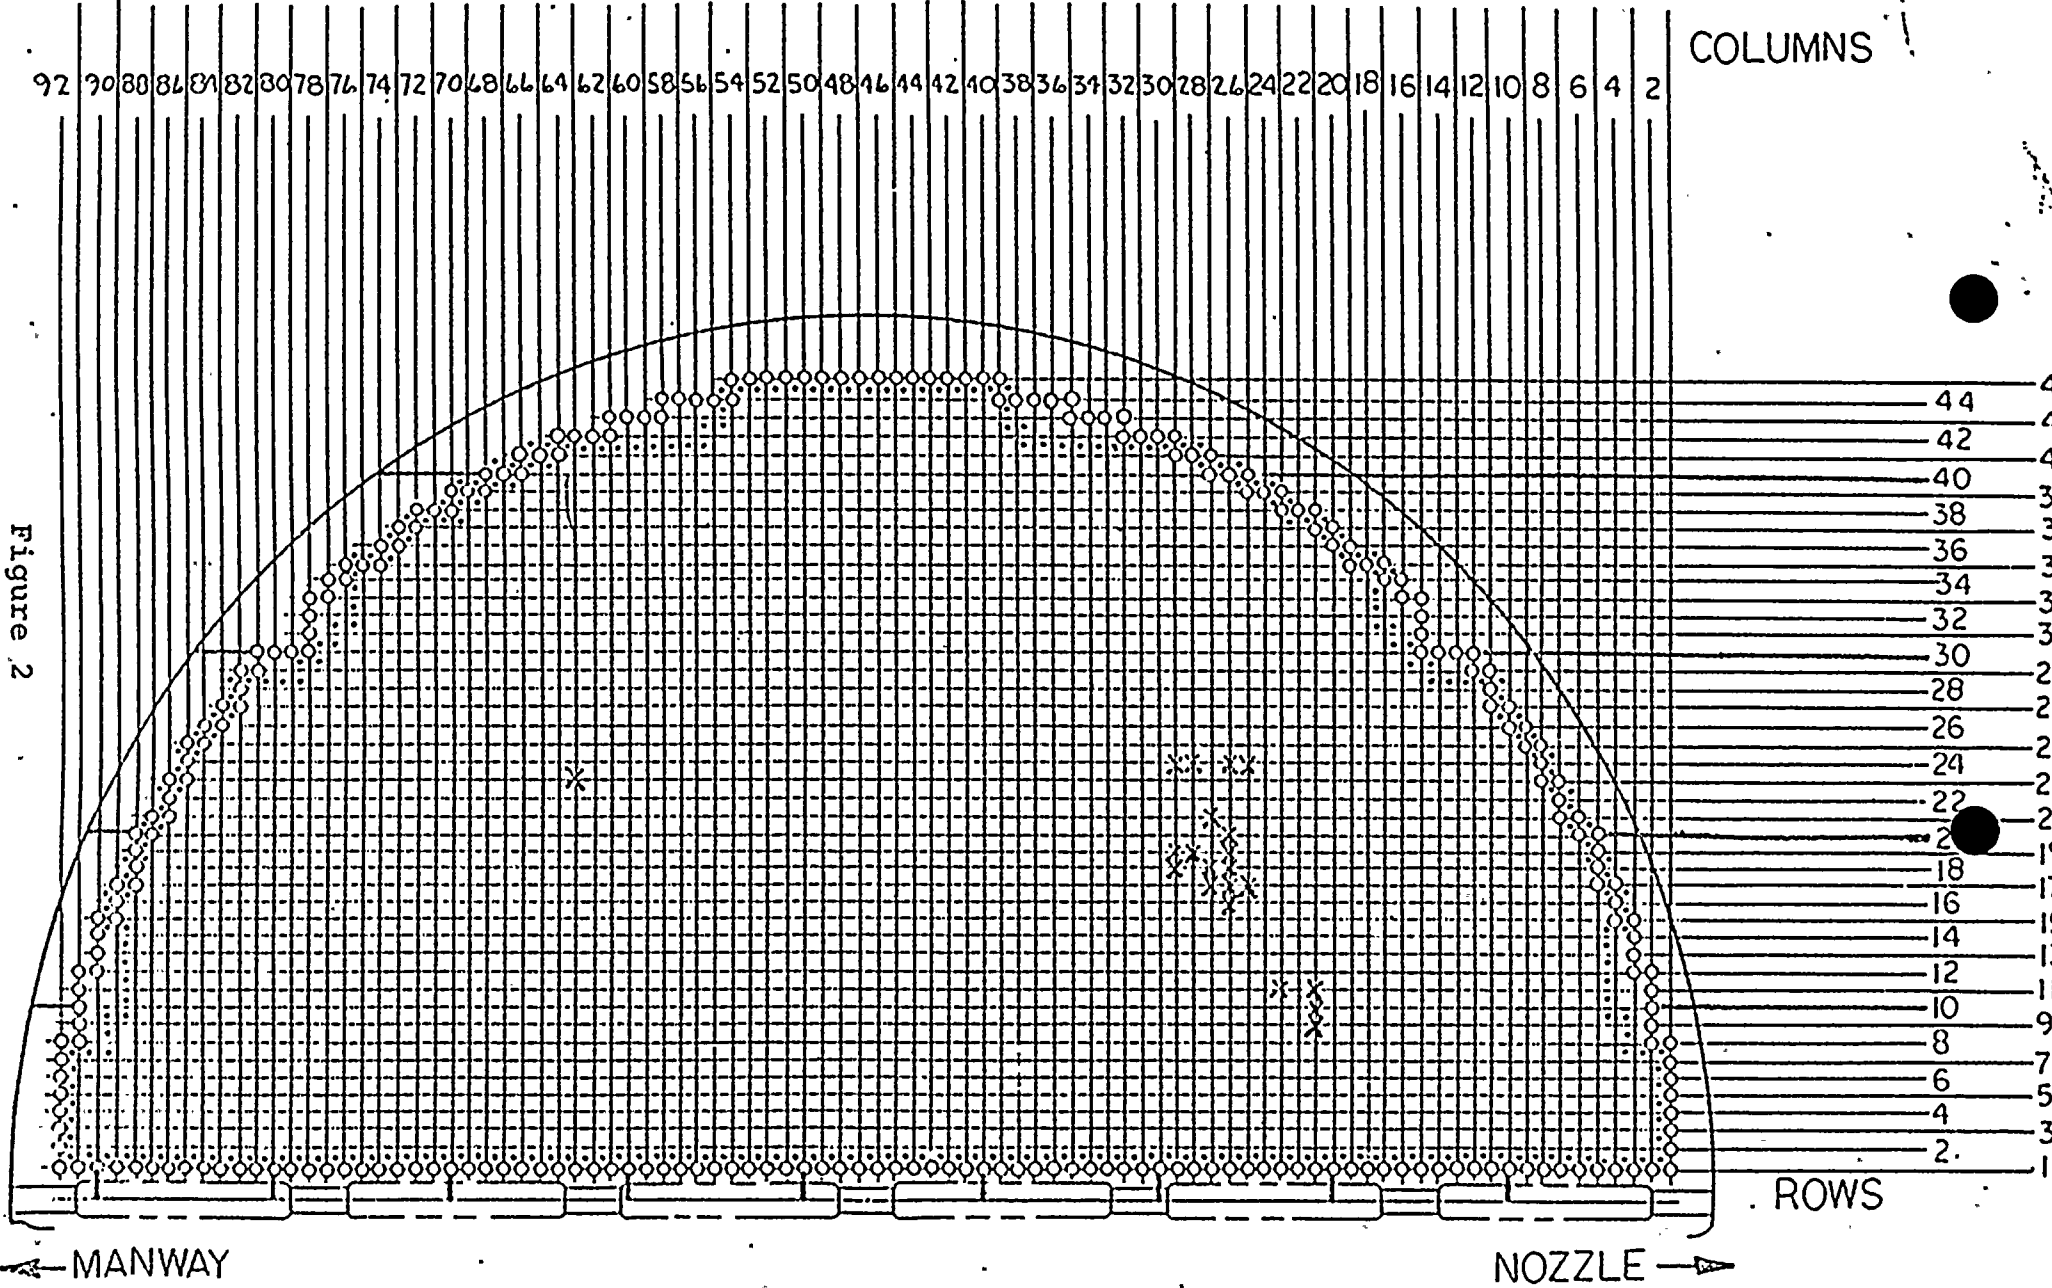
Figure 2

"B" INLET EDDY CURRENT INDICATION

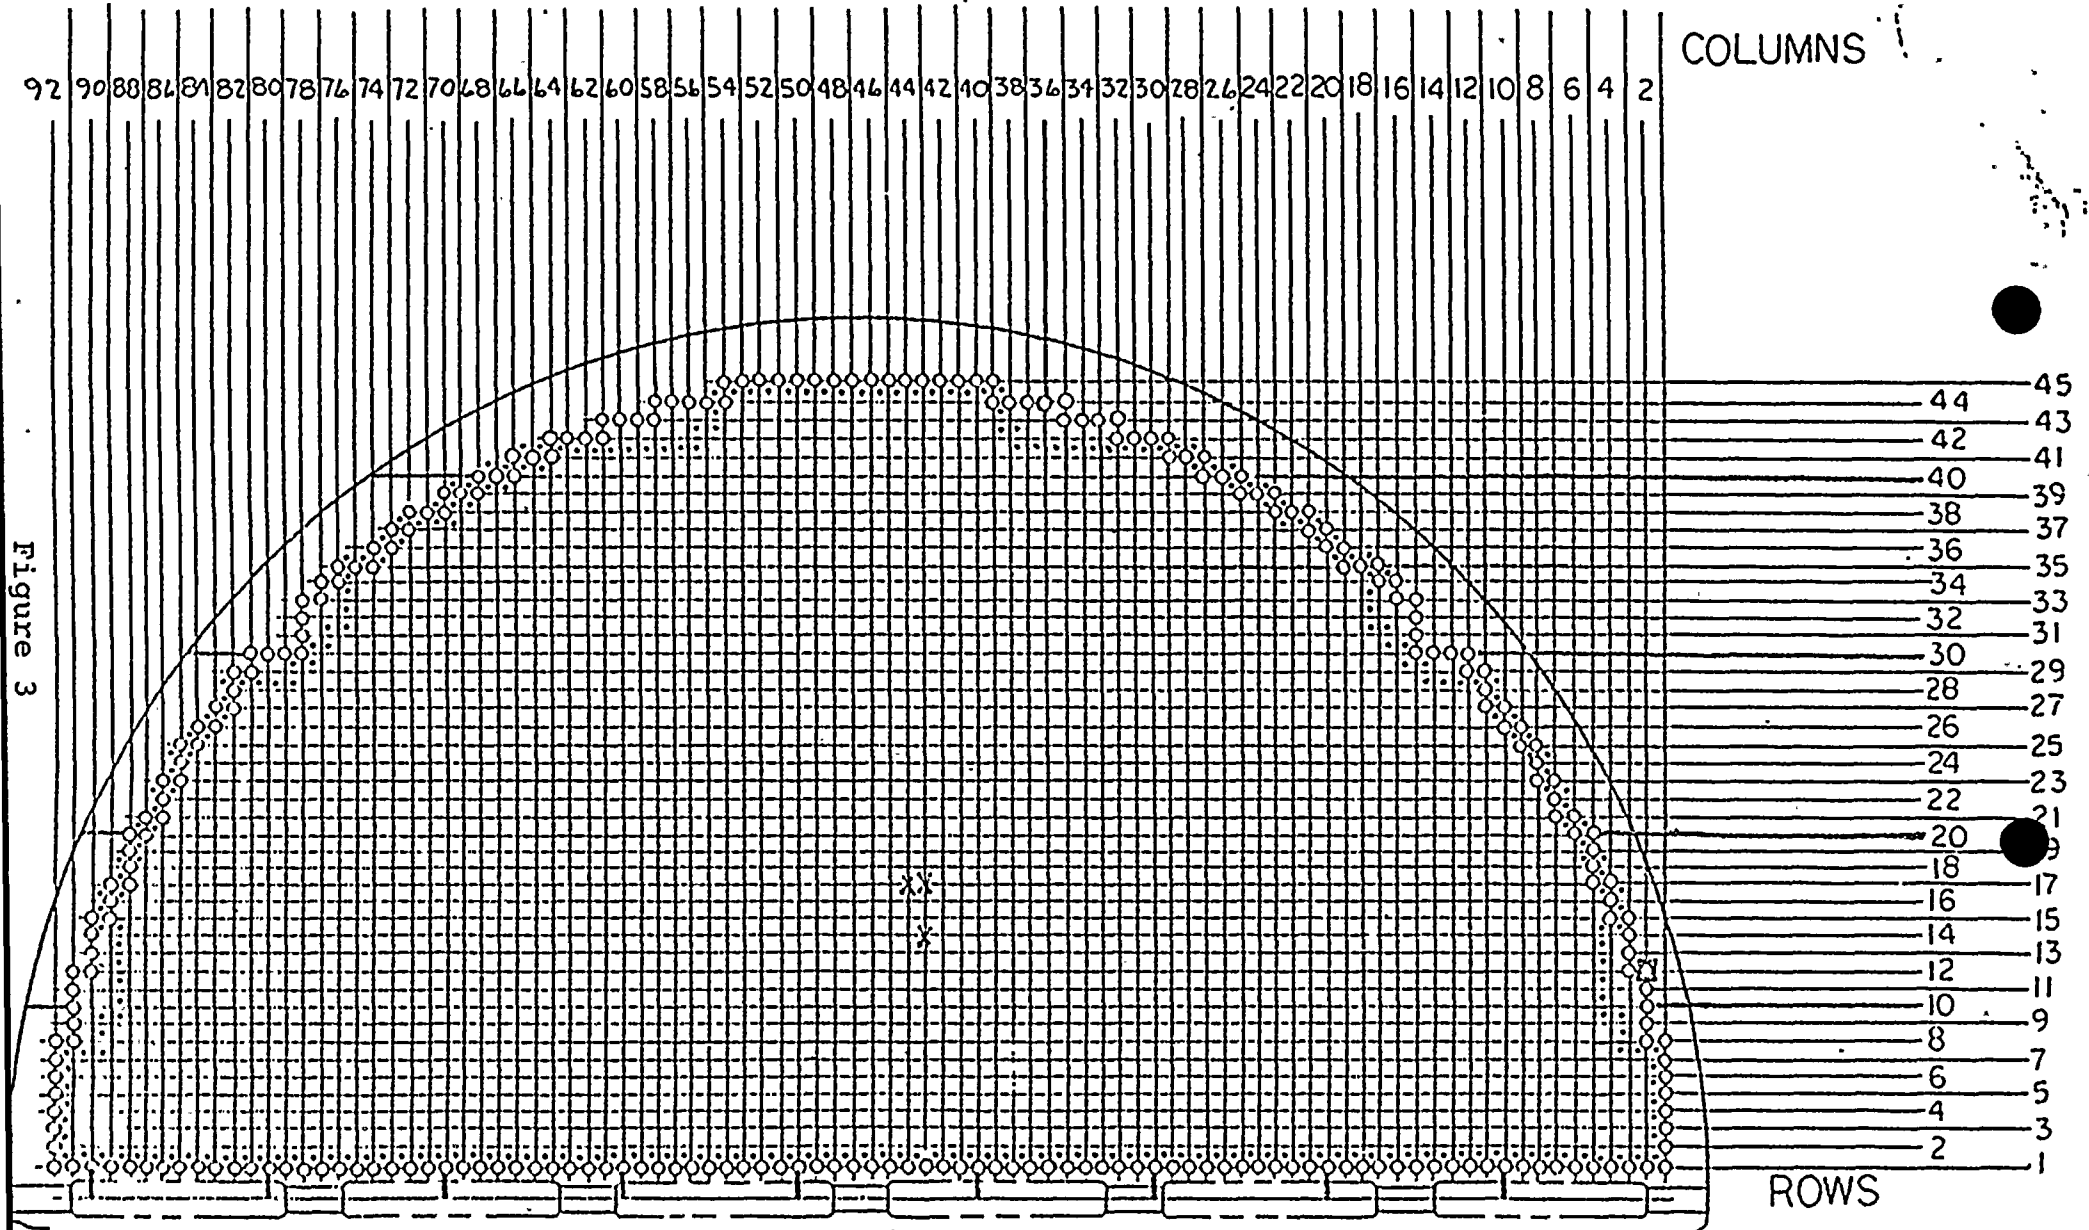
Figure 3

D. OUTLET EDDY CURRENT INDICATION
