LTR-NRC-18-34
May 23, 2018

Subject: Notification of the Potential Existence of Defects Pursuant to 10 CFR Part 21

The following information is provided pursuant to the requirements of 10 CFR Part 21 to report a defect. It has been discovered that for Westinghouse nuclear steam supply system (NSSS) plants that have thermal sleeves in the control rod drive mechanism (CRDM) penetration tubes, wear of the thermal sleeve flange against the tube could have safety consequences that were not previously considered. Recent operating experience, during startup procedures at an Électricité de France (EdF) plant, has shown the possibility for the flange remnant from a thermal sleeve to interfere with control rod movement. The safety evaluations in report PWROG-16003-P, Rev. 1 and Technical Bulletin TB-07-2, Rev. 3 considered this interference to be highly unlikely and the inspection recommendations reflected a conservative time frame. Considering the new operating experience from EdF, the inspection guidelines that were based on the information available at that time may be non-conservative. While there have been no reported events of control rods failing to insert into the core during steady

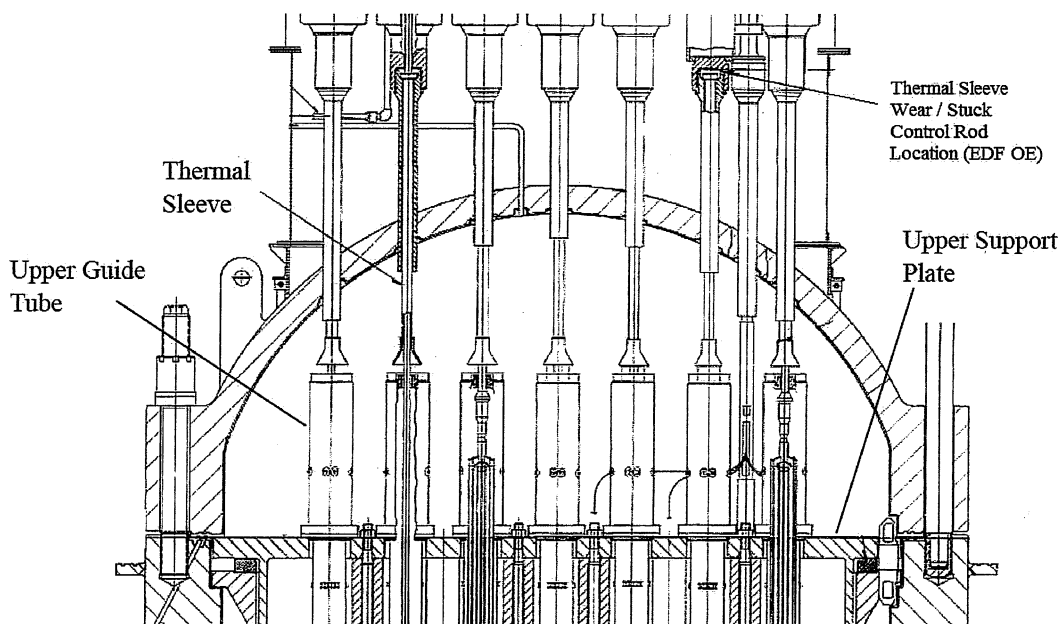
Figure 1 Thermal Sleeve Location in the Reactor Vessel Head

The defect deals with inspection guidelines for the thermal sleeve flange, located in the reactor vessel internals. Figure 1 shows the location of the flange in the upper right. The label in Figure 1, "Thermal Sleeve Wear / Stuck Control Rod Location (EDF OE)" indicates the specific area of observed wear leading to interference with control rod movement.

In December 2017, a 4-Loop 1300 MW EdF plant in France, Belleville Unit 2, experienced complete wear-through and separation of one of their thermal sleeve flanges at a rodded location (core location H-8). This is the first OE of a failure of a thermal sleeve at a rodded location due to flange wear. This condition was discovered while performing low-power physics testing (LPPT) and rod drop testing prior to returning to power. The issue was first identified due to difficulty stepping the rod into the core during LPPT. The rod was able to be freed by exercising the drive rod but then was stopped prior to full insertion during the subsequent rod drop testing. Evaluations of the condition following this discovery showed that the thermal sleeve had worn through the flange, leaving a ring in the CRDM penetration housing similar to the one discovered at the plant in 2014. This flange remnant is believed to be the cause of the rod stepping and dropping issue experienced by EdF at core location H-8.

Wearing of the thermal sleeve flange to the point of separation, can result in a loose part (flange remnant) positioned at the top of the CRDM penetration housing just below the CRDM latch assembly. During steady state operation, little to no flow passes in the region of the flange remnant and therefore it is expected to remain in the pocket worn into the CRDM penetration housing. Under certain conditions, such as during a scram (rod drop) or a filling and venting operation prior to reactor start-up, there is a coolant flow up into the CRDM which can disturb this flange remnant and lift it from the wear pocket. If this occurs, the orientation of the flange remnant is uncertain and has a size capable of being caught by the drive rod lobes, pulled into the CRDM housing, and has the potential to impede the insertion of the rods. Although only possible under specific conditions, in this case due in part to flow in the region of the flange remnant, the Belleville Unit 2 event shows that these conditions can exist and jamming of the drive rod during both stepping and rod drop is possible. Therefore if no action is taken to monitor and correct this condition, flange wear failures could result in control rods failing to insert at multiple

A Westinghouse communication will be supplied to affected licensees to inform them that this defect has been reported and to provide updated recommendations concerning future inspection guidance. The communication will recommend that affected licensees perform inspections on a more accelerated schedule than presented in TB-07-2, Revision 3.
