VIRGINIA ELECTRIC AND POWER COMPANY

SURRY UNIT 2

REACTOR TRIP AND FEEDWATER

PIPE FAILURE REPORT

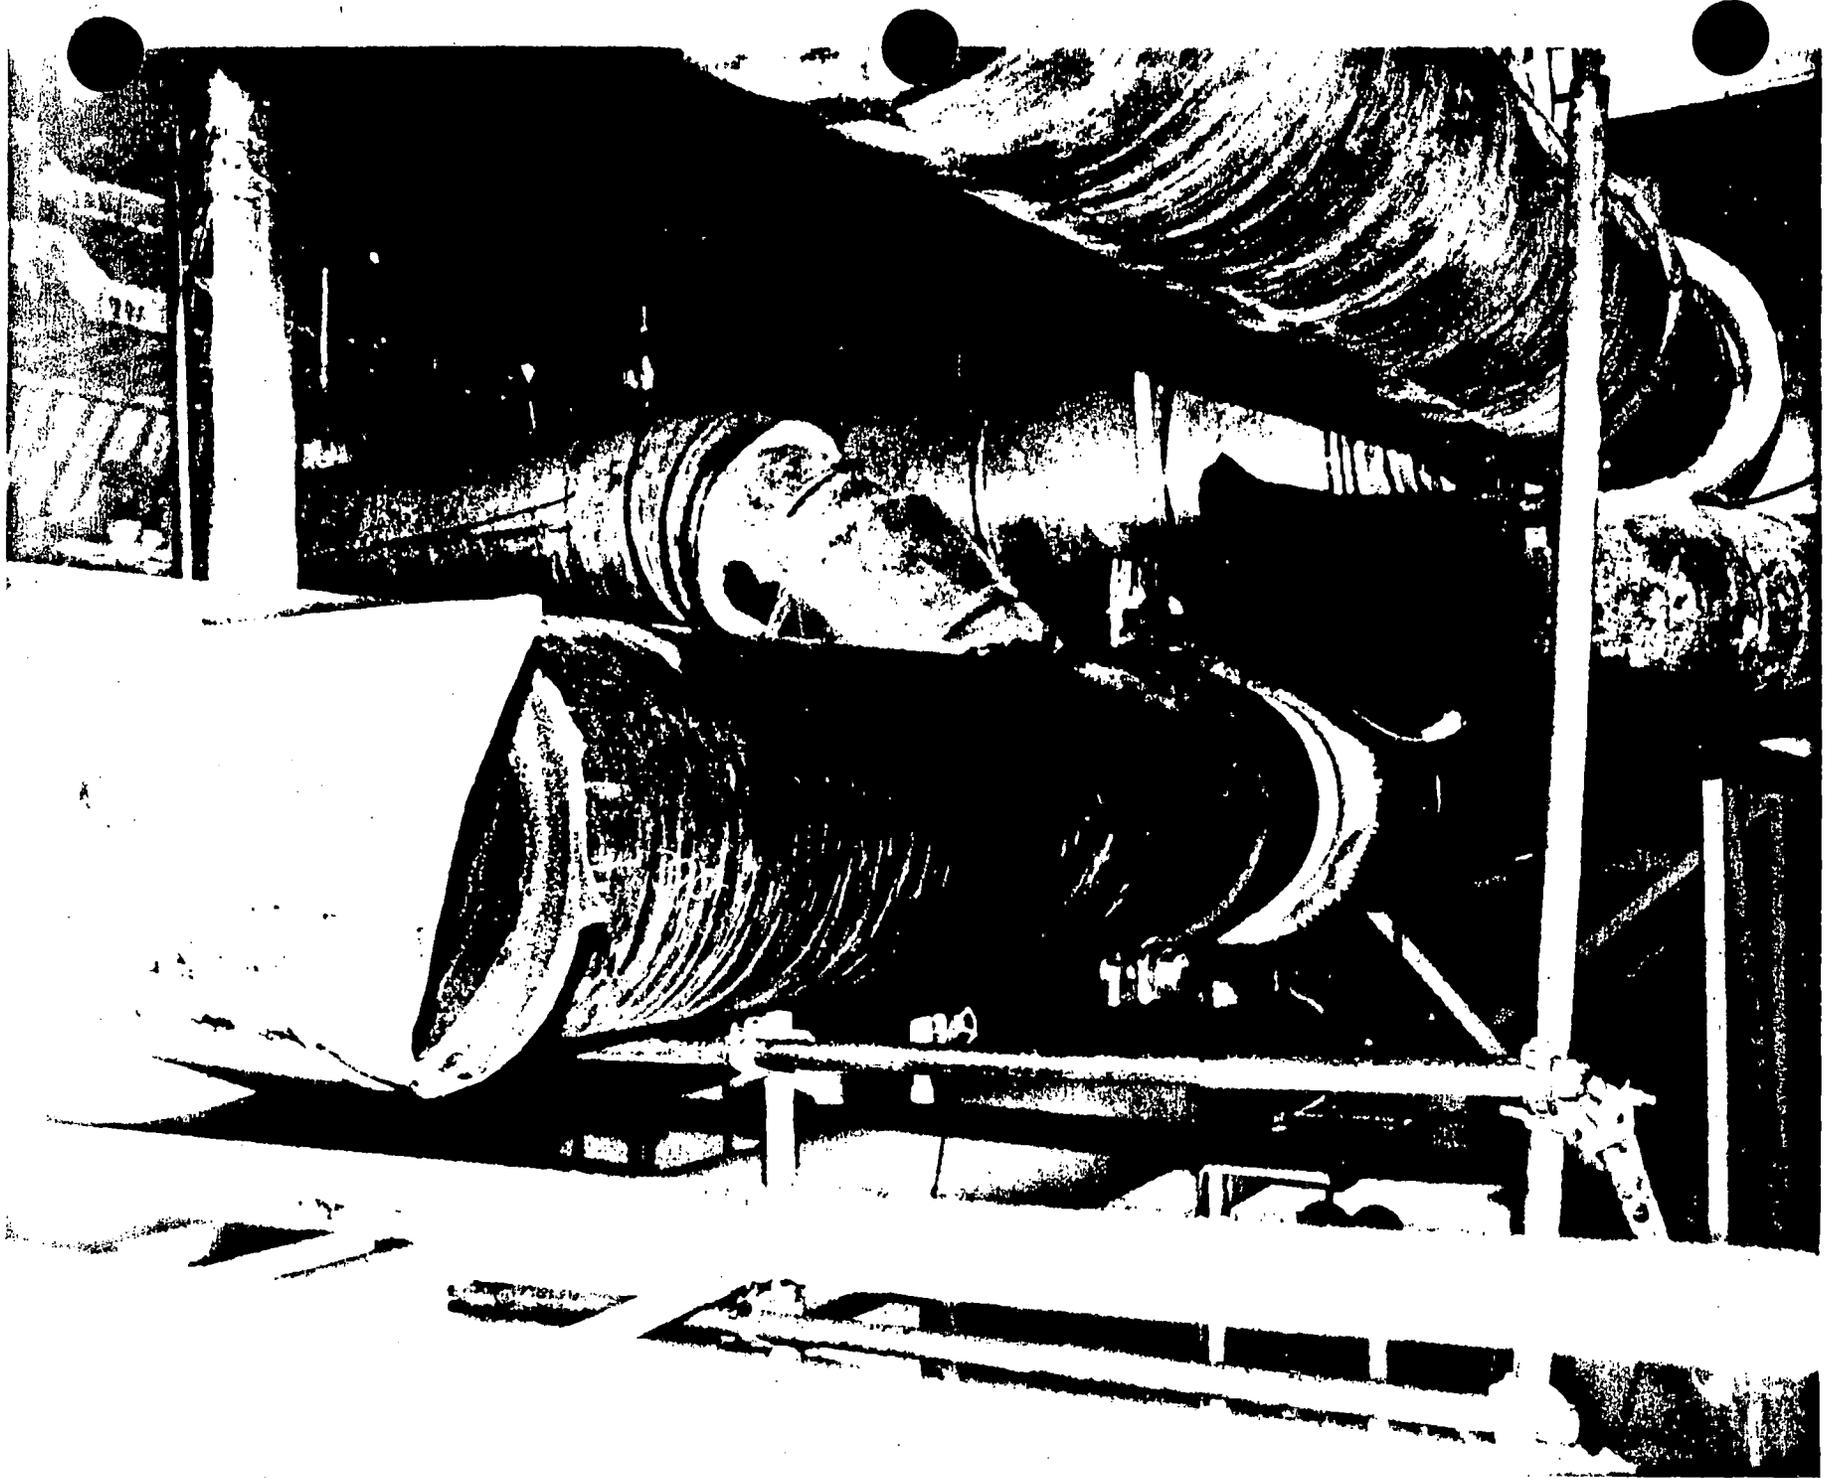
Since installation, the bulk single-phase corrosion/erosion mechanism, as described in Section VI.B of this report, had substantially reduced the original wall thickness. Ultrasonic wall thickness measurements and micrometer measurements taken on the elbow following the failure showed a gradually sloping wall thickness loss over much of the suction line. At several locations, usually near welds, localized cavities had been formed in the elbow inner surface by the corrosion/erosion process. The remaining wall thickness at these localized areas has been measured as low as 0.048 inches while adjacent locations were 0.090 to 0.140 inches in thickness.

FIGURE IV-1 - Failure site showing complete fracture of 18" diameter elbow.

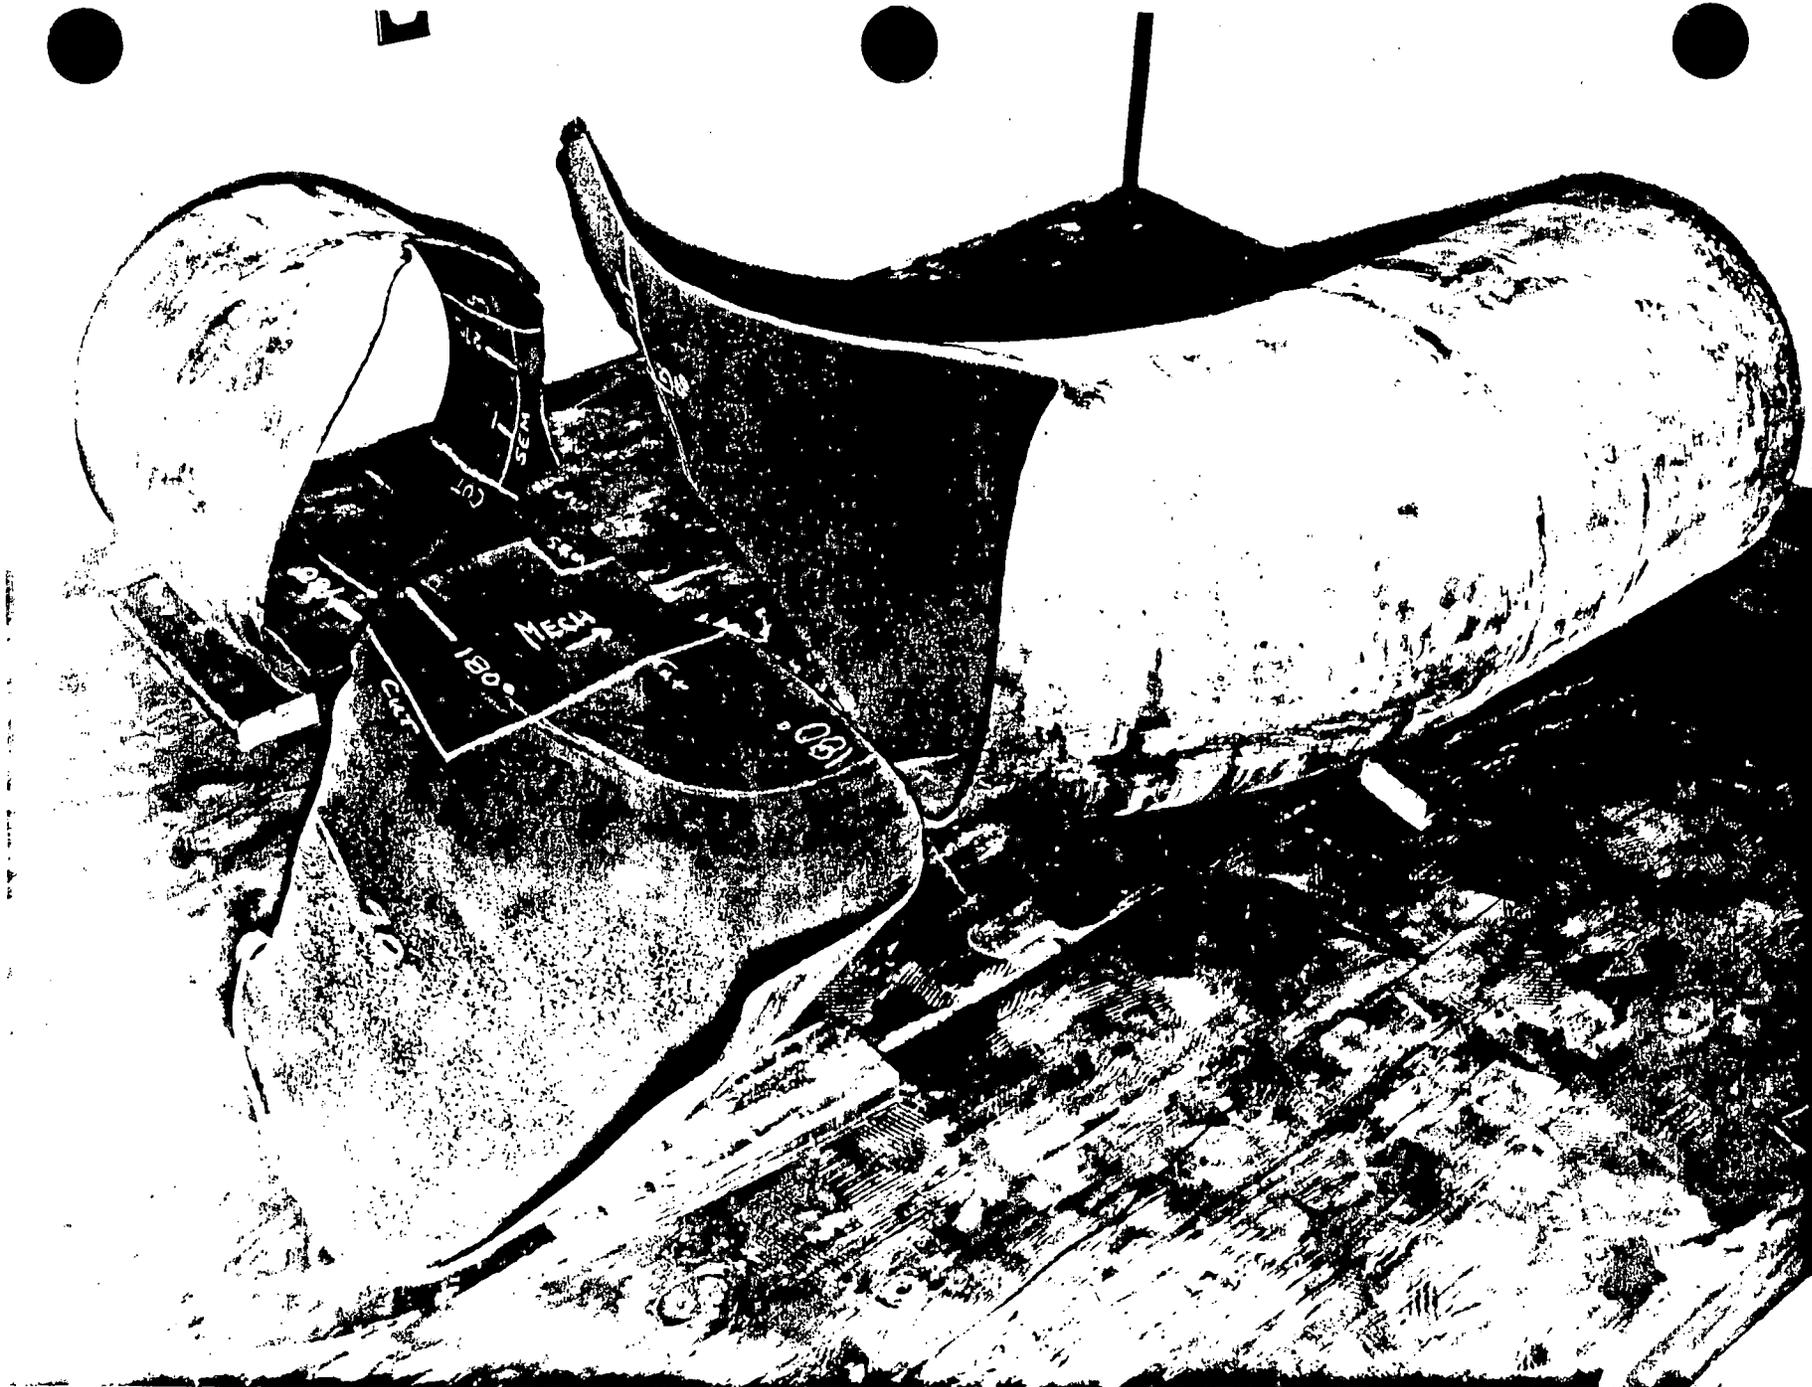
FIGURE VI-1 - Failed 18" diameter elbow after removal showing relationship of fractured sections.

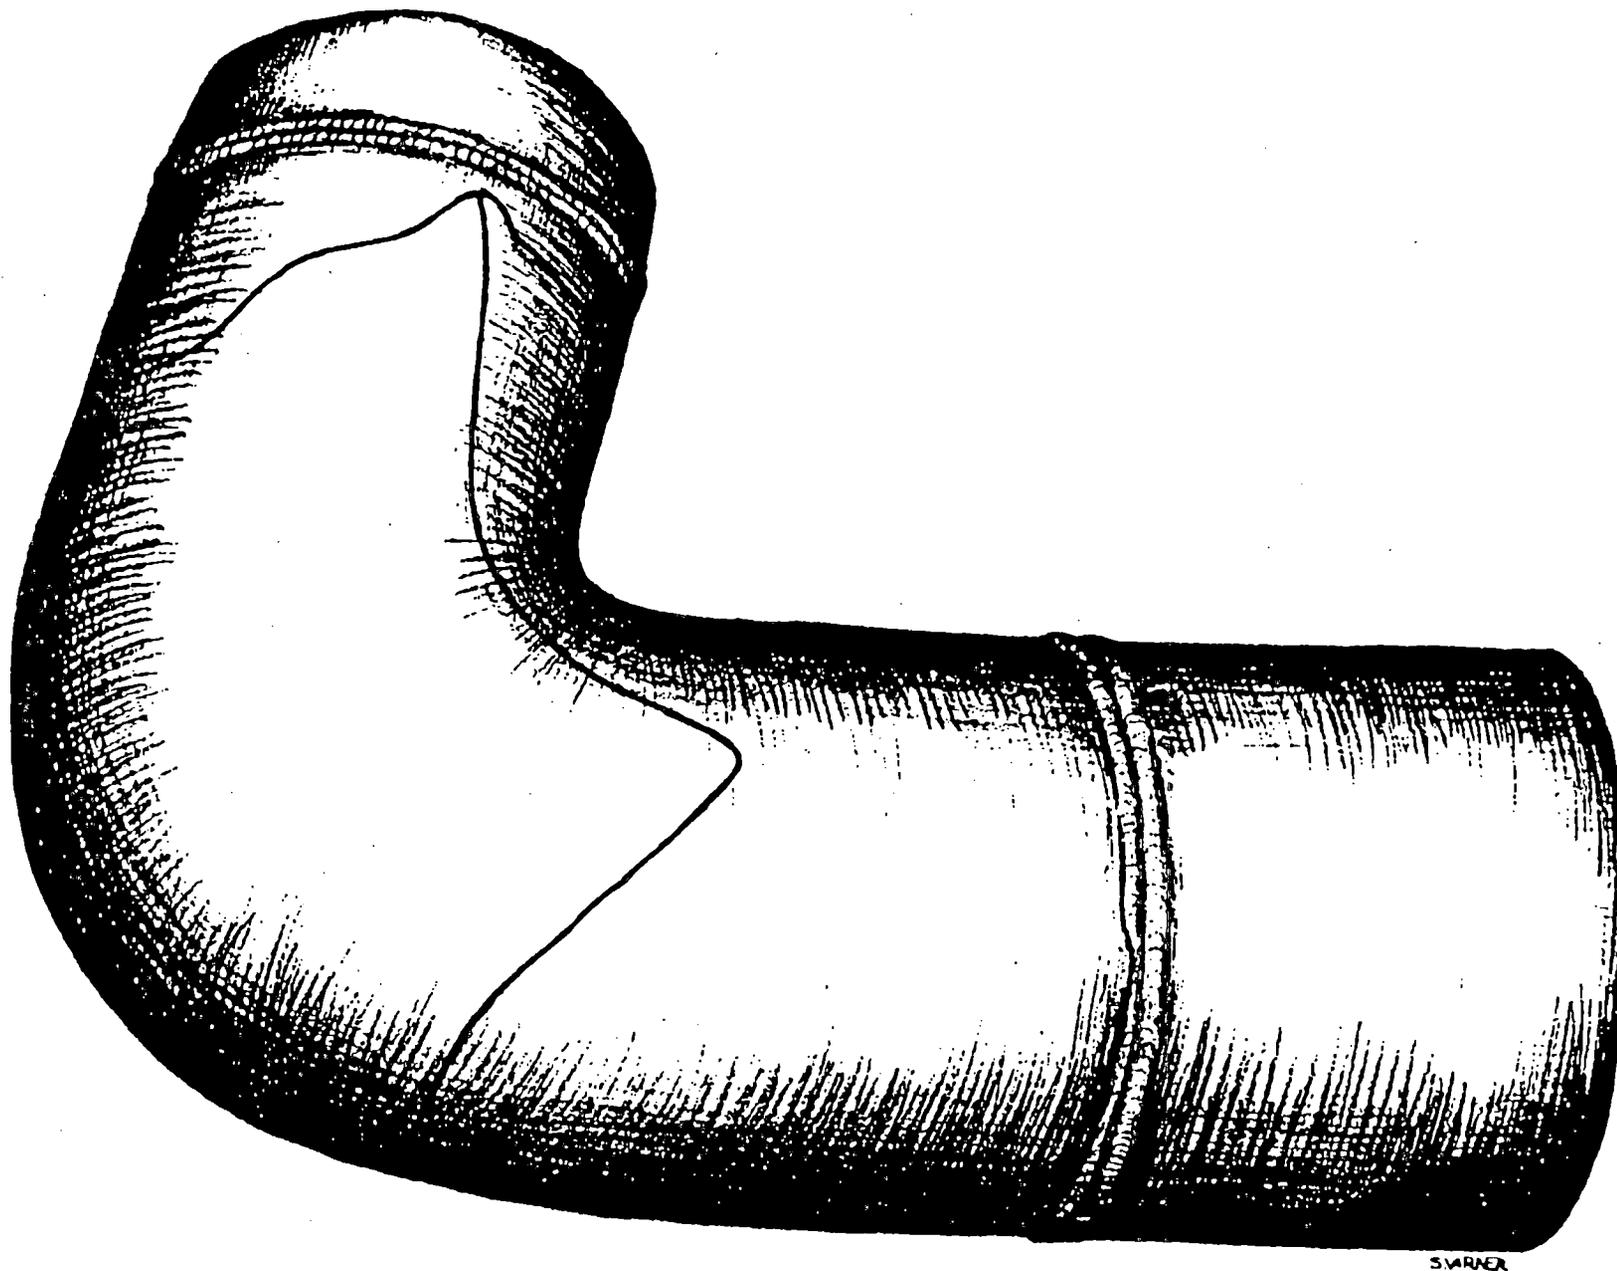
FIGURE VI-2 - Artist rendering of intact 18" piping elbow with failed section drawn in.

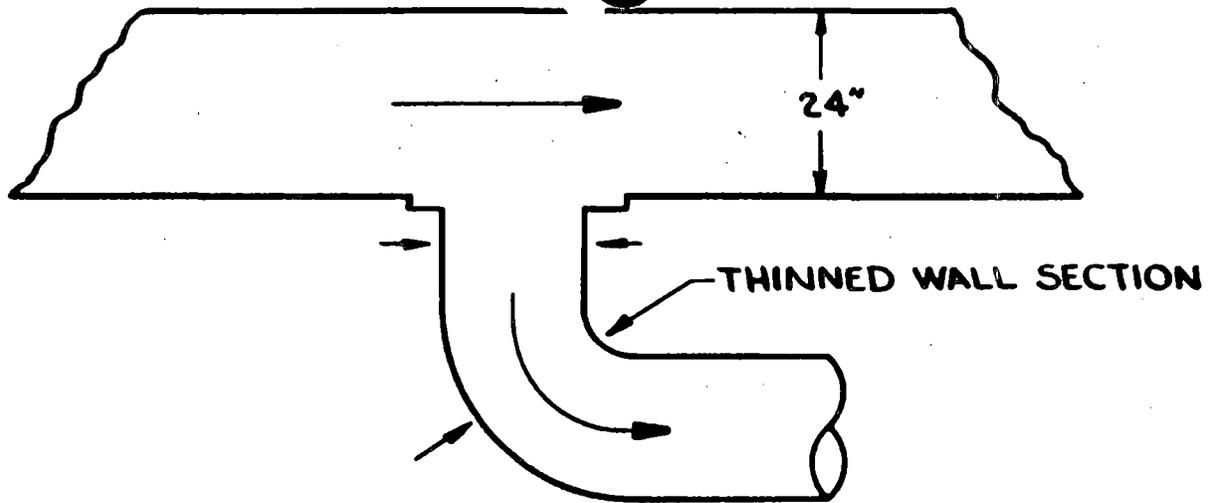
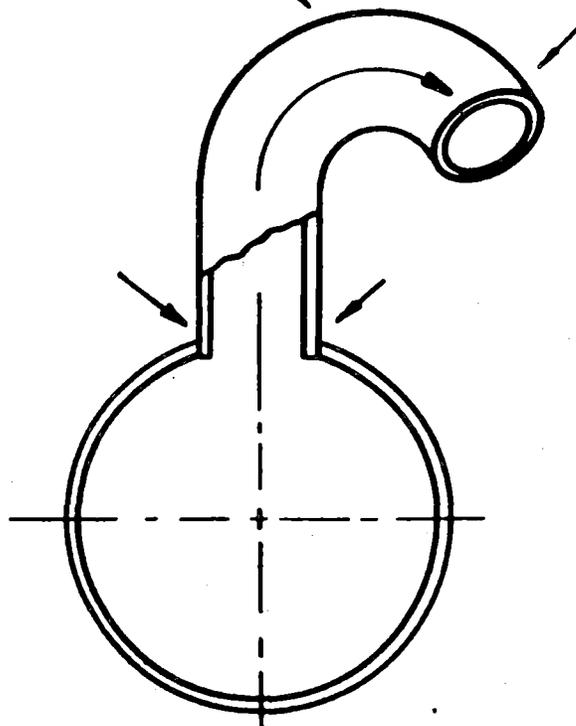
FIGURE VI-4 - Schematic diagram of Surry 18" feedwater suction line and steam generator J-nozzle showing similarities in design geometry.
