ANALYSIS OF FLOODING VULNERABILITIES

Effective Date: 09/01/2018

Attachment 1
Images of Flooding Vulnerabilities Identified and Corrected at ANO-1

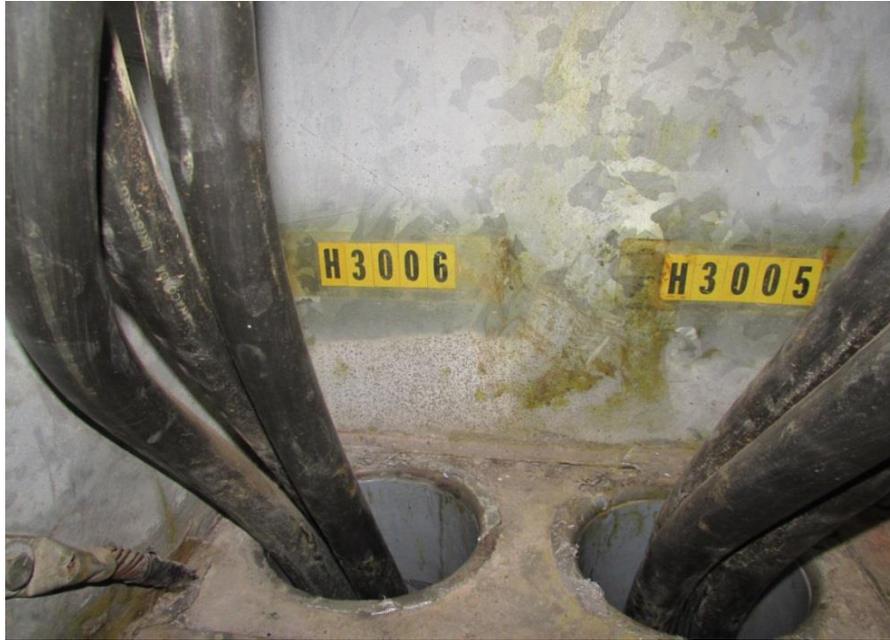
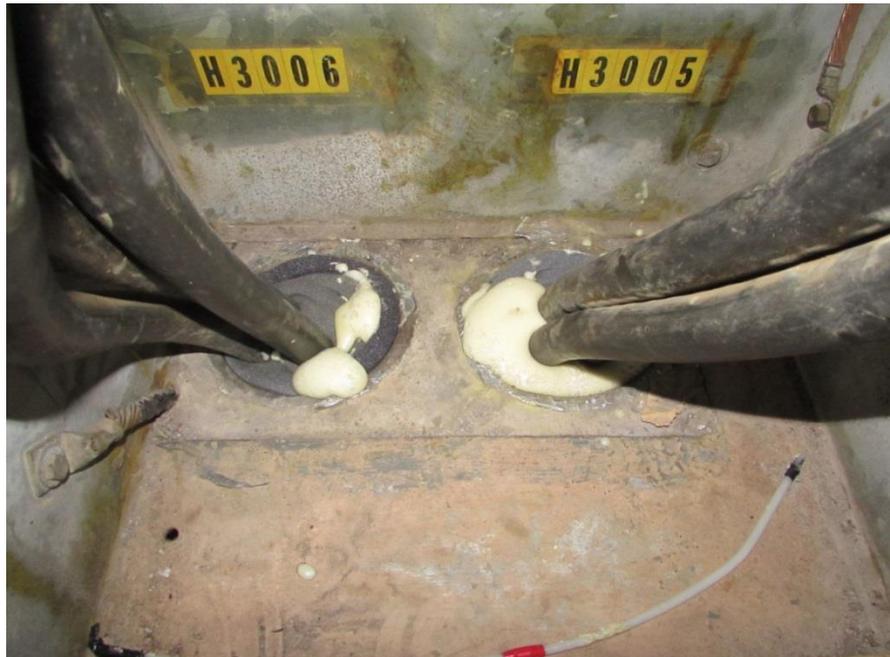
“As-found” (top) and “As-left” (bottom) condition of embedded 6.9kV conduits which penetrate the Turbine and Auxiliary Building at ANO-1. Some of the penetrations are in floors or walls that are flood boundaries.

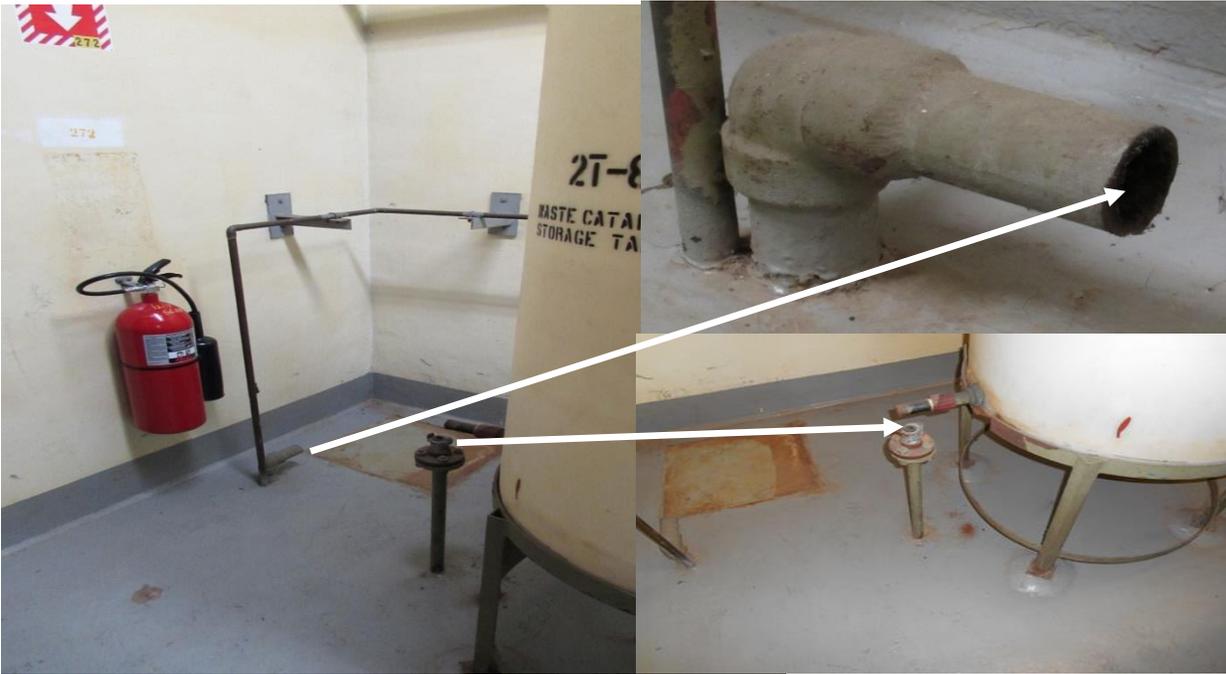
Above, pipes in the “as-found” images were cut and abandoned in place. They provided a potential pathway for flood water to flow into a flood-protected space underneath this room.
