UNITED STATES  
NUCLEAR REGULATORY COMMISSION  
REGION II  
101 MARIETTA ST., N.W.  
ATLANTA, GEORGIA 30323

Report Nos.: 50-280/88-34 and 50-281/88-34

Facility Name: Surry 1 and 2

#### SURRY UNIT 1 - REACTOR CAVITY SEAL FAILURE

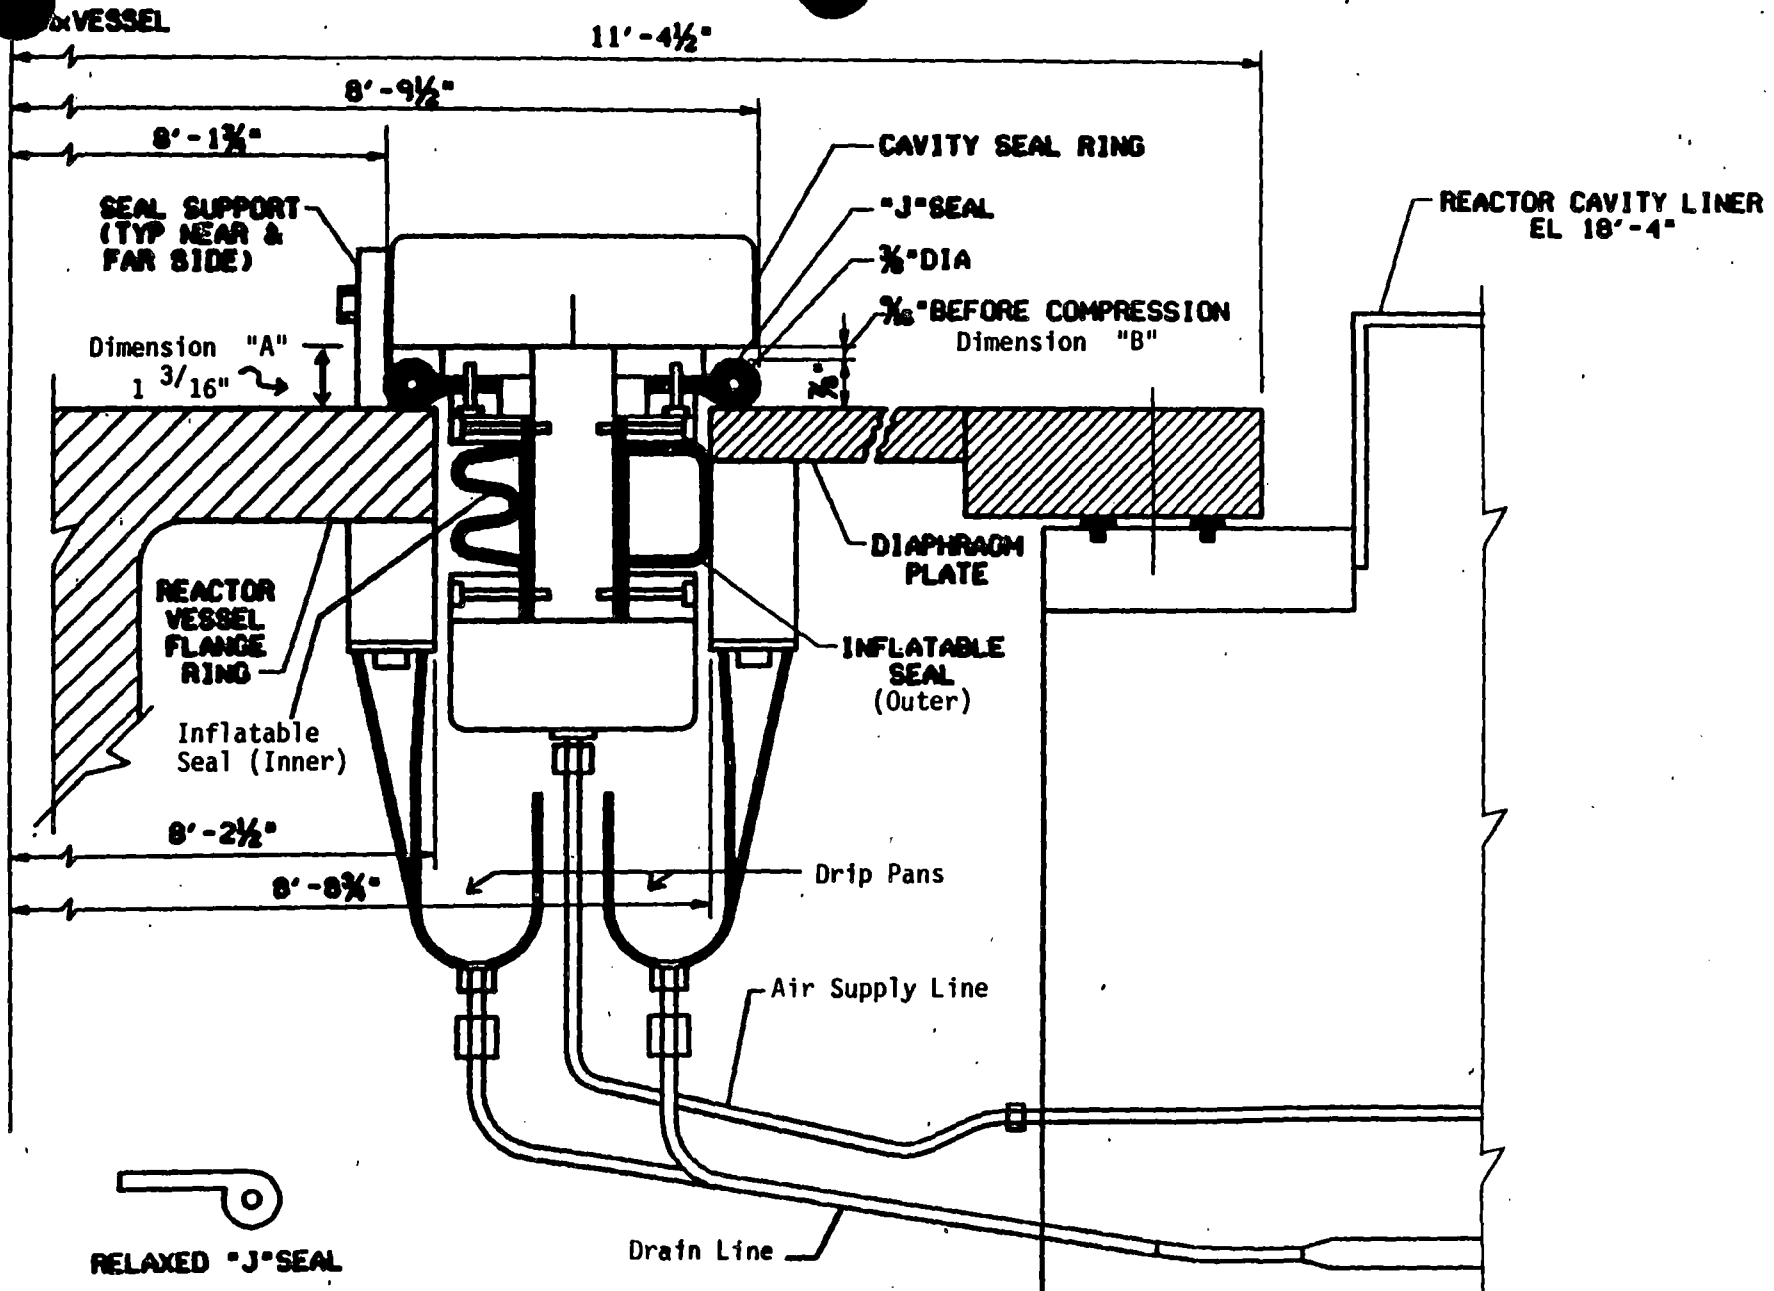
Figure 1

In line with their investigation, the IOER group initiated a detailed design review of the "J" seal. They concluded that "the lack of a positive backing plate on the seal can allow the upward displacement of the bulbous portion of the seal due to forces exerted underneath it. These forces result from the flow of water past the seal due to surface imperfections or seal deterioration." Additionally, it was stated that "the calculated buoyancy of the seal in borated water with an air hole in the center is very near the buoyancy point."

The report went on to further discuss the refueling cavity floor seal installation procedure, MMP-C-RC-37. MMP-C-RC-37 requires the stand-off supports be set at 1 3/16 inches. Calculations performed by the licensee show that for a 30% compression (which results from the stand-offs being set at 1 3/16 inches) there will be about 3/8-inch of surface contact between the "J" seal and mating surface. Due to the lack of a backing plate, there is nothing to guard against a reduction in this surface contact. In addition, it was stated that "if the seal were not regularly replaced, resiliency is lost and the ability of the seal to accommodate surface imperfections is lost."

**SURRY REACTOR CAVITY SEAL RING ASSEMBLY**

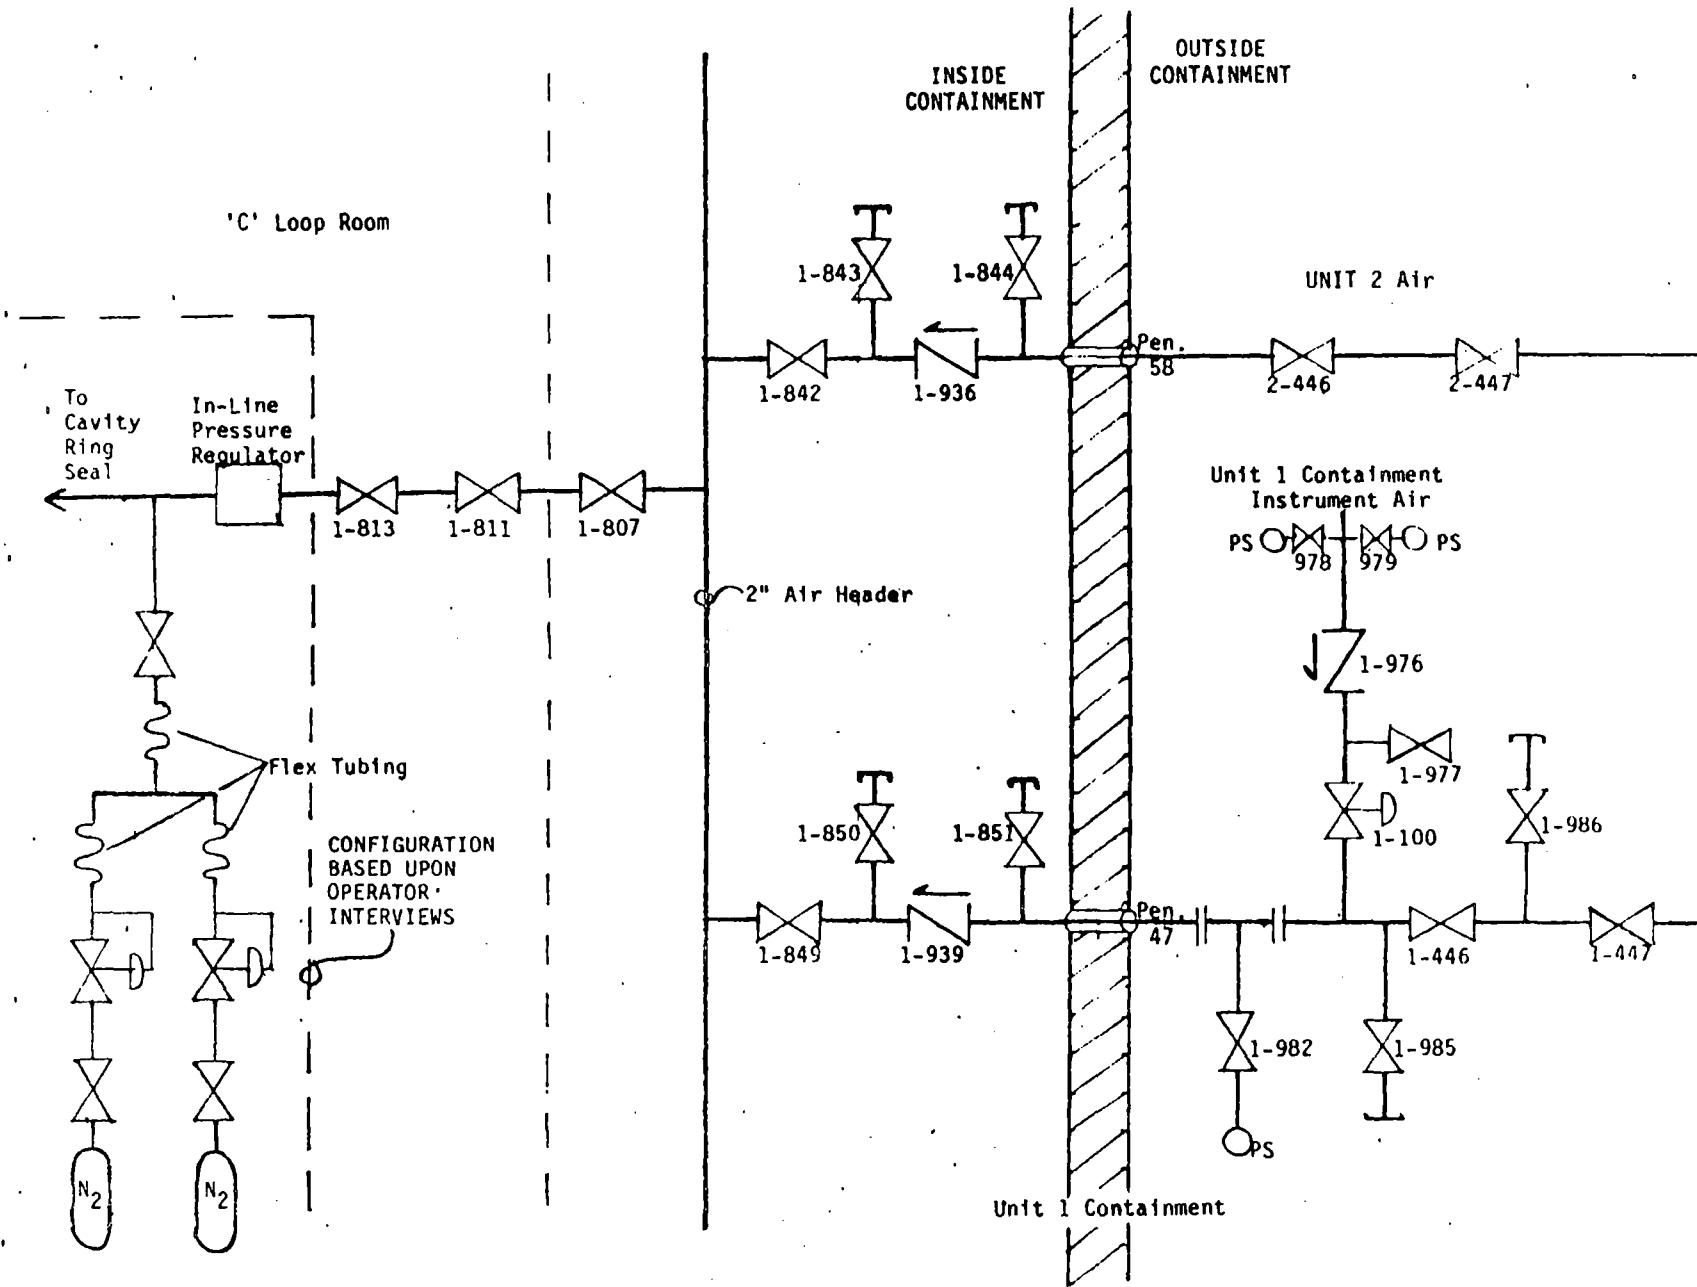
Figure 2

The licensee, on May 16, 1988, was conducting LLRT on containment penetration No. 47. The testing was being conducted in accordance with PT-16.4, "Containment Isolation Valve Leakage," dated April 8, 1988. Penetration 47 supplies IA to a two-inch IA pipe header inside containment. This header distributes air to various components including the inflatable refueling cavity floor seal. The purpose of the test being conducted was to measure back leakage through check valve 1-IA-939. See IA description in Appendix 3B and Figure 2.

On May 17, 1988, at about 0830 hours, repair activities commenced on 1-IA-849. Operations, to support this effort, had isolated IA to containment. The NLO assigned to this work entered the "C" loop room to verify the nitrogen bottles were supplying the seal (see Figure 2) at which time he discovered water cascading down the walls.

Instrument Air System/Nitrogen Backup System

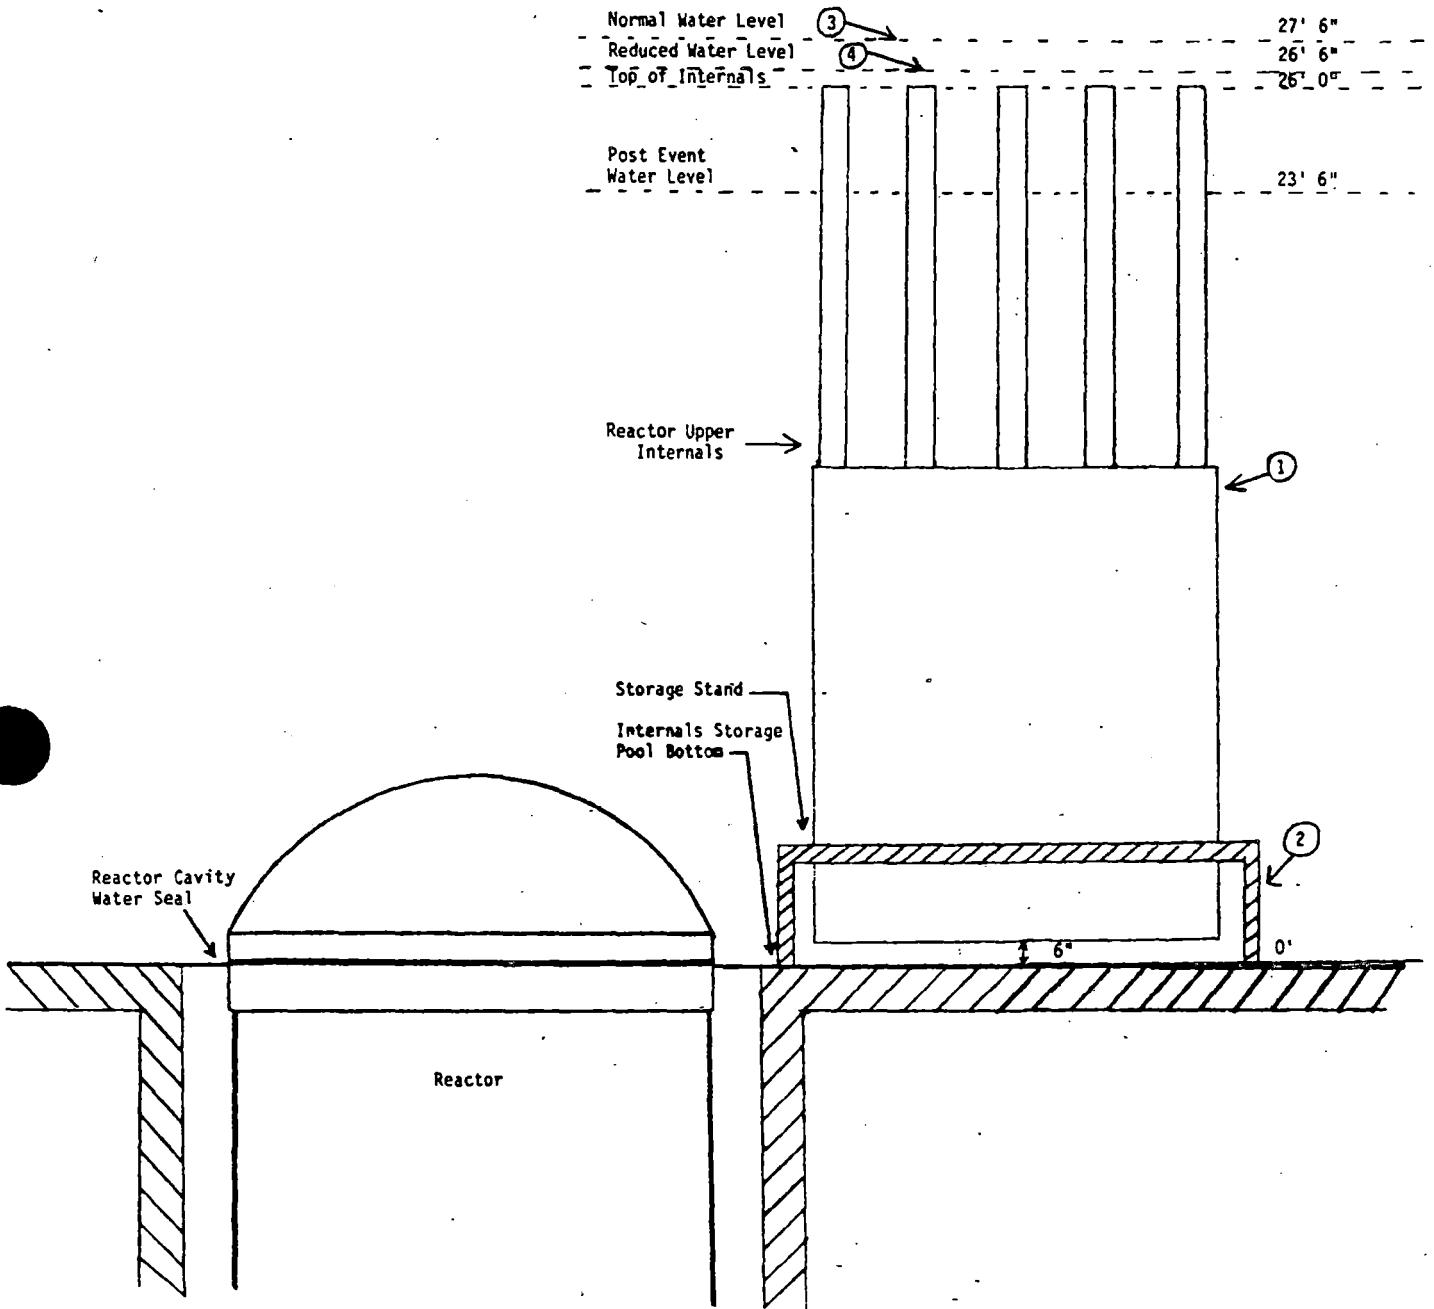
Figure 3

As shown on the attached drawing, Figure 3, the upper internals package (item 1) rests in the storage area on a stand (item 2) which holds the internals up some 6" off the bottom of the reactor cavity. The total height of the upper internals package, including the 6" offset provided by the stand, is 26'. When the refueling cavity water level is "normal" (item 3) the top of the upper internals package is about 1'6" below the surface of the water.

On March 17, 1988, W contractor personnel were working on upper internals thermocouple lead conduit. This work was being performed from the refueling bridge positioned directly over the upper internals package storage location. The water level had been reduced about one foot below (item 4) the normal level thus reducing the remaining shielding to six inches. Due to the loss of refueling cavity water through the refueling cavity floor seal, this shielding water was reduced an additional three feet. Following the event the water level could have dropped to approximately twenty-four feet. Thus allowing about two feet six inches of the upper internals package to be out of the water.

# UPPER CORE INTERNALS STORAGE
