VIRGINIA ELECTRIC AND POWER COMPANY
RICHMOND, VIRGINIA 23261

VIRGINIA ELECTRIC AND POWER COMPANY
SURRY POWER STATION UNITS 1 AND 2
GENERIC LETTER 87-02 – UNRESOLVED SAFETY ISSUE (USI) A-46
REQUEST FOR ADDITIONAL INFORMATION

RESPONSE TO REQUEST FOR ADDITIONAL INFORMATION GENERIC LETTER 87-02 SURRY POWER STATION UNITS 1 AND 2

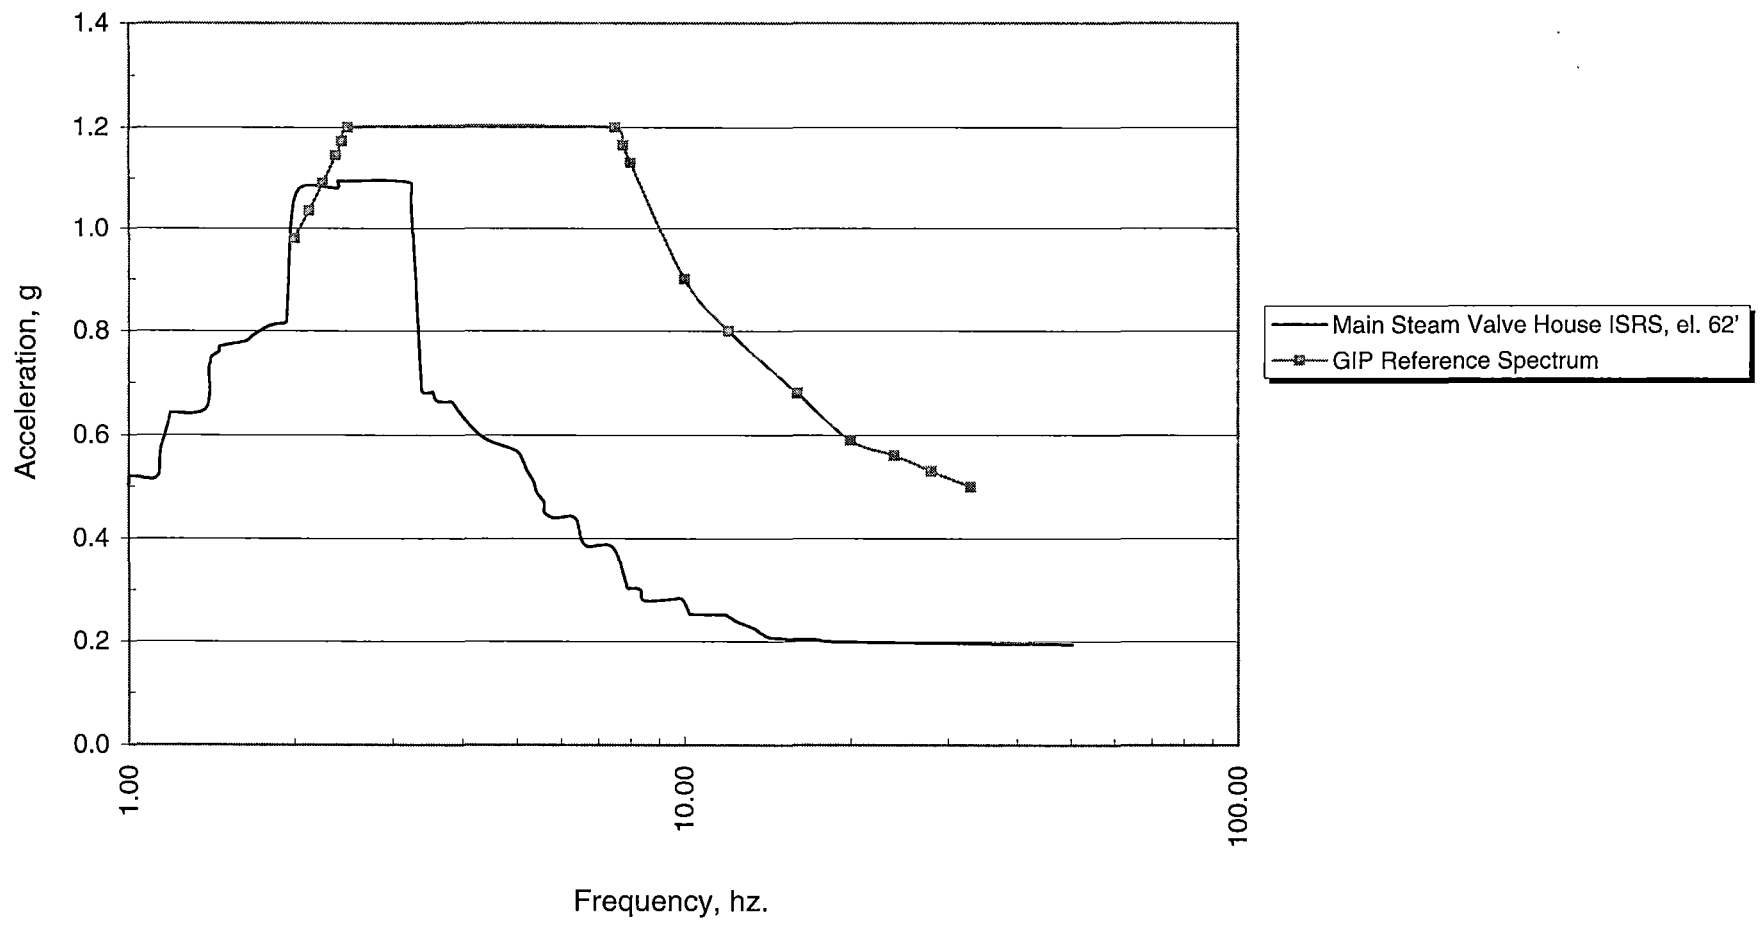
In-Structure Response Spectrum (ISRS) - Design Basis Earthquake Main Steam Valve House - El. 62' - Horiz. Direction - 5% Spectral Damping SURRY POWER STATION UNITS 1 AND 2

² Peaks are extrapolated from 1% damping ISRS to obtain 5% damping ISRS for comparison with the Reference Spectrum. A few valves are located at elev. 62', and a slight excursion near 2 hz. is judged to meet the intent of GIP.

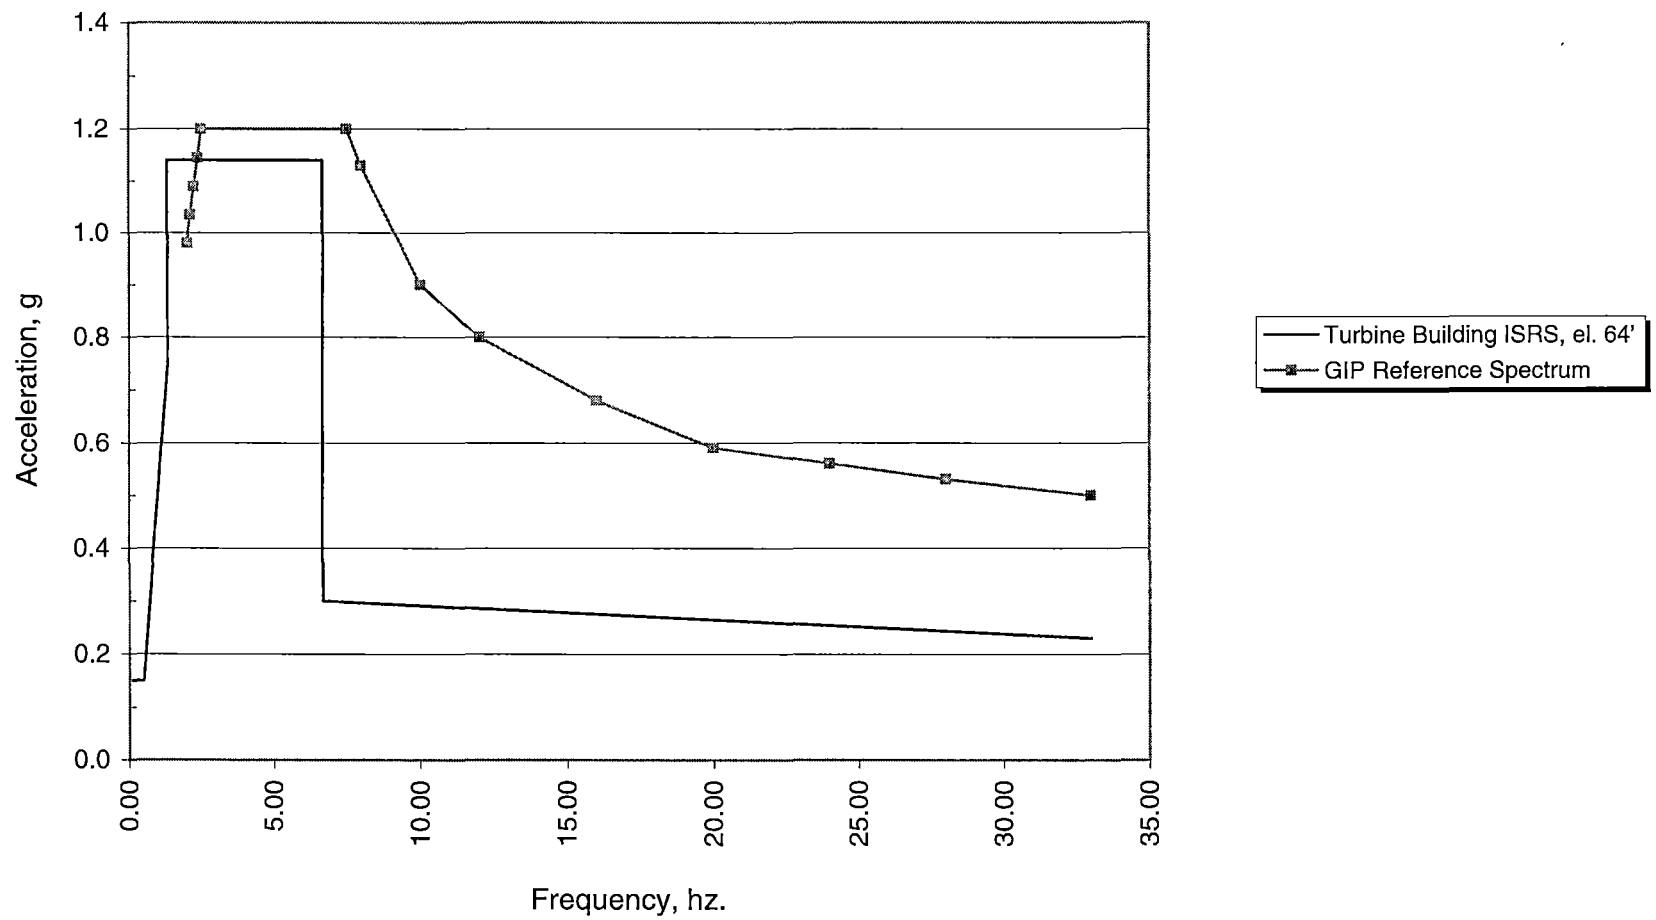
In-Structure Response Spectrum (ISRS) - Design Basis Earthquake Turbine Building - Elev. 64' - Horizontal Direction - 5% Spectral Damping SURRY POWER STATION UNITS 1 AND 2

⁴ No new analysis was done for the Turbine Building to generate ISRS. The conservative, design ISRS at all elevations in this building is based on the Taft earthquake input and was developed in the 1971 time frame for 1% spectral damping. From this, ISRS at 5% spectral damping was recently developed, and is compared with the 5% damped Reference Spectrum of the GIP. A slight exceedance near 2 hz is judged to meet the intent of the GIP.

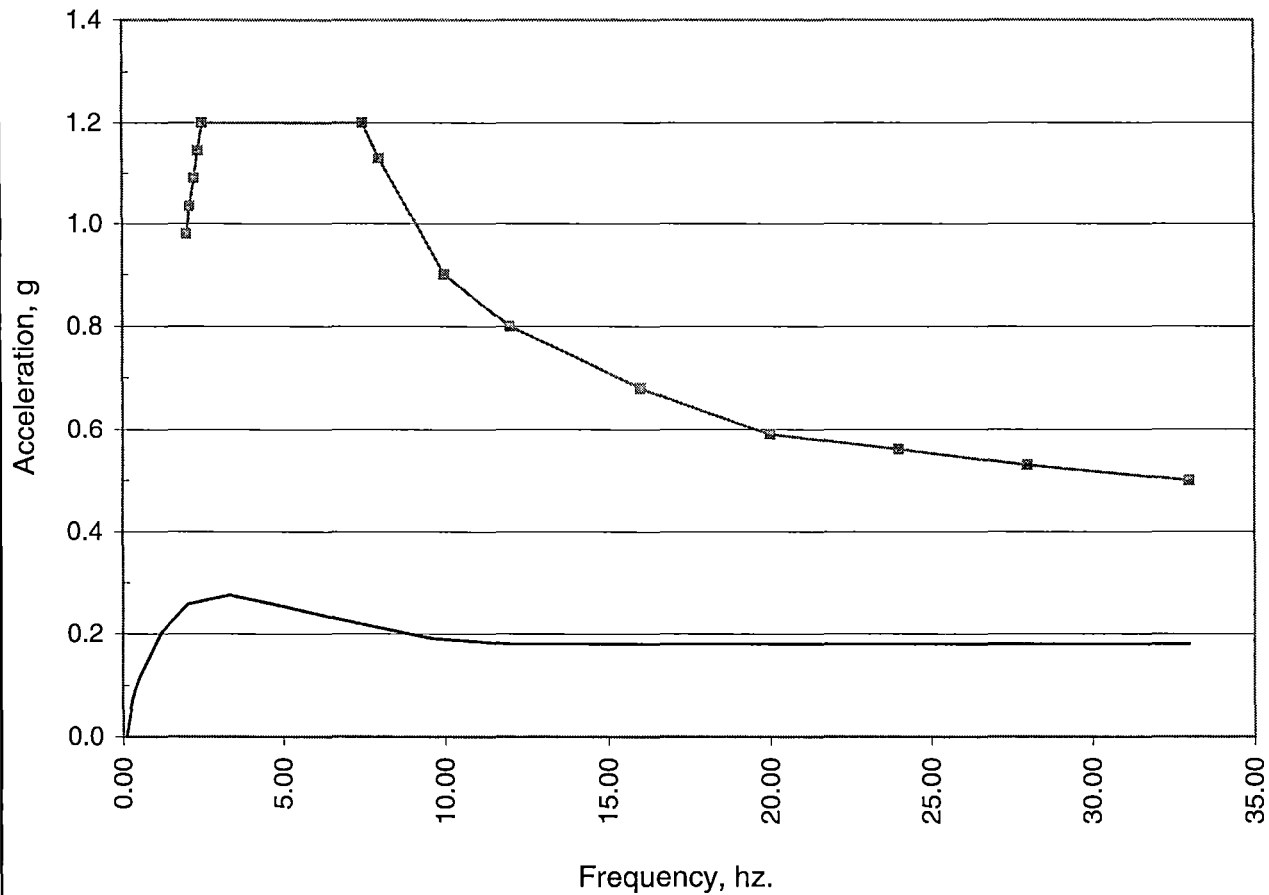
Ground x 1.2 Response Spectrum - Design Basis Earthquake
(Applies to Emer. Serv. Water Pump Intake Struct. & Fuel Oil Pump House)
Horizontal Direction, 5% Spectral Damping
SURRY POWER STATION UNITS 1 AND 2

⁵ No Housner basis design ISRS was developed for this structure. A study concluded that the ISRS is not larger than 1.2 times the ground spectrum at the highest elevation where SSEL components are located in this building.

⁶ This is a compact structure, and SSEL components are located below the grade level. Therefore, the ISRS is judged to be less than 1.2 times the ground response spectrum.

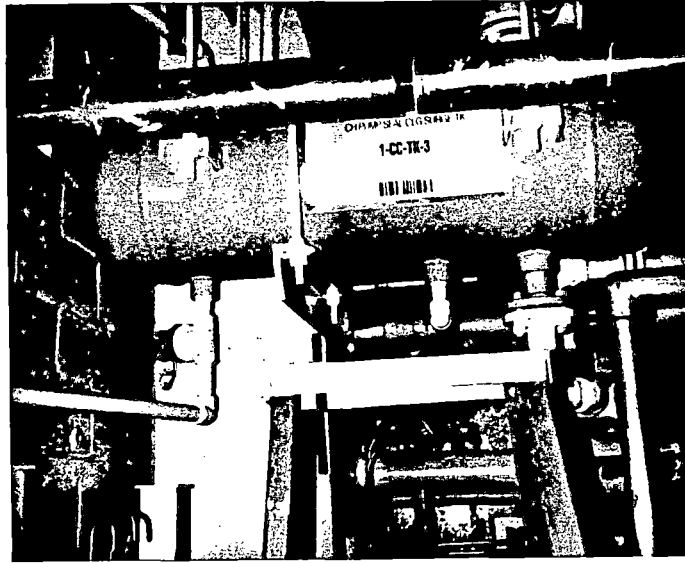
1-CC-TK-3

The charging pump seal cooling surge tanks (1/2-CC-TK-3) are suspended tanks. Each tank is fabricated from 16" outer diameter, schedule 10 pipe and is about four feet in length. A previously performed calculation for the IPEEE (seismic) program showed that its High-Confidence-of-Low-Probability-of-Failure (HCLPF) capacity was much greater than 0.3g, expressed in terms of peak ground acceleration (pga). As requested by the staff, this calculation has been revised. The revision, which was performed in accordance with the deterministic USI A-46 methodology of the GIP, is provided as Enclosure 3. It demonstrates that the tank anchorage has substantial capacity to withstand the design basis earthquake loads based on the USI A-46 approved in-structure response spectra and the GIP-2 methodology.
