UNITED STATES  
 NUCLEAR REGULATORY COMMISSION  
 REGION II  
 101 MARIETTA STREET, N.W., SUITE 2900  
 ATLANTA, GEORGIA 30323-0199

Report Nos.: 50-280/94-16 and 50-281/94-16

Facility Name: Surry Power Station Units 1 and 2

Inspection Conducted: June 20-24, 1994

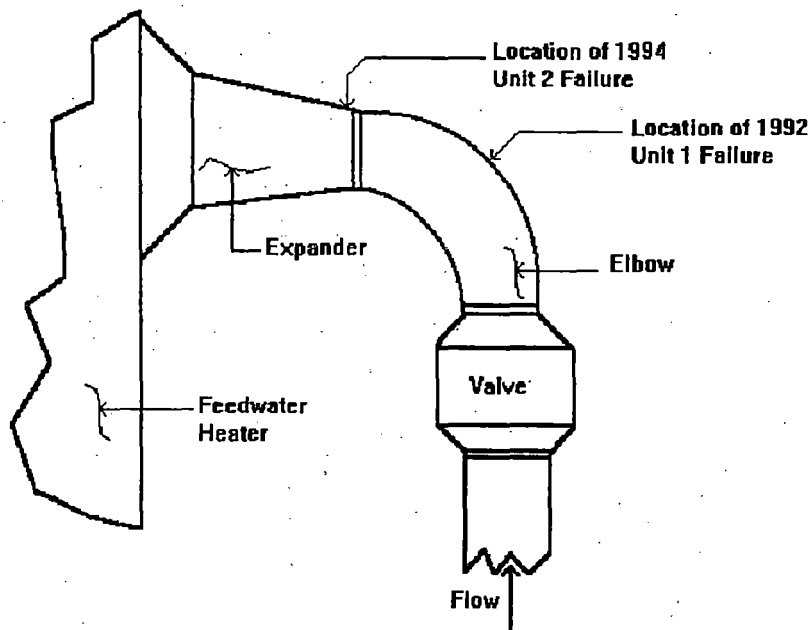
Figure 1

The licensee noted water on the floor adjacent to the 2A Feedwater heater. On May 25, 1994, after isolation and cool down of the 2A Feedwater heater, the insulation was removed exposing a through-wall hole in heater drain line 10"-WLD-101-301, at a 10" x 14" expander. The hole was located at the 12:00 position in the heat affected zone of the weld connecting the horizontal expander to a down directed 10" elbow (see Figure 1). The licensee cut out the carbon steel expander and elbow and replaced the fittings with low alloy steel, 2½Cr 1Mo, fittings. At this writing, the licensee is conducting a metallurgical failure analysis.

In 1992, prior to the implementation of the CHECMATE® program, the licensee ultrasonically examined the elbow and expander on the Unit 1 "B" train line (in the same relative position as above). The minimum wall thickness value found, though acceptable then, would have been unacceptable prior to the end of the next fuel cycle. The maximum point of wear was approximately 16" to 20" down the extrados of the elbow at the 12:00 position (see Figure 1).

Unit 1 "B" train elbow was replaced with a low alloy steel, 2½Cr 1Mo, fitting. The Unit 1 "B" train expander remains the original carbon steel.
