VIRGINIA ELECTRIC AND POWER COMPANY

LICENSEE EVENT REPORT (LER)

FACILITY NAME (1) Surry Power Station, Unit 1	DOCKET NUMBER (2) 0 5 0 0 0 2 8 0	PAGE (3) 1 OF 0 5
--	--------------------------------------	----------------------

TITLE (4) Manual Reactor Trip/Turbine Trip Initiated Following Loss of Power to Semi-Vital Bus Caused by a Fault on "A" RSST

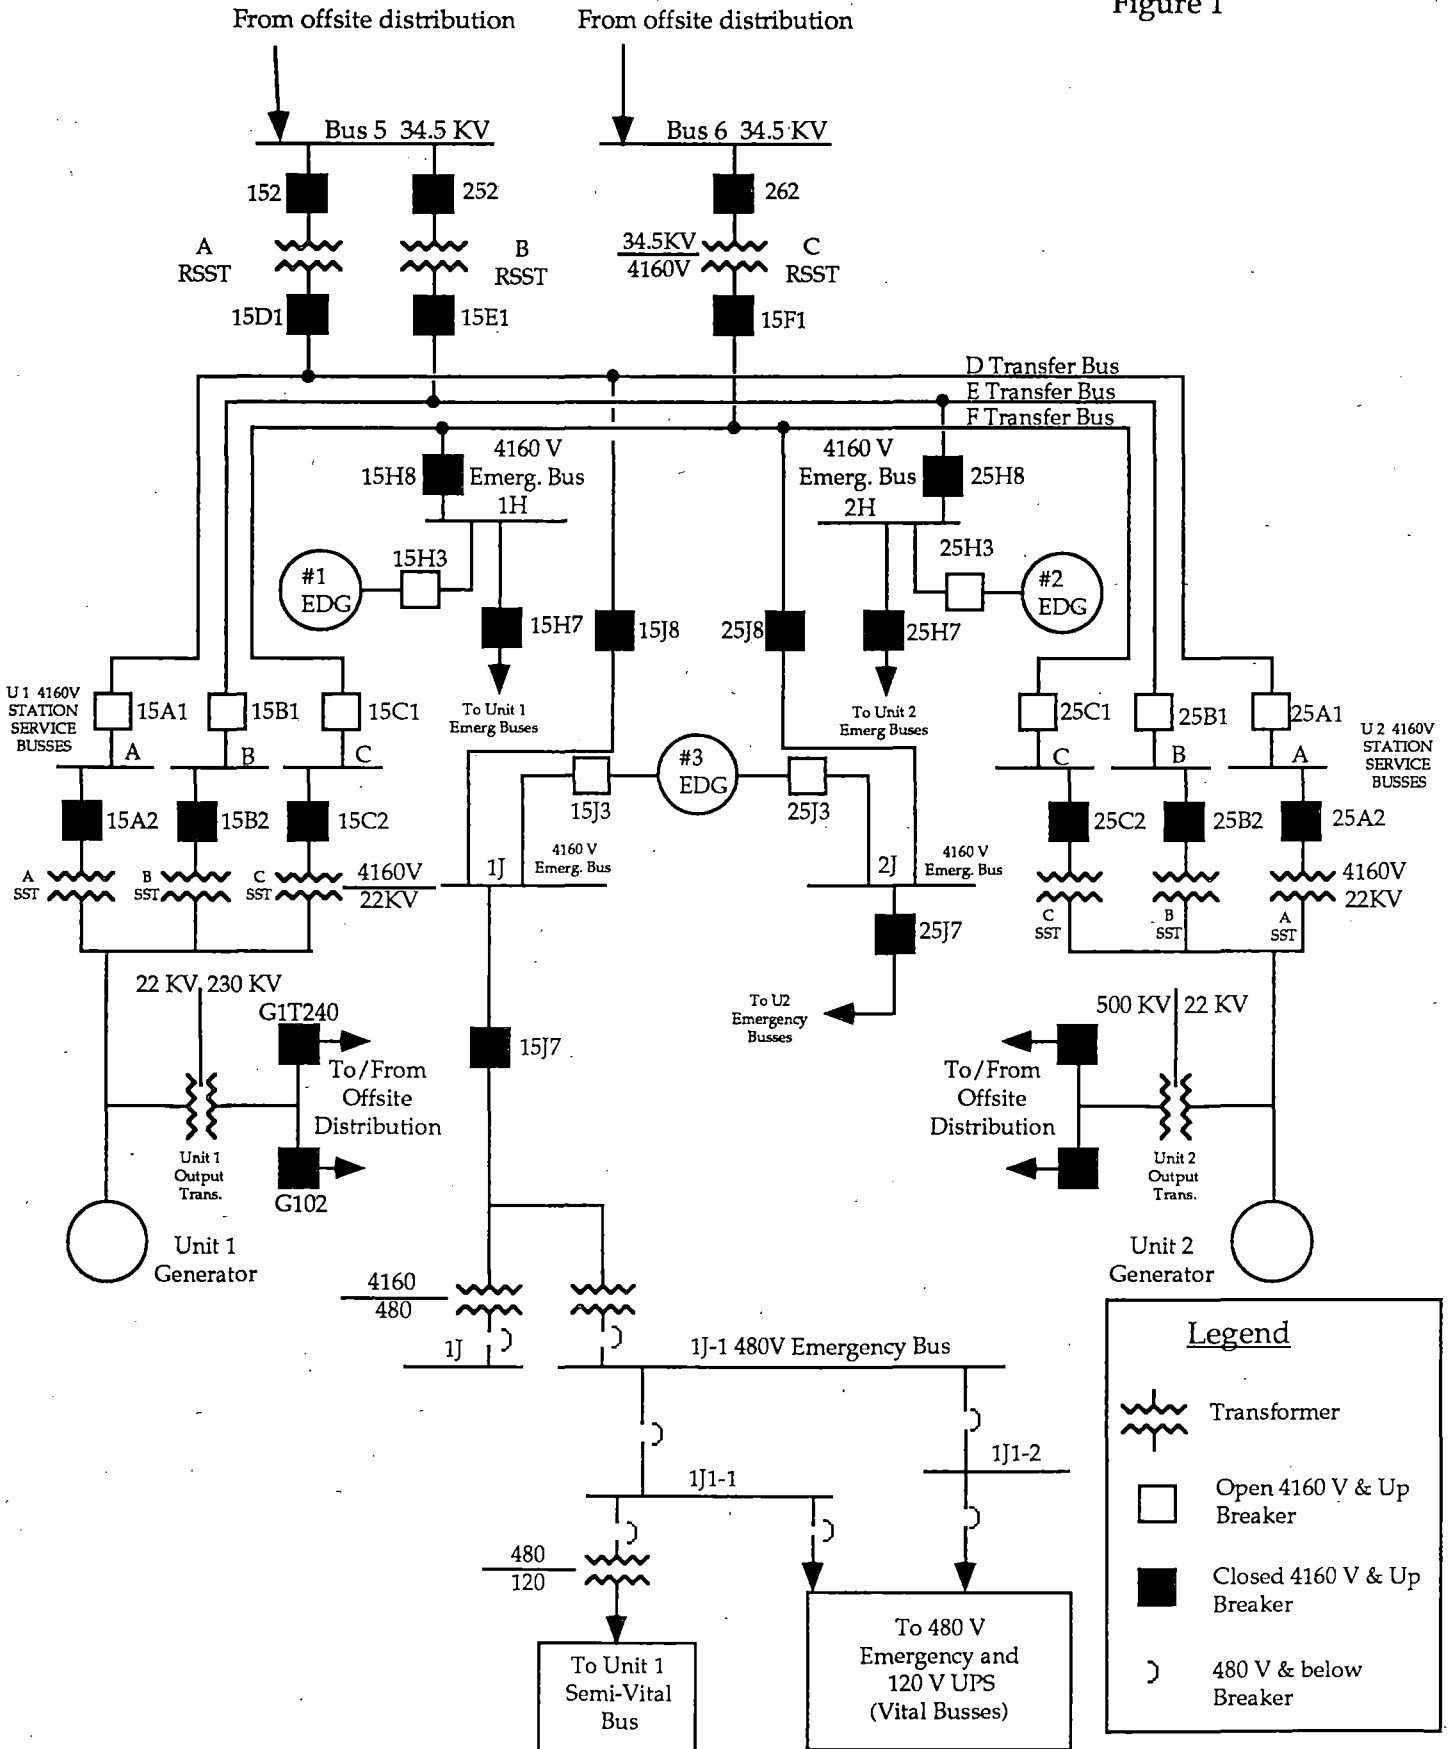
LER 280-89-044
Attachment 1
Figure 1

BREAKER POSITION PRIOR TO EVENT

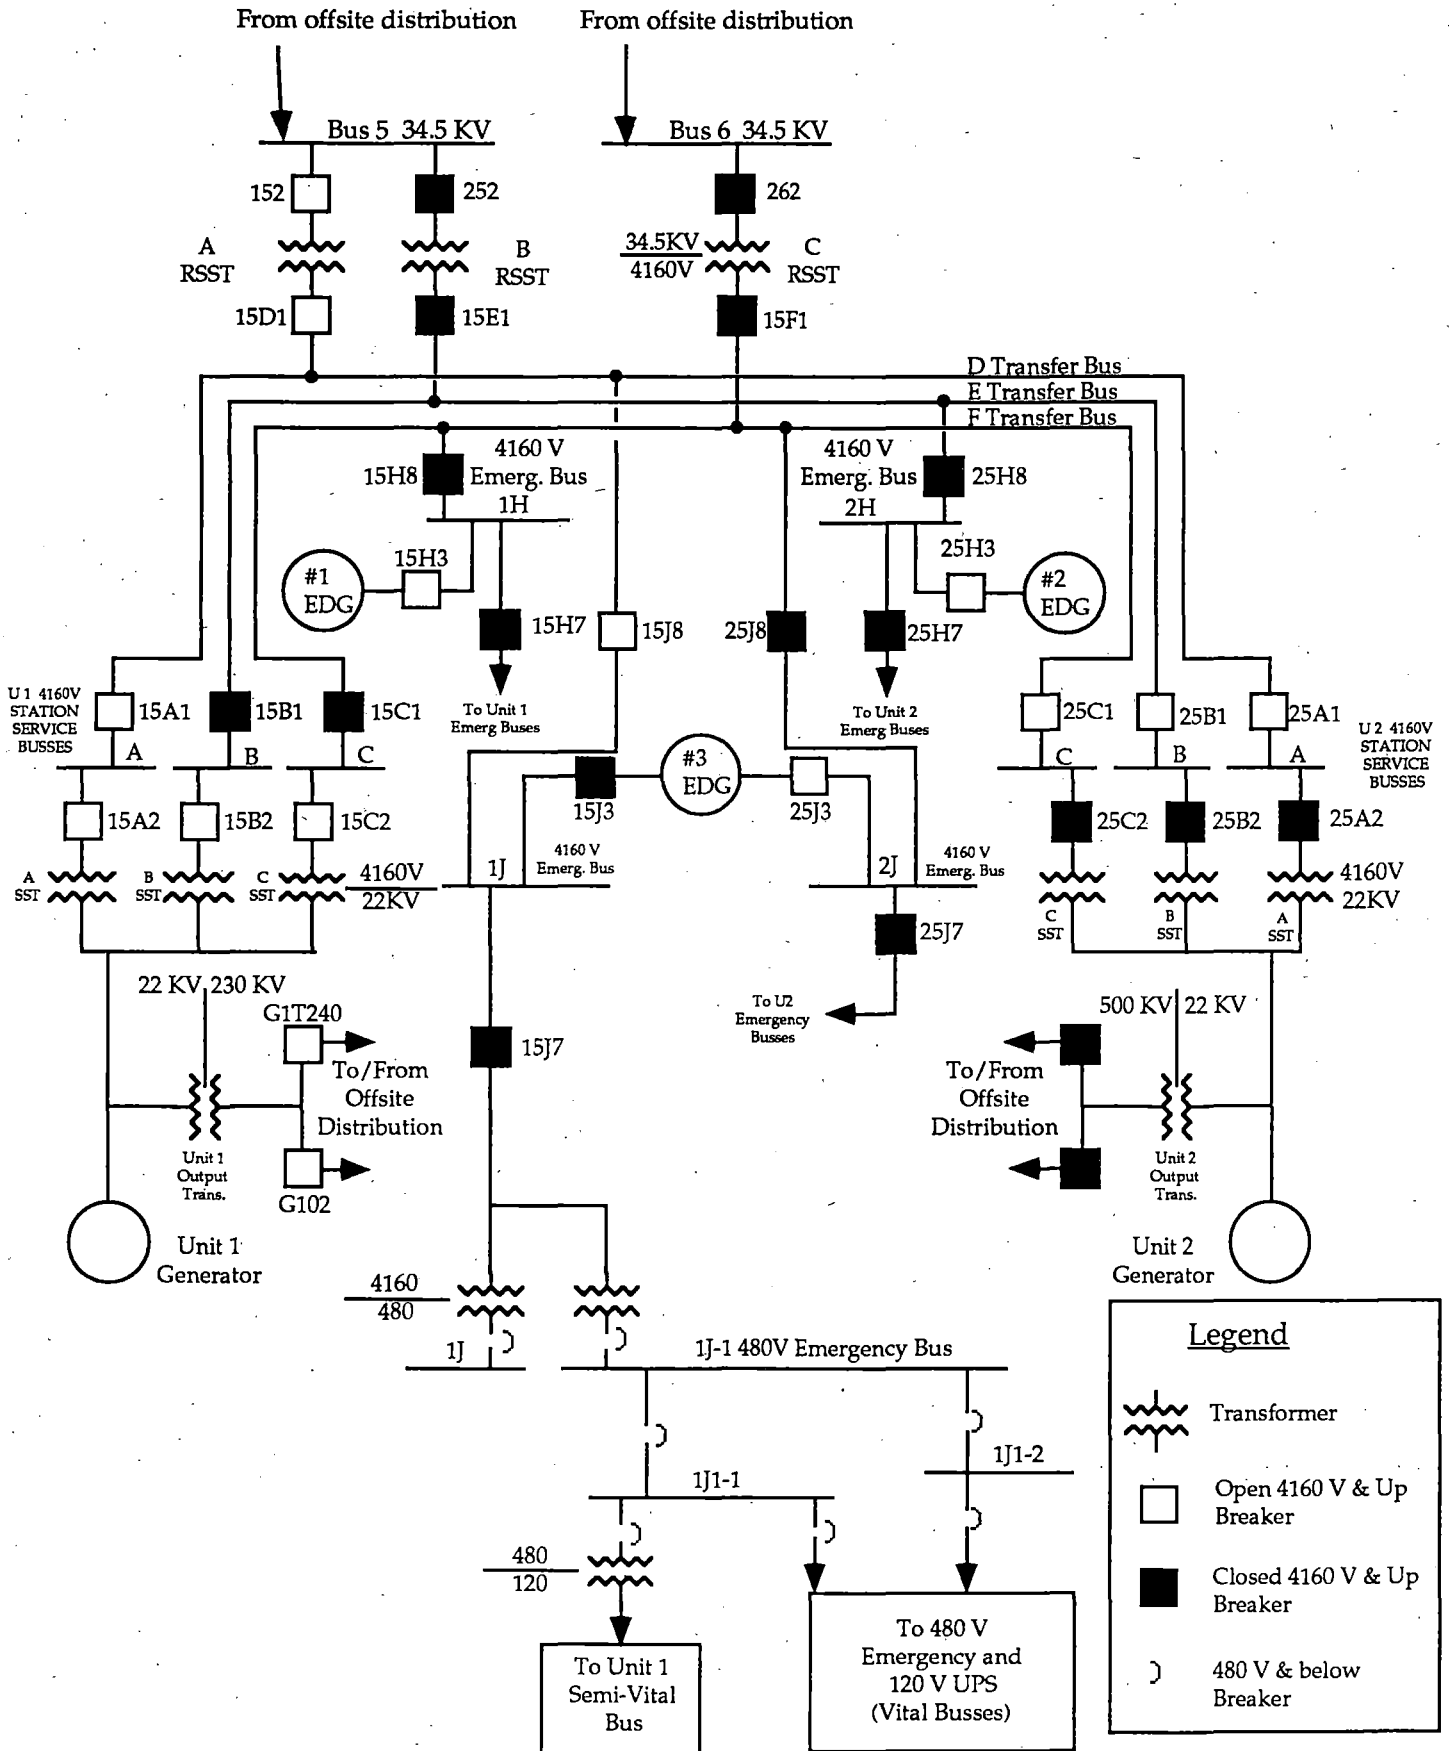
LER 280-89-044
Attachment 1
Figure 2

The fault resulted in a pilot wire differential lockout of the transformer, tripping and locking out the following breakers: Circuit breaker 152, the feed to the "A" RSST; Circuit breaker 15D1, "D" transfer bus feed; circuit breaker 15J8 Unit 1J 4160V emergency bus feed. It also locked out the following breakers; 15A1, Unit 1 "A" Station Service Bus alternate feed and 25A1, Unit 2 "A" SS bus alternate feed (see attachment I).

**BREAKER POSITION AFTER EVENT
UNIT 1 GENERATOR OUTPUT BREAKERS OPEN**
