SUBJECT: TYPE SLV11A1 OVER/UNDER VOLTAGE RELAY

Subject: GE Type SLV11A Relays

SUBJECT: SLV11A STATIC OVER/UNDER VOLTAGE RELAY

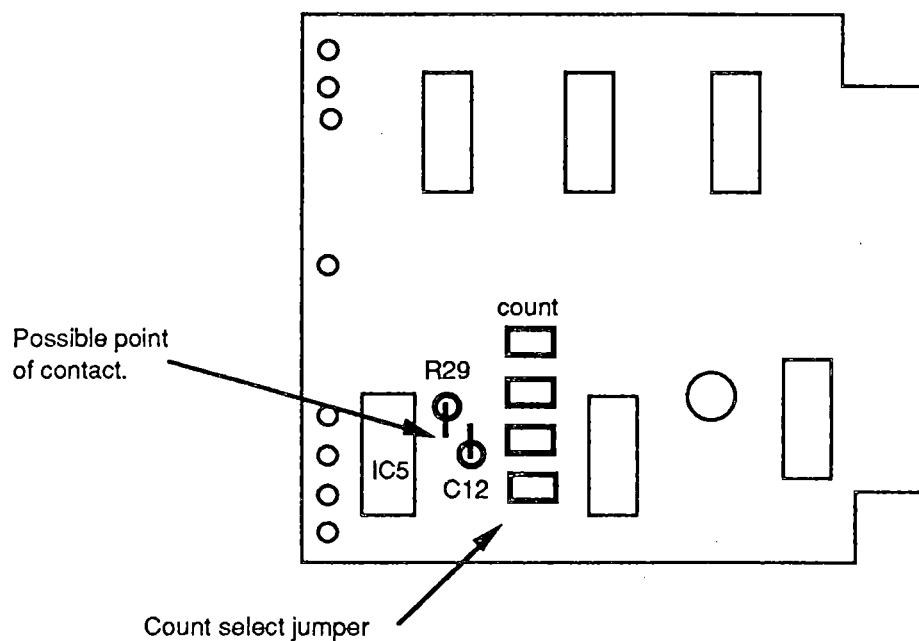
FIGURE 1

Our lab evaluation of the returned relay indicated that component IC5 was defective on each PC card that had failed to produce an output. On each PC card with a defective IC5 we also found the exposed lead of capacitor C12 was touching the exposed lead of resistor R29. A short between these component leads will result in damage to component IC5, preventing a relay output from the associated phase.

A review of the layout of the card indicated that C12 and R29 are adjacent to a user selection link identified as the "count select". It is possible that C12 can be accidentally pushed into contact with R29 during placement of the count select jumper.

Relays in the field may be inspected for clearance between C12 and R29. Figure 1, attached, shows the location of these components on the threshold detection board. Functional performance of the relay may be verified using the procedure in the testing section of the SLV11A instruction book, GEK-65535.
