UNITED STATES  
NUCLEAR REGULATORY COMMISSION  
REGION II  
101 MARIETTA STREET, N.W.  
ATLANTA, GEORGIA 30323

Report Nos.: 50-280/90-11 and 50-281/90-11

Facility Name: Surry 1 and 2

Inspection Conducted: February 12-16, 1990

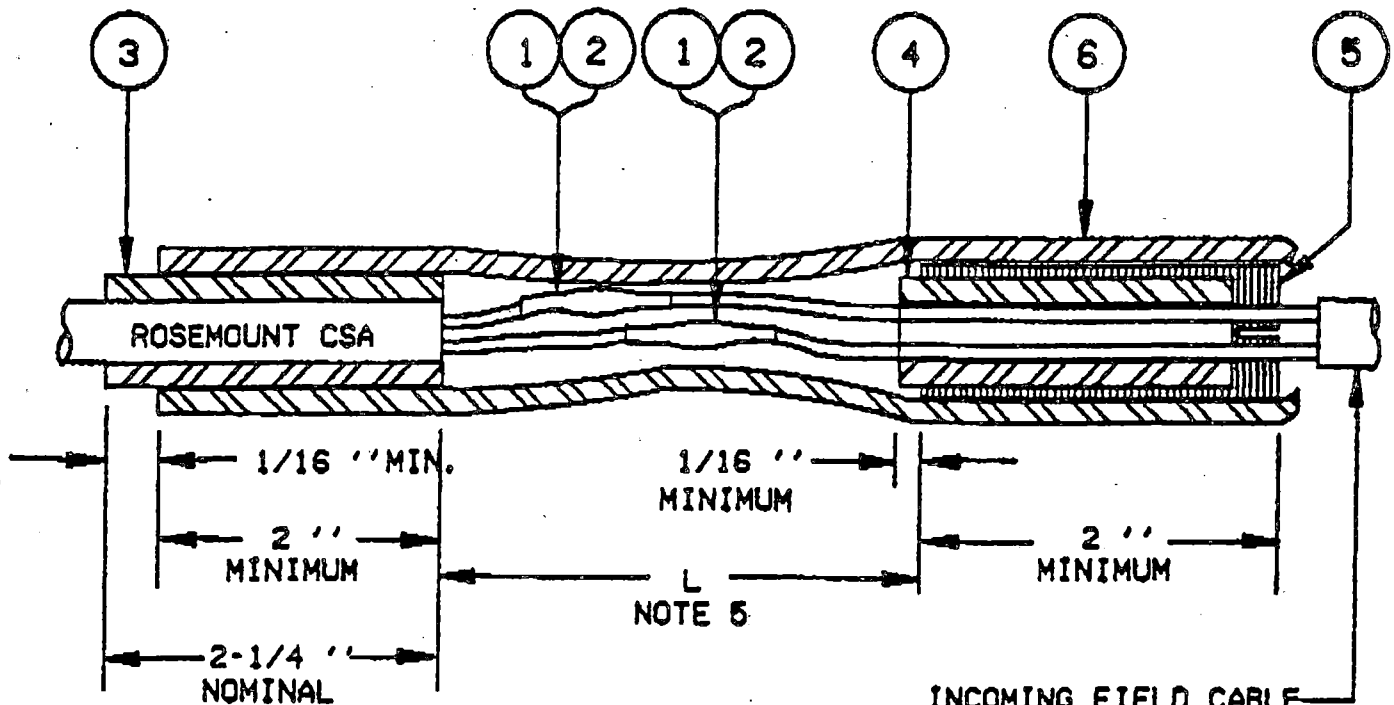
RAYCHEM BREAKOUT SPLICE  
WITH  
ROSEMOUNT CONDUIT SEAL  
FIGURE NO. 10

The Raychem splice, as shown in the attachment, is used on Rosemount conduit seal connectors inside containment. There are six (6) of these splices in Unit 1 and fifteen (15) splices in Unit 2. This splice design is used whenever the licensee replaces an existing Conax conduit seal connector with a Rosemount, model 353C, conduit seal connector (CSC). This occurs whenever the transmitter is replaced. Both the Conax and Rosemount CSCs are EQ qualified but the Conax is difficult to disassemble in the field; therefore, the licensee is replacing them.

The Raychem splice is an unusual design that was necessitated by the unqualified inline butt splice (items 1 and 2 in the attachment) and the fact that the licensee did not want to seal on the jacket of the incoming field cable. The inspector considers the splice to be qualified because all the Raychem parts that make it up are individually qualified in similar applications. The term "splice" as used is somewhat of a misnomer when in actuality the design should be called an enclosure.

The inspector agrees with the licensee that the subject splice, even though it is an unusual design, is qualified for the intended use as a water/moisture proof enclosure for the two (2) unqualified inline butt splices. The concern was not substantiated.
