UNITED STATES  
NUCLEAR REGULATORY COMMISSION  
REGION II  
101 MARIETTA STREET, N.W.  
ATLANTA, GEORGIA 30323

Report Nos.: 50-280/90-17 and 50-281/90-17

Facility Name: Surry Units 1 and 2

Inspection Conducted: April 9, 1990 thru April 12, 1990

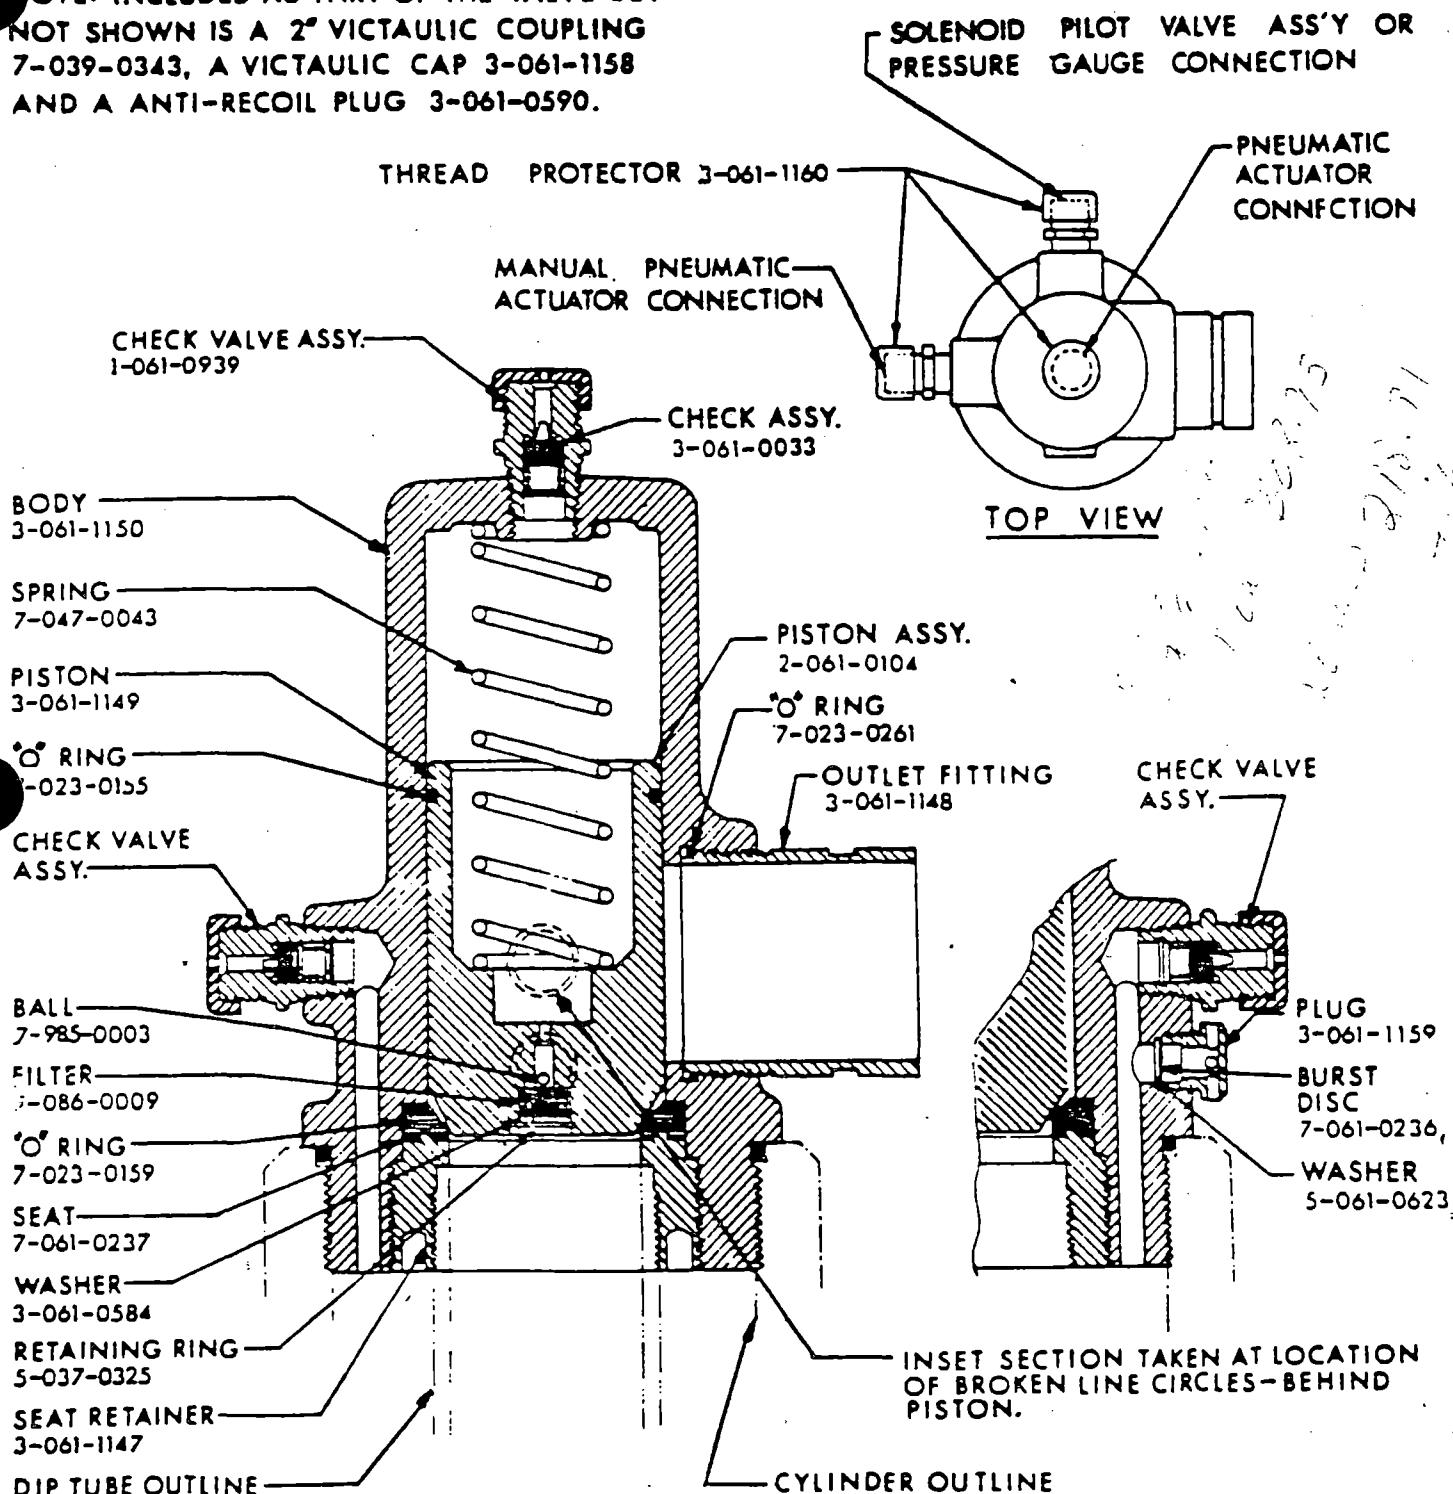
PLATE H-27E

At the time of this inspection the licensee had completed inspection, repair, and return-to-service of the affected Halon systems. The Halon systems' vendor/contractor noted during their inspection that fire Halon cylinder safety burst disc (#7-061-0236, See Attachment Plate H-27E) on cylinders nearest the pipe rupture had relieved during the pipe rupture event. These safety devices are designed to burst at 1000 psi cylinder pressure thus relieving internal Halon gas pressure to atmosphere preventing cylinder overpressurization or rupture of the Halon cylinder.
