**Virginia Electric and Power Company
Surry Power Station
P. O. Box 315
Surry, Virginia 23883**

50-280/92-008-00

FACILITY NAME (1) Surry Power Station, Unit 1 DOCKET NUMBER (2) 0500021801 PAGE (3) 05

TITLE (4) Unit 1 Charging/High Head Safety Injection Pump Configuration Outside Plant Design Basis Because of Inadequate Procedure Change Implementation

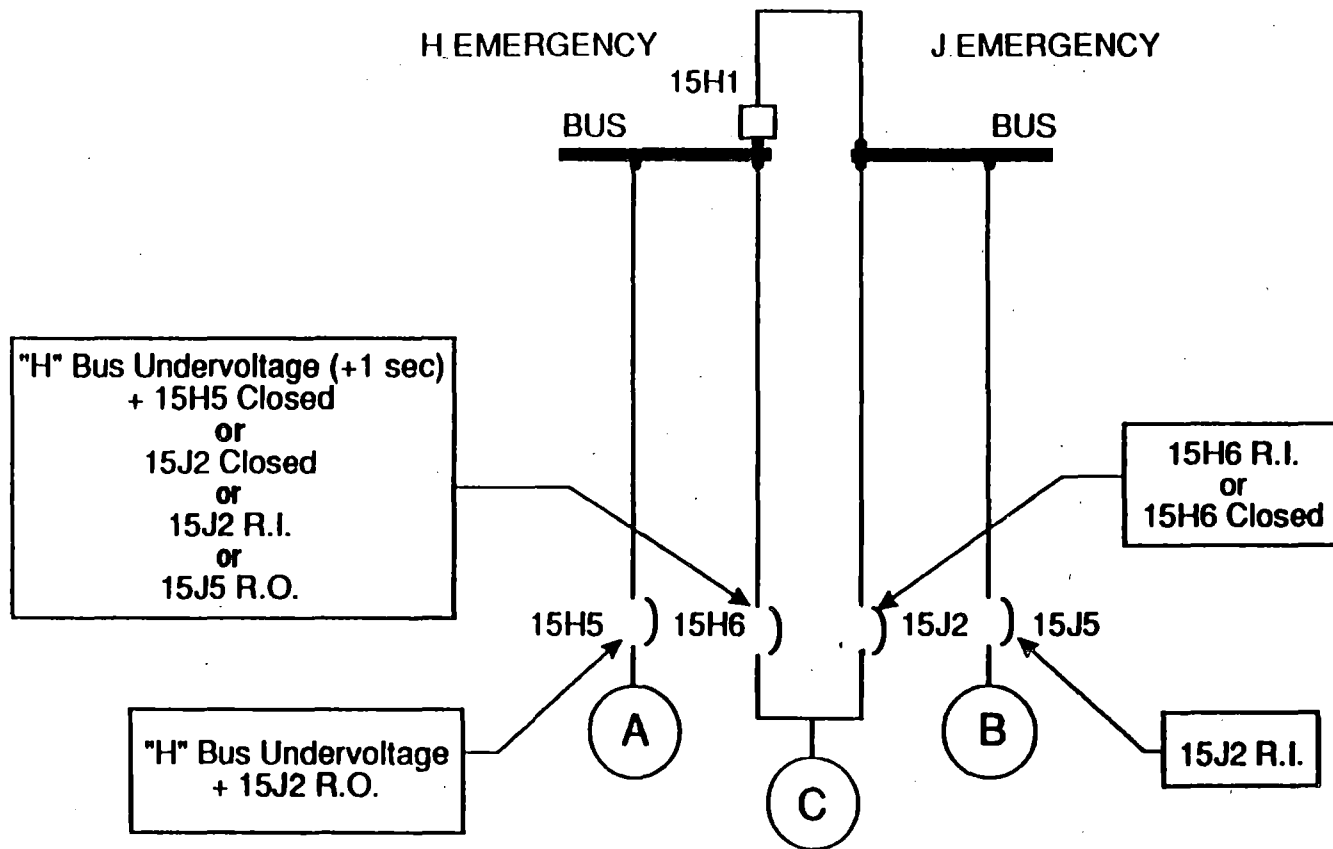
Figure 1

On May 11, 1992, with both Unit 1 and Unit 2 at 100% power, a Licensed Control Room Operator in the process of assuming duties at the Unit 1 control board, noted that the Unit 1 Charging Pump configuration was such that the undervoltage lockout on Charging/High Head Safety Injection (HHSI) Pump "A" [EIIS-BQ, P] should have been defeated. Investigation determined that this lockout had not been defeated which rendered two of the three HHSI Pumps on Unit 1 technically inoperable, considering the most limiting single failure. This condition existed because the "A" pump interlock would have prevented automatic initiation of HHSI flow in a certain accident sequence. Specifically, an emergency bus [EIIS-EB, BU] undervoltage condition with the "C" Pump alternate power supply breaker [EIIS-EB, BKR] racked out would result in a trip and lockout of the "A" Pump. Thus, with the "A" and "B" Pumps initially operable and the "C" Pump handswitch in the pull-to-lock position, operator action would have been necessary to ensure HHSI flow in a design basis accident with a loss of off site power and a failure of the "B" Pump to start. Critical operation for greater than twenty-four hours with less than two Charging/HHSI Pumps operable is prohibited by Technical Specification 3.3.B.2. This configuration, which placed Unit 1 in a condition outside its design basis, existed from initial criticality on May 1, 1992, until its discovery on May 11, 1992.

The breaker interlock/lockout arrangement for the Surry Charging/HHSI Pumps is shown in Figure 1. The undervoltage lockout of the "A" Pump was part of the original plant design and was provided to ensure that no more than one Charging/HHSI Pump could be powered by a single Emergency Diesel Generator [EIIS-EB, DG].

With the "A" and "B" Charging/HHSI Pumps initially operable and the "C" Pump handswitch in the pull-to-lock position, a LOCA with a Loss of Off Site Power and a single active failure would have resulted in a lack of automatic HHSI initiation. Manual operator action would have been necessary to restart the "A" Pump.

Conditions Which Will Trip and Lockout Surry Charging Pump Breakers

The Unit 1 Charging/HHSI Pumps were immediately realigned to a configuration where the "B" and "C" Pumps were operable, and the "A" Pump was in pull-to-lock. This evolution was accomplished from the Control Room by switch manipulation. In this configuration, lockout of the "A" Pump was no longer a concern, and two pumps were operable in accordance with Technical Specification requirements.
