Virginia Electric and Power Company  
Surry Power Station  
P. O. Box 315  
Surry, Virginia 23883

50-280/93-001-00

FACILITY NAME (1) <b>Surry Power Station Unit 1</b>		DOCKET NUMBER (2) <b>050002801</b>	PAGE (3) <b>07</b>
--	--	---------------------------------------	-----------------------

TITLE (4) **Reactor Trip and Safety Injection Due to Spurious High Consequence Limiting Safeguards Signal Caused by Malfunctioning Relay**

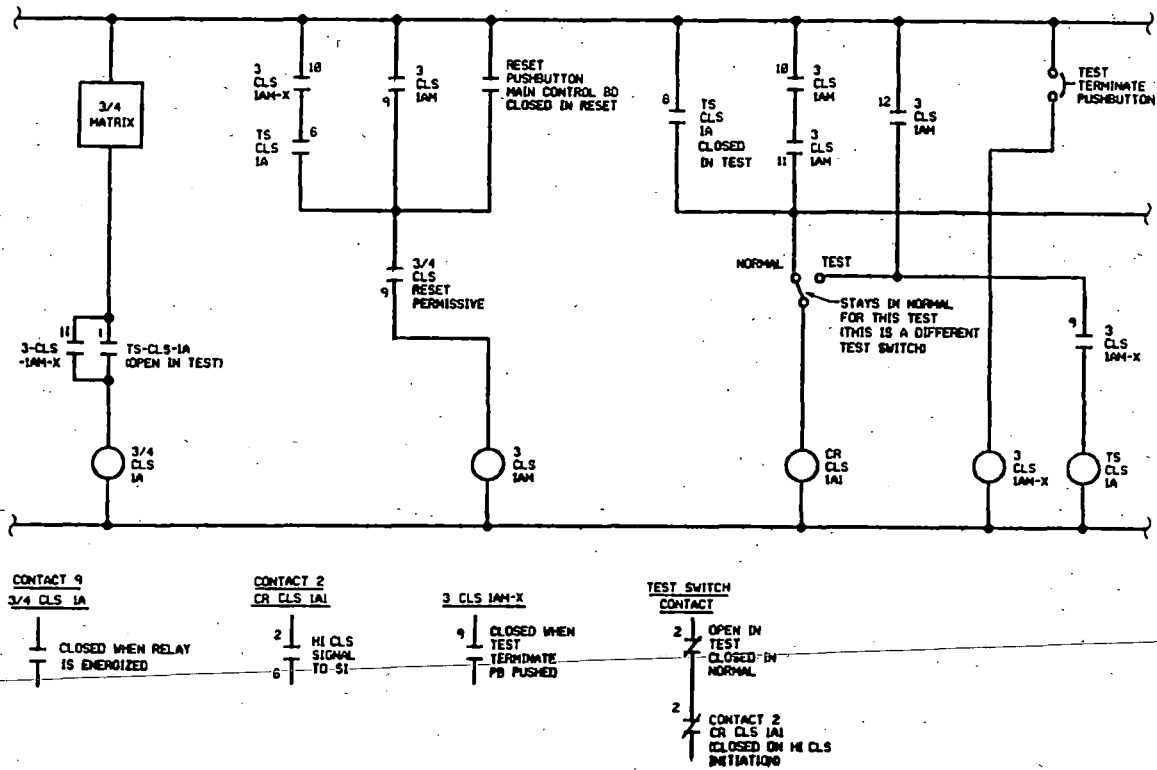
Figure 1

A root cause evaluation determined that the January 8, 1993 Hi CLS initiation was caused by intermittent cycling of relay 3-CLS-1AM. This relay is normally energized and de-energizes on a Hi-CLS signal. It is de-energized during logic testing and is re-energized at the conclusion of testing by depressing the test terminate pushbutton. During the troubleshooting steps, relay 3-CLS-1AM energized, resulting in the test switch returning to normal because the test terminate pushbutton was being held in. It then quickly de-energized, initiating the train A Hi-CLS and safety injection as designed. The root cause evaluation team identified two conditions which could have caused the spurious cycling.

First, the negative lead on relay 3/4-CLS-1A was found to be loose during relay replacement. The loose connection could have caused an intermittent cycling of relay 3-CLS-1AM, since the negative terminal of 3-CLS-1AM was wired to the negative terminal of 3/4-CLS-1A.

The second condition was high resistance across contact 9 on relay 3/4-CLS-1A, which could cause an intermittent cycling of relay 3-CLS-1AM. The high resistance was caused by oxidation and dust accumulation.

Hi-CLS Simplified Logic Schematic

Relay 3/4-CLS-1A and source range / intermediate range detector assembly N-31/N-35 were replaced. Evaluations of the causes of the component failures were conducted.

Single point relays (relays whose failure could cause spurious safety system actuations) will be identified. The feasibility of modifying circuitry to remove single point failures will be evaluated.
