Calvert Cliffs Nuclear Power Plant; Unit Nos. 1 & 2
Renewed Facility Operating License Nos. DPR-53 and DPR-69
Docket Nos. 50-317 & 50-318

Subject: Response to NRC Integrated Inspection Report 05000317/2018001 and 05000318/2018001

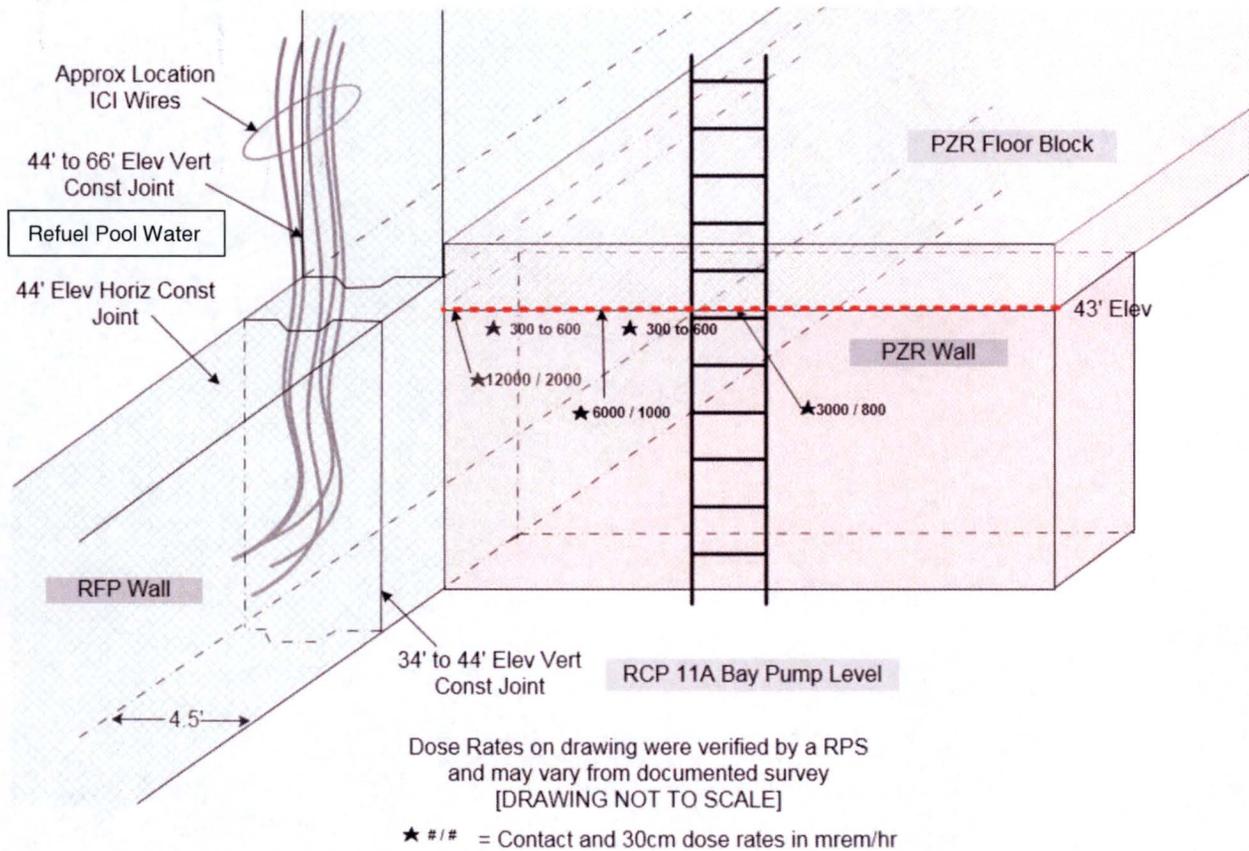
The subsequent root cause investigation into this event determined the most probable cause for the unexpected increase in dose rates in 11A RCP bay was due to discovery of a previously unknown anomaly within the refuel pool concrete wall. This unforeseen anomaly resulted in localized radiation streaming within 11A RCP bay that was not eliminated until the ICI wires were relocated 14 feet below the waterline (i.e., approximately four feet below typical storage height). Discussions with engineers and workers associated with the work ongoing in the 11A RCP bay indicated there were no visible signs of concrete cracking or spalling but did identify there were vertical and horizontal construction joints that merge together in the general area of highest dose rates in 11A RCP bay. Thus, the most likely cause of the localized radiation streaming experienced in 11A RCP bay was a previously unknown anomaly that exists within the tongue and groove construction joint at that location. Below is an illustration of the area where the high, unforeseen, radiation levels occurred. This area does not contain any nozzles, penetrations, or gates that are potential sources where radiation streaming might reasonably be expected to occur.
