Calvert Cliffs Nuclear Power Plant
1650 Calvert Cliffs Parkway
Lusby, MD 20657

Calvert Cliffs Nuclear Power Plant; Unit Nos. 1 & 2
Renewed Facility Operating License Nos. DPR-53 and DPR-69
Docket Nos. 50-317 & 50-318

Subject: Response to NRC Integrated Inspection Report 05000317/2018001 and 05000318/2018001

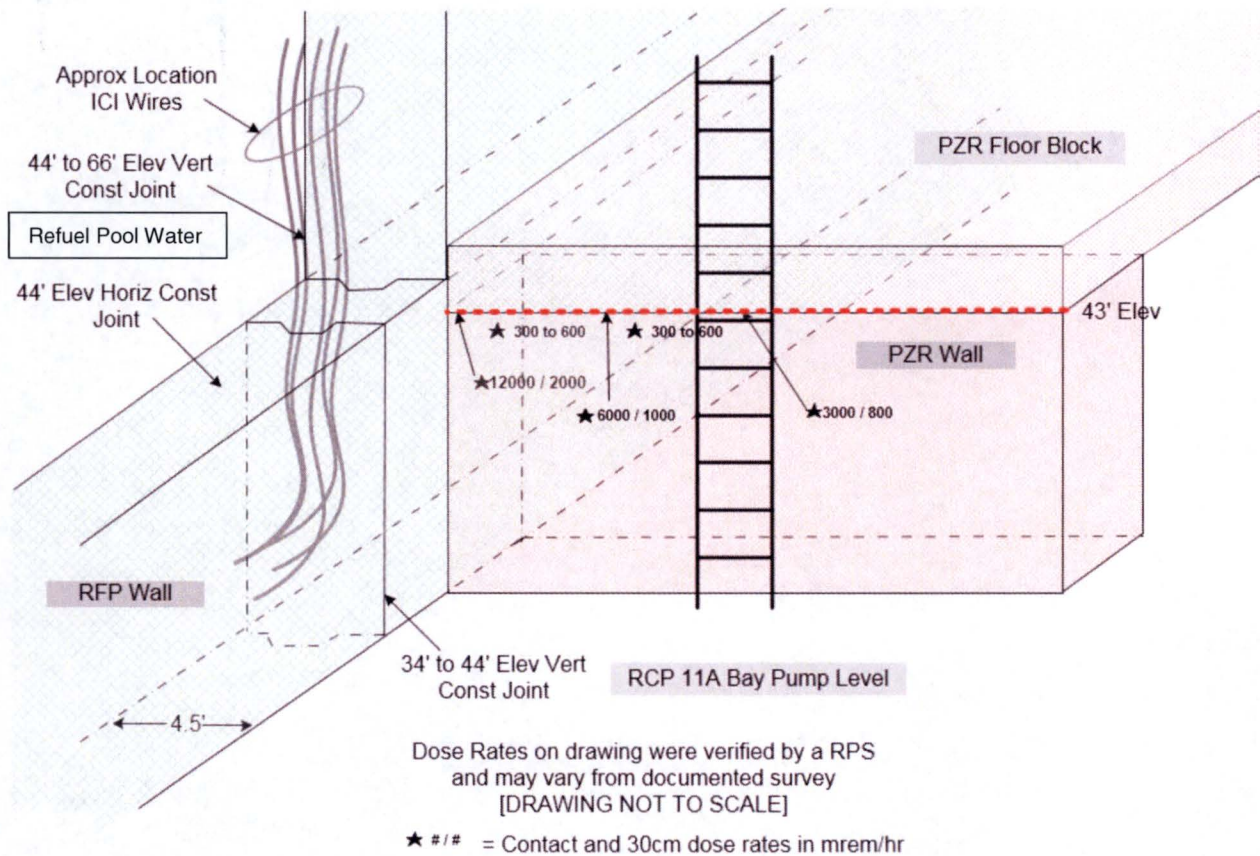
The subsequent root cause investigation into this event determined the most probable cause for the unexpected increase in dose rates in 11A RCP bay was due to discovery of a previously unknown anomaly within the refuel pool concrete wall. This unforeseen anomaly resulted in localized radiation streaming within 11A RCP bay that was not eliminated until the ICI wires were relocated 14 feet below the waterline (i.e., approximately four feet below typical storage height). Discussions with engineers and workers associated with the work ongoing in the 11A RCP bay indicated there were no visible signs of concrete cracking or spalling but did identify there were vertical and horizontal construction joints that merge together in the general area of highest dose rates in 11A RCP bay. Thus, the most likely cause of the localized radiation streaming experienced in 11A RCP bay was a previously unknown anomaly that exists within the tongue and groove construction joint at that location. Below is an illustration of the area where the high, unforeseen, radiation levels occurred. This area does not contain any nozzles, penetrations, or gates that are potential sources where radiation streaming might reasonably be expected to occur.
