## Durita, Colorado, Disposal Site Inspection Report, May 22, 2008

Participants: Dave Holland, Hecla Mining Co; Earl Reams, Reams Construction; Edgar Ethington, CDPHE; Tracy Ribeiro, DOE; Cheri Bahrke, Stoller; Marilyn Kastens, Stoller; Mike Widdop, Stoller

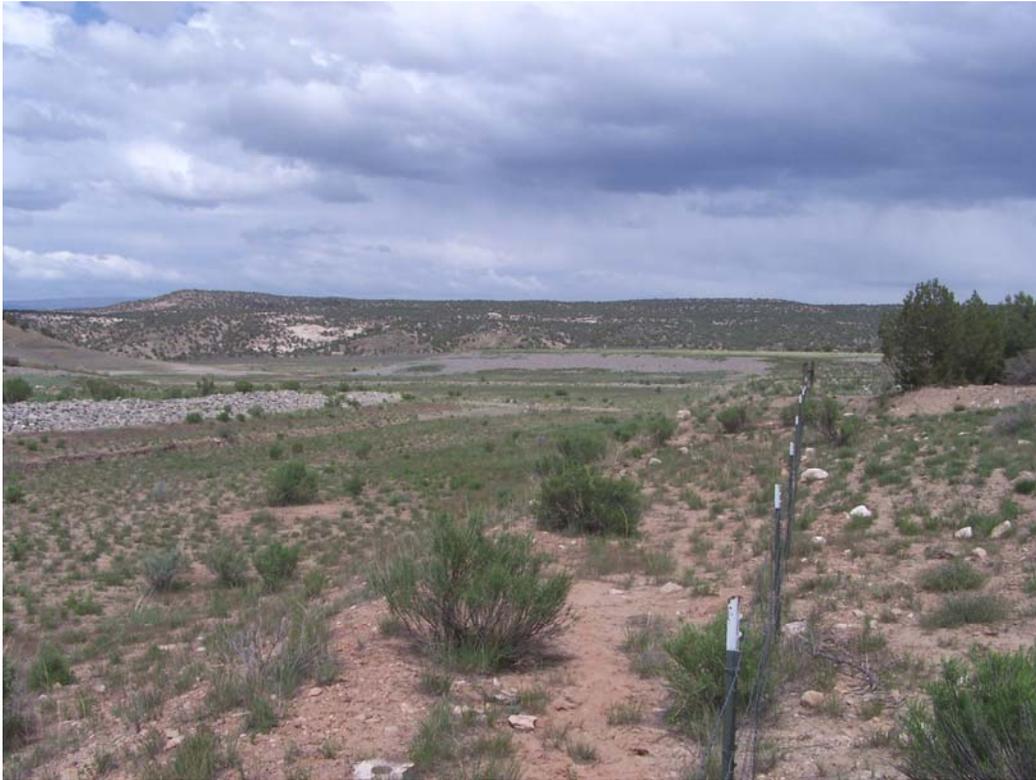
All diversion channels generally appeared to be functioning as designed with regard to containing storm water and conveying it past the disposal structures. The Central Diversion Channel is eroded at the south (upslope) end but the erosion is contained within the lateral limits of the floodplain. The slope of the floodplain appears steeper here, and storm water has incised several minor channels less than 2 feet deep from tributary sources into the normal flow channel, which also is incised. Nearby, a tributary channel from the upslope undisturbed area has been armored with large riprap that is dropping into a head cut, as designed. This area should be allowed to equilibrate, and no intervention is deemed necessary.

*South end of Central Diversion Channel looking east, showing minor incising along flow line, self-armoring tributary entering from right (south), and leach tank LT-203 in background.*

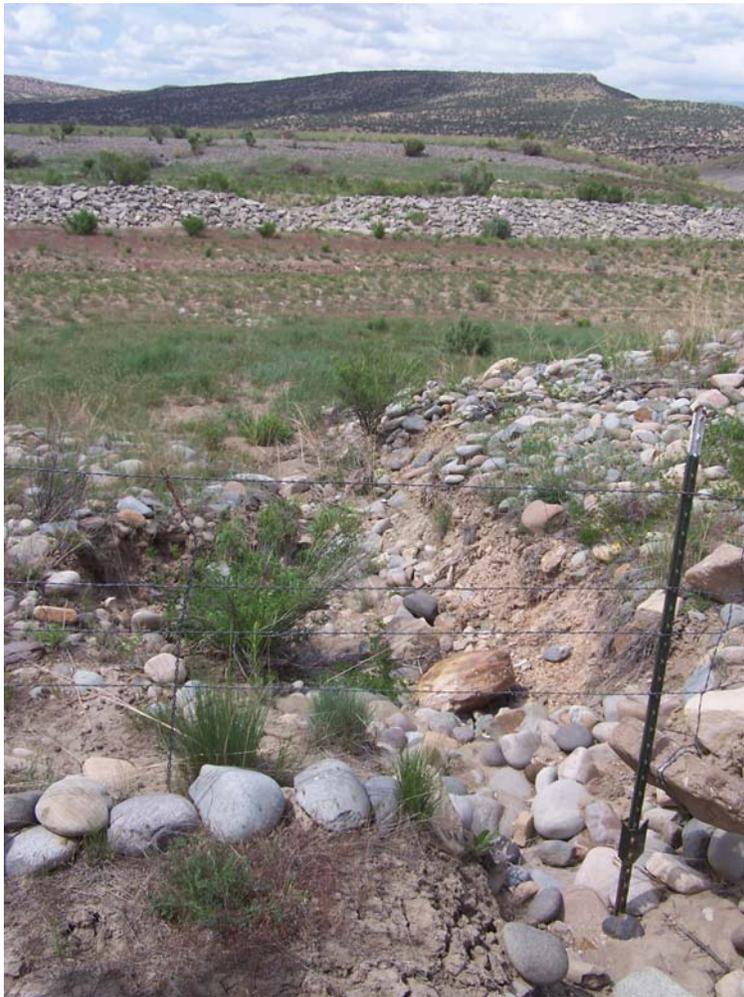
*Self-armoring tributary to north end of Central Diversion Channel. Incised flow channel, scour protection, and Leach Tank LT-202 in background.*

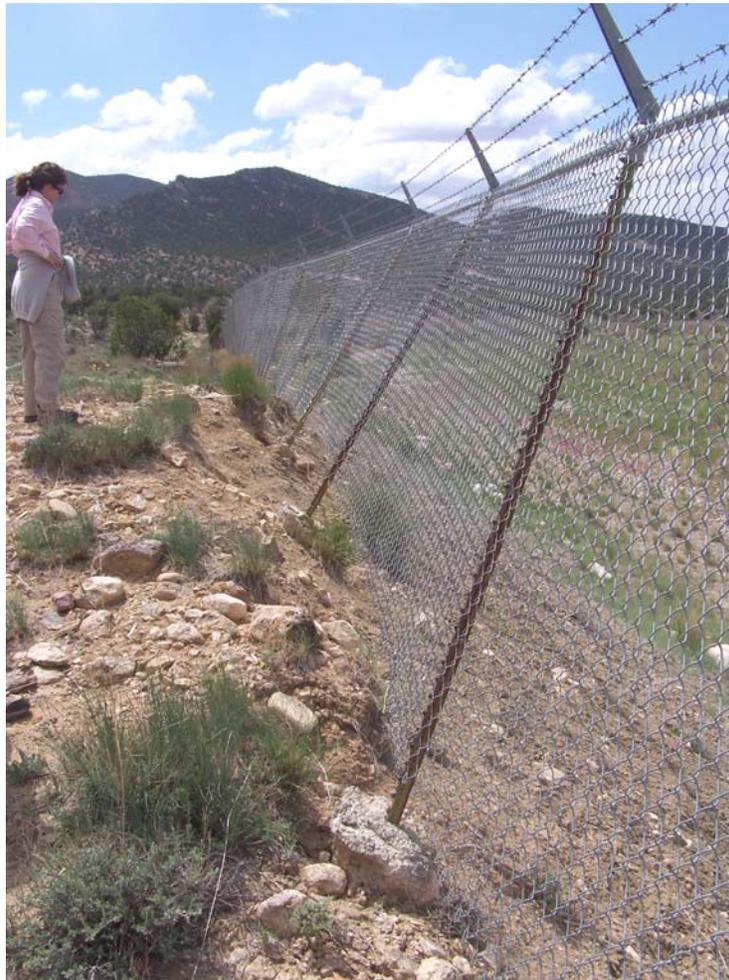
**Fencing**—Most of the fence surrounding the site is chain-link topped with three strands of barbed wire on angle brackets. Fence posts consist of 8-foot-long steel t-posts driven into the ground or steel tubing set in concrete. Portions of the fence were replaced in 1999 when construction was completed; these portions are in good condition. The remainder of the chain link fencing is in fair to poor condition but remains generally serviceable (i.e., it seems to keep livestock off the site). The fencing along the north half of the west side and the entire north side are the most deteriorated. Within this portion, many angle brackets are broken. The barbed wire is unattached or broken at many locations. Along the west side, the fabric is below the top rail and attached to the top rail with soft mechanic's wire, which rusts and breaks in only a few years. The fence is leaning at several locations.

*Chain link fence deterioration between southwest corner and Site B.*

Fencing is required at the Durita site to keep livestock off the vegetated top slopes of the leach tanks. Intrusion should not be an issue, so the barbed wire at the top of the chain link fencing can be removed rather than repaired. The deteriorated portions of the chain link fence should be repaired; ideally, those portions would remain serviceable for as long as the newer sections.

6. DOE will confirm that Closure Cell berms were constructed on clean material.
7. DOE will ask the licensee to repair or alter the deteriorated portions of the chain-link fence and move the wire fence away from the slope break in Site D.

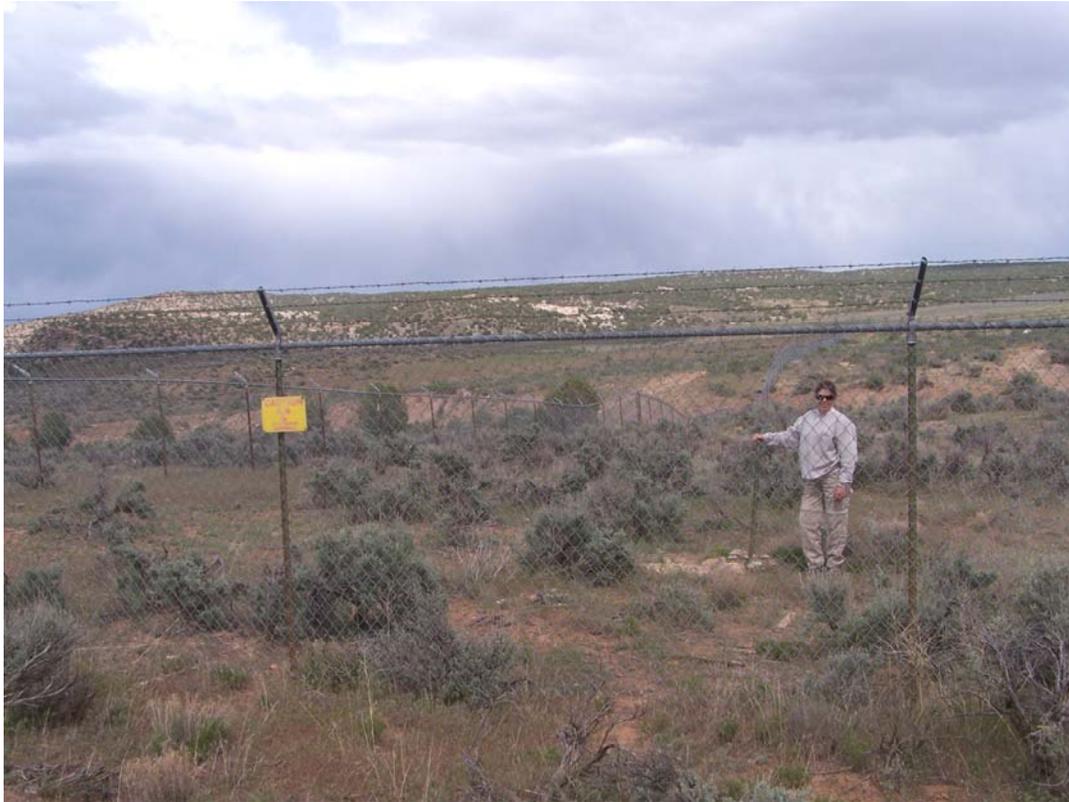
Fencing has been installed outside the site boundary on the west and north sides of the site. At the northwest corner, the encroachment appears to be 17 feet onto the private property to the west and 36 feet onto BLM property to the north, based on the location of the survey monument. The licensee must resolve this issue before transition.

Northwest corner of site showing fence encroachment; looking east, visitor standing at boundary monument.

8. The licensee must resolve the issue of fence encroachment.
9. Debris, mostly tumbleweeds, accumulates against the fence in places. Removal may be necessary if the debris interferes with drainage and this item will be added to the inspection checklist.

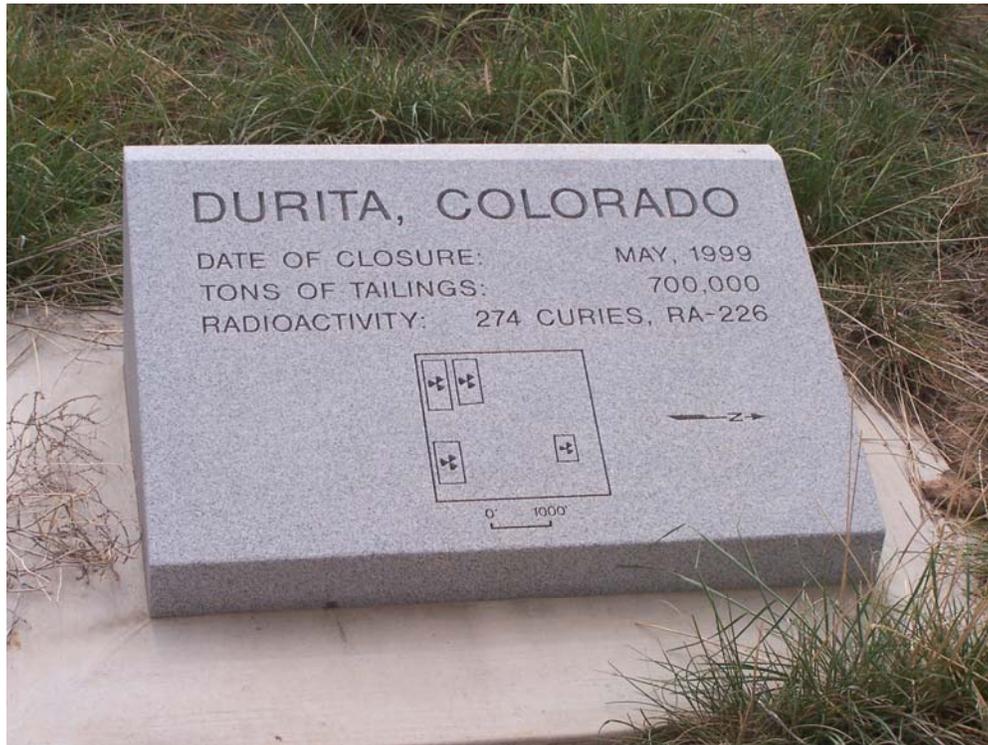
**Site Surveillance Features**—Site surveillance features at the Durita site consist of the granite site marker, six monuments that define the site boundary, and warning signs. The site marker, located inside the entrance gate, is in excellent condition. The DOE team found four of the six monuments. The located monuments consist of approximately 3-inch-diameter aluminum caps set above ground on what are probably standard monument structures. The monument midway down the east side was not located, nor was the monument at the northeast corner. Two different monuments were found at the northeast corner, consisting of approximately 1.5-inch-diameter aluminum caps. One is stamped as the  $\frac{1}{4}$  corner and the other appears to have been used for site survey control. DOE should confirm whether a monument was installed at the northeast corner that meets specifications established in *Guidance for Implementing the Long-Term Surveillance Program for UMTRCA Title I and Title II Disposal Sites* (see [http://www.lm.doe.gov/documents/3\\_pro\\_doc/guidance/guide\\_doc/s0033600.pdf](http://www.lm.doe.gov/documents/3_pro_doc/guidance/guide_doc/s0033600.pdf)). DOE should determine if a monument was installed on the east side of the site.

*Site marker.*

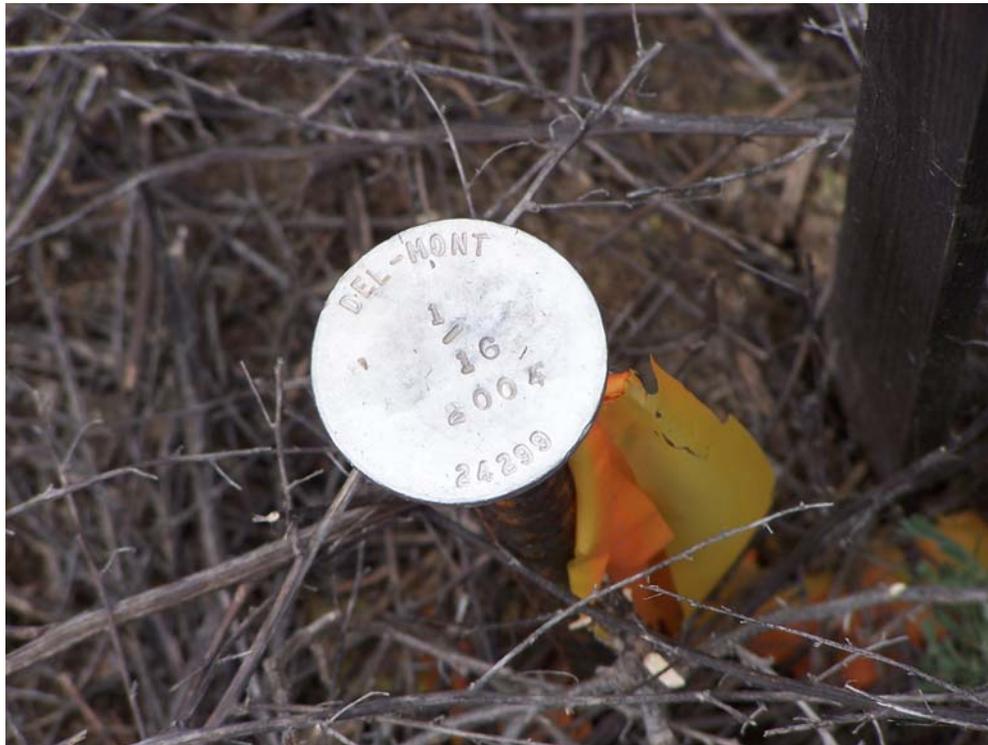
*Northeast corner boundary monument.*

11. DOE should confirm whether standard monuments were installed at the northeast corner and east side of the site.
12. DOE and the licensee should discuss installing the warning signs.

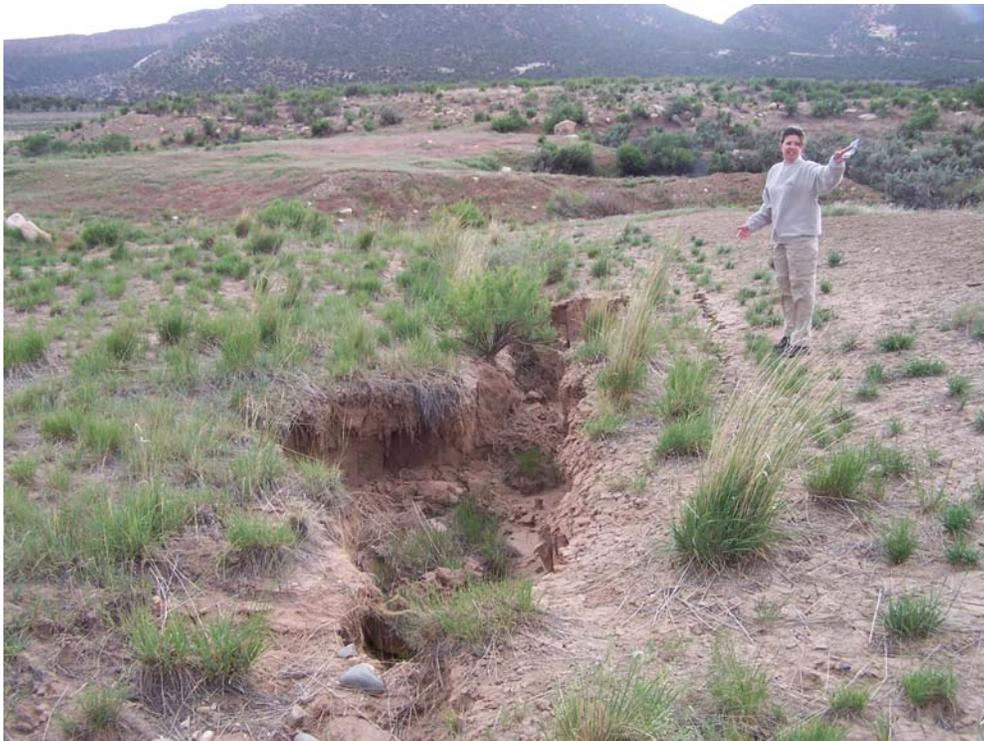
Another erosion feature was found near the north end of the Central Diversion Channel. A deep (4 to 5-foot-deep) channel is eroding back toward the Closure Cell Diversion Channel. The head cutting is a long way from critical structures; however, the depth of cut and amount of material removed since final grading was completed in 1999 suggests there is sufficient gradient and storm water for the erosion to continue. It appears that the storm water has left the bounds of the diversion channel. An engineer should evaluate this erosion to determine if engineered structures are threatened and if corrective action is required to arrest the erosion, adjust the grade, or harden features upslope of the area.

*Head cutting at south end of Central Drainage Channel.*

18. The licensee should evaluate the erosion and head cutting at the north end of the Central Diversion Channel to determine if engineered structures are threatened, and if corrective action is required to adjust the grade or harden features upslope of the area.

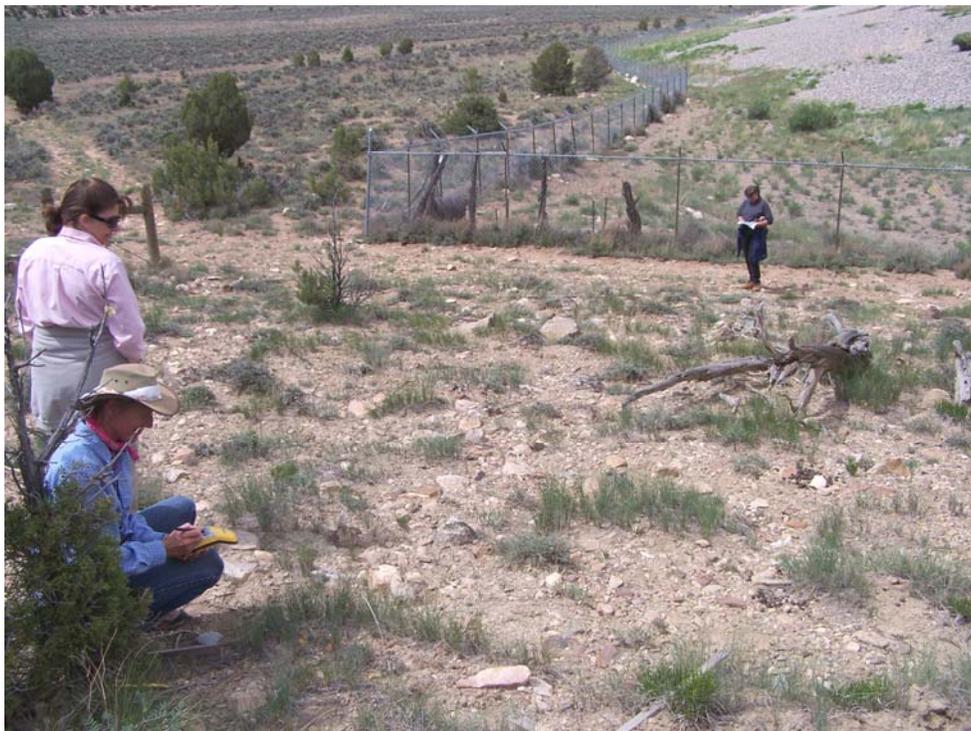
Debris was found inside the southwest corner of the site, which the licensee should remove.

*Southwest boundary monument, debris, and toe of leach tank LT-202 extending into Site A.*

19. DOE will ask the licensee to remove debris inside the southwest corner of the site.
20. DOE will request the profile of the Central Diversion Channel. DOE will evaluate the process that resulted in the incised drainage ditch below the Central Diversion Channel. DOE will request preconstruction topographical information and look for evidence of an abandoned drainage where the incised drainage rejoins the pre-existing watercourse. DOE will determine if the process presents a threat to site integrity or may result in property damage or regulatory noncompliance.

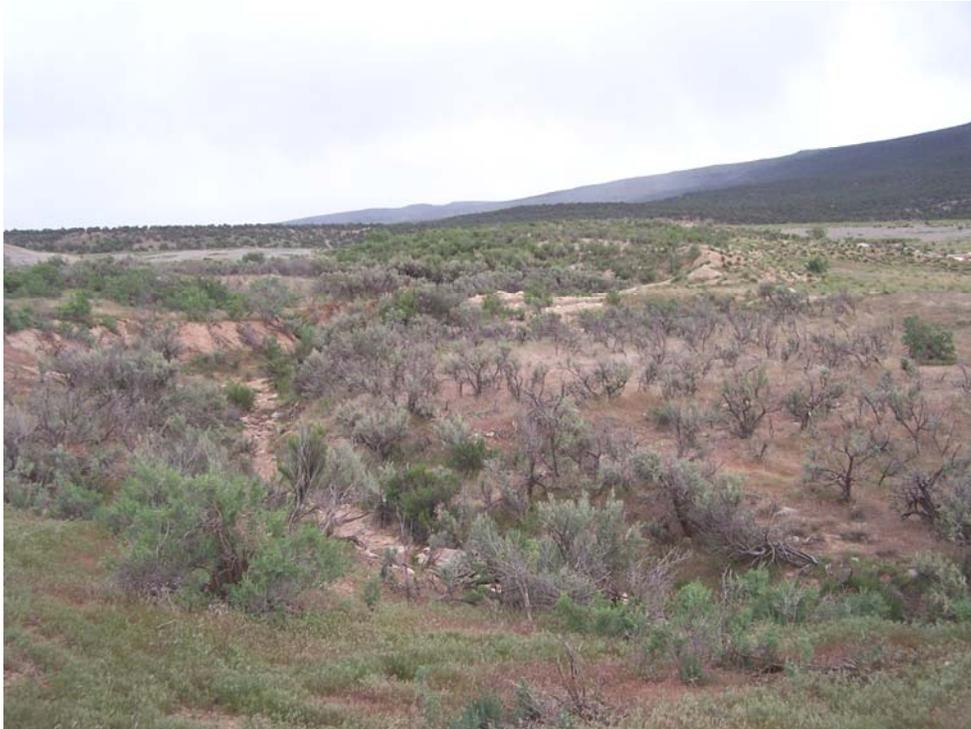
The Central Diversion Channel drains toward a natural drainage to the north. Below the bottom of the channel, the watercourse is deeply incised and the channel walls are vertical with an abrupt brink at the top of the walls. The channel has cut as much as 15 feet deep through a weathered shale knob with lenses of gravel. This incising is recent. Further down the drainage the walls are weathered to more mature and stable slopes.

The design flattened the gradient of the storm water diversion channels, more so over the reaches near the engineered structures. This would have created a hydraulic jump at the transition to the undisturbed drainage, and increased velocities would result in incising. Alternatively, the pre-existing drainage flow may have been diverted to accommodate tank construction and the drainage has incised a new channel. The profile for the Central Drainage Channel is not in the DOE records collection but should be acquired and reviewed.

*View upstream of incised drainage below the Central Diversion Channel, showing broad meander and topographic high through which the drainage has eroded.*

DOE will evaluate the process that resulted in the incised drainage ditch below the Central Diversion Channel. DOE will request preconstruction topographical information and look for evidence of an abandoned drainage where the incised drainage rejoins the pre-existing watercourse. The goal of this effort is to determine if the process presents a threat to site integrity or may result in property damage or regulatory noncompliance.

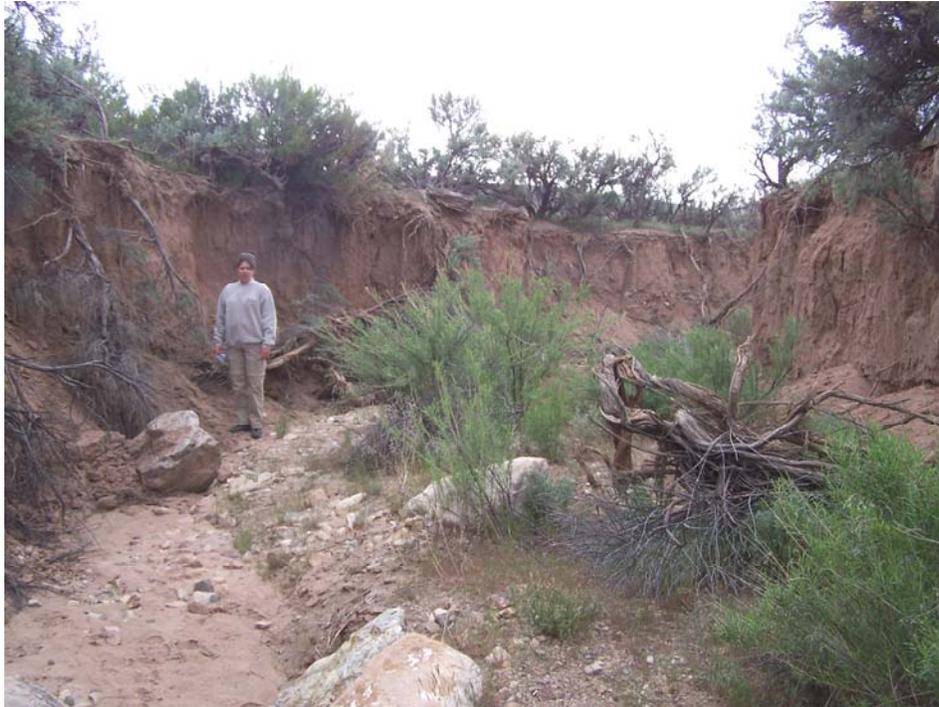
The floor of the incised portion of the drainage has a uniform gradient with only minor local changes and no head cutting. Therefore, it appears that the down cutting has reached equilibrium under “normal” conditions. If this incising occurred because of construction completed in the late 1990s, more severe storm events will result in additional erosion, and the likelihood of a storm causing significant erosion is enhanced in this young channel. Downstream, the drainage continues across BLM rangeland.

*Floor of incised drainage showing active lateral movement of meander, uniform gradient and armoring of floor, and steep, unstable walls.*

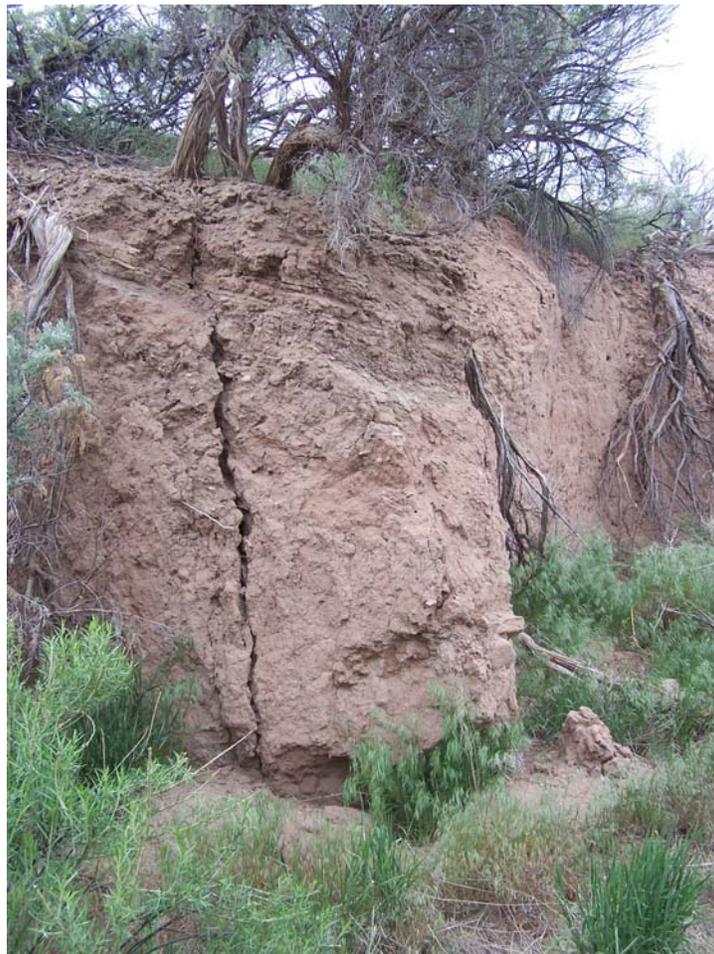
Much additional material will be transported downstream as the vertical walls slump, the channel meanders, and the walls erode back to stable slopes. Topographical data preceding site construction should be compared to the present topography. A 1964 USGS 7.5-minute quadrangle map was found but lacks sufficient detail to compare the present and past drainage locations.

*Unstable walls of incised channel will result in additional sediment transport.*
