SUBJECT: THREE MILE ISLAND UNIT-2 INDEPENDENT SPENT FUEL STORAGE
INSTALLATION INSPECTION REPORT 07200020/2018-001

Report Number: 07200020/2018-001

Facility: Three Mile Island Unit 2 Independent Spent Fuel Storage Installation

Dates: May 29-31, 2018

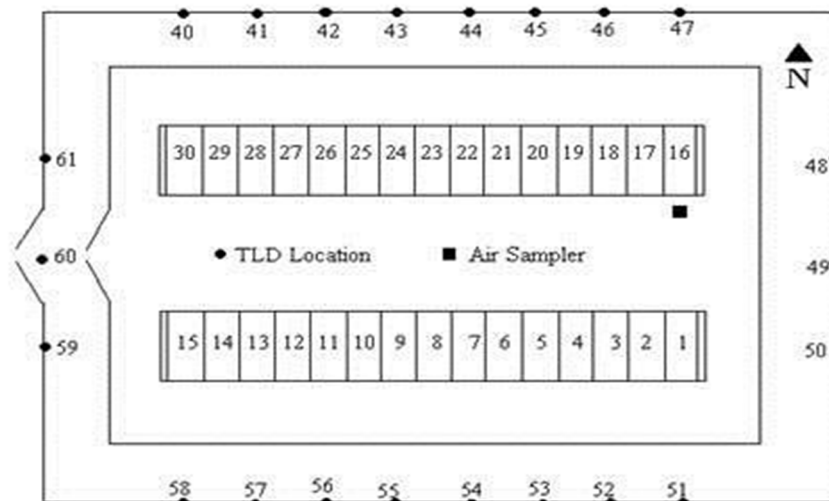
Figure 1 TMI-2 ISFSI

Thirty HSMs were situated on the TMI-2 ISFSI pad. Twenty-nine were loaded with spent fuel debris from the TMI-2 reactor. One additional HSM was placed on the pad with an oversized overpack installed to serve as a backup in case one of the DSCs developed a leak and needed confinement. The 30 HSMs were arranged in two rows of 15 with door openings facing inward, numbering 1–15 on the south row and 16–30 on the north row, going east to west (see Figure 1, above).

The walk-down of the ISFSI pad found the concrete to be in good condition. There was no overt vegetative growth in or around the pad. No flammable or combustible materials were observed on the ISFSI pad. There was a low volume air sampler situated on the ISFSI pad in close proximity to HSM #16 that was used as part of the periodic airborne radioactivity sampling process to assess airborne radiological environmental impacts due to TMI-2 ISFSI operations. The material condition of the 30 HSMs was observed to be acceptable. Signs of repairs made to the concrete were evident on many of the storage modules. The repairs were intact and appeared to be free from further degradation. All of the inspected hardware, doors, latches, and ports installed in the TMI-2 HSMs were in good condition.
