SUBJECT: THREE MILE ISLAND UNIT-2 INDEPENDENT SPENT FUEL STORAGE  
INSTALLATION INSPECTION REPORT 07200020/2018-001

Report Number: 07200020/2018-001

Facility: Three Mile Island Unit 2 Independent Spent Fuel Storage Installation

Dates: May 29-31, 2018

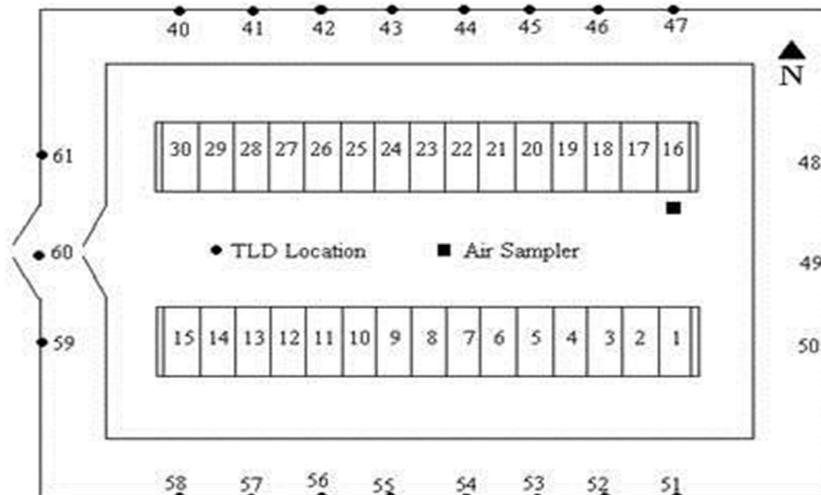
Figure 1 TMI-2 ISFSI

Thirty HSMs were situated on the TMI-2 ISFSI pad. Twenty-nine were loaded with spent fuel debris from the TMI-2 reactor. One additional HSM was placed on the pad with an oversized overpack installed to serve as a backup in case one of the DSCs developed a leak and needed confinement. The 30 HSMs were arranged in two rows of 15 with door openings facing inward, numbering 1–15 on the south row and 16–30 on the north row, going east to west (see Figure 1, above).

The walk-down of the ISFSI pad found the concrete to be in good condition. There was no overt vegetative growth in or around the pad. No flammable or combustible materials were observed on the ISFSI pad. There was a low volume air sampler situated on the ISFSI pad in close proximity to HSM #16 that was used as part of the periodic airborne radioactivity sampling process to assess airborne radiological environmental impacts due to TMI-2 ISFSI operations. The material condition of the 30 HSMs was observed to be acceptable. Signs of repairs made to the concrete were evident on many of the storage modules. The repairs were intact and appeared to be free from further degradation. All of the inspected hardware, doors, latches, and ports installed in the TMI-2 HSMs were in good condition.
