Ginna Station  
Steam Generator Inspection

Final Report

May 11, 1977

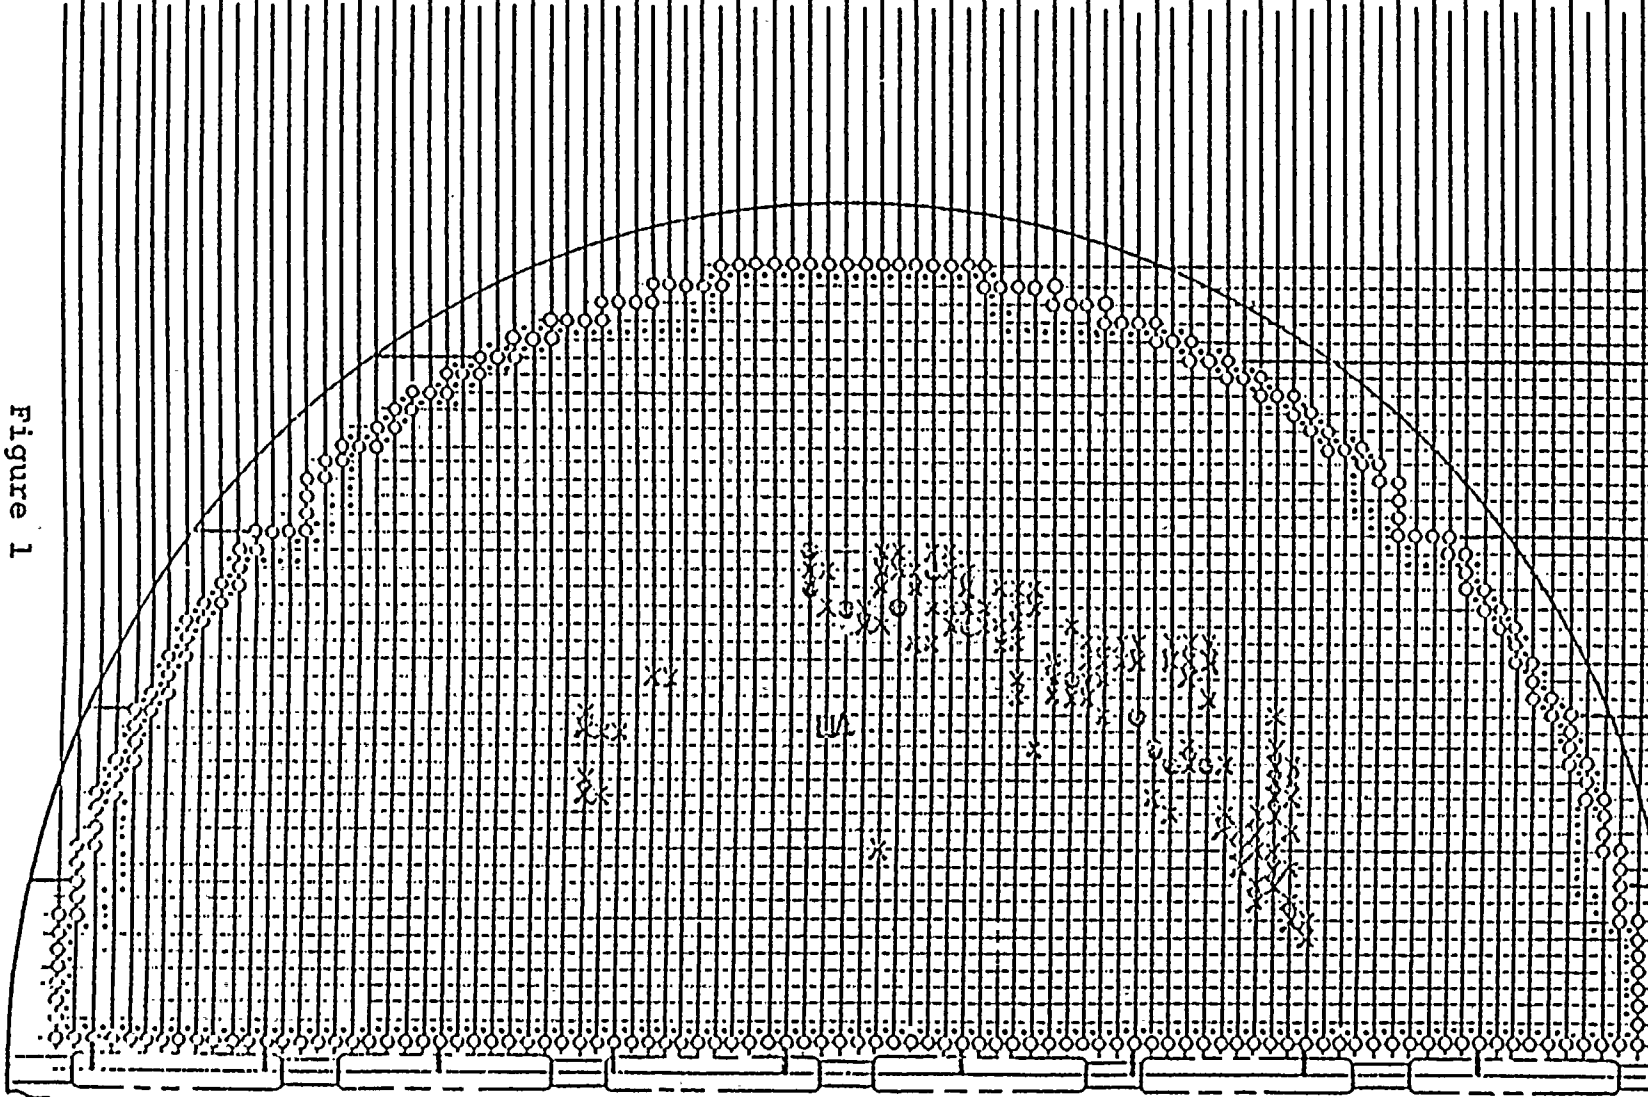
Figure 1

Results of these examinations are given in Figures 1 through 3 which includes the "A" inlet and the "B" inlet and outlet, respectively. Tables (1) and (2) of this report are included for comparison of the last five steam generator inspections.

tubes, in the "A" inlet, due to their large growth rate compared to the mean, may have been caused by concentrations of caustics. Confirmation of this is not possible since the eddy current examination method cannot differentiate between indications resulting from either wastage or stress corrosion cracking, but can accurately measure the maximum defect penetration to within normal statistical variation. The indications are seen only in those areas where indications have been previously noted, with the exception of the indication in the "B" steam generator U-bend area. There has been no expansion of the indication region to other areas of the steam generators. This inspection verified that there are not any other tubes with ID Indication in the periphery tubes associated with the wedge areas where there had been a leak in April 1976 (see Licensee Event Report 76-15).

The small number of tubes in the "A" inlet which have experienced deterioration, inconsistent with the average, are believed to have deteriorated from the concentration of residual phosphates in the secondary side sludge deposits. These concentrations of phosphates are caused by the remaining traces of sludge deposits formed during the period of phosphate control of the secondary system water chemistry before the conversion to AVT chemistry control in November 1974.

"A" INLET

# EDDY CURRENT INDICATIONS

- a. All tubes with eddy current indications of wall penetration greater than or equal to 40% were plugged.
- b. A thorough lancing of the secondary side of the tube sheets was performed in both steam generators to remove as much as possible any remaining phosphates and/or caustics contained within the sludge. Sludge lancing of both steam generators will be continued in an effort to keep sludge content to a minimum. The lancing, coupled with blowdown during startup and normal operation, should considerably reduce the probability of significant tube degradation during the plants' subsequent operation.

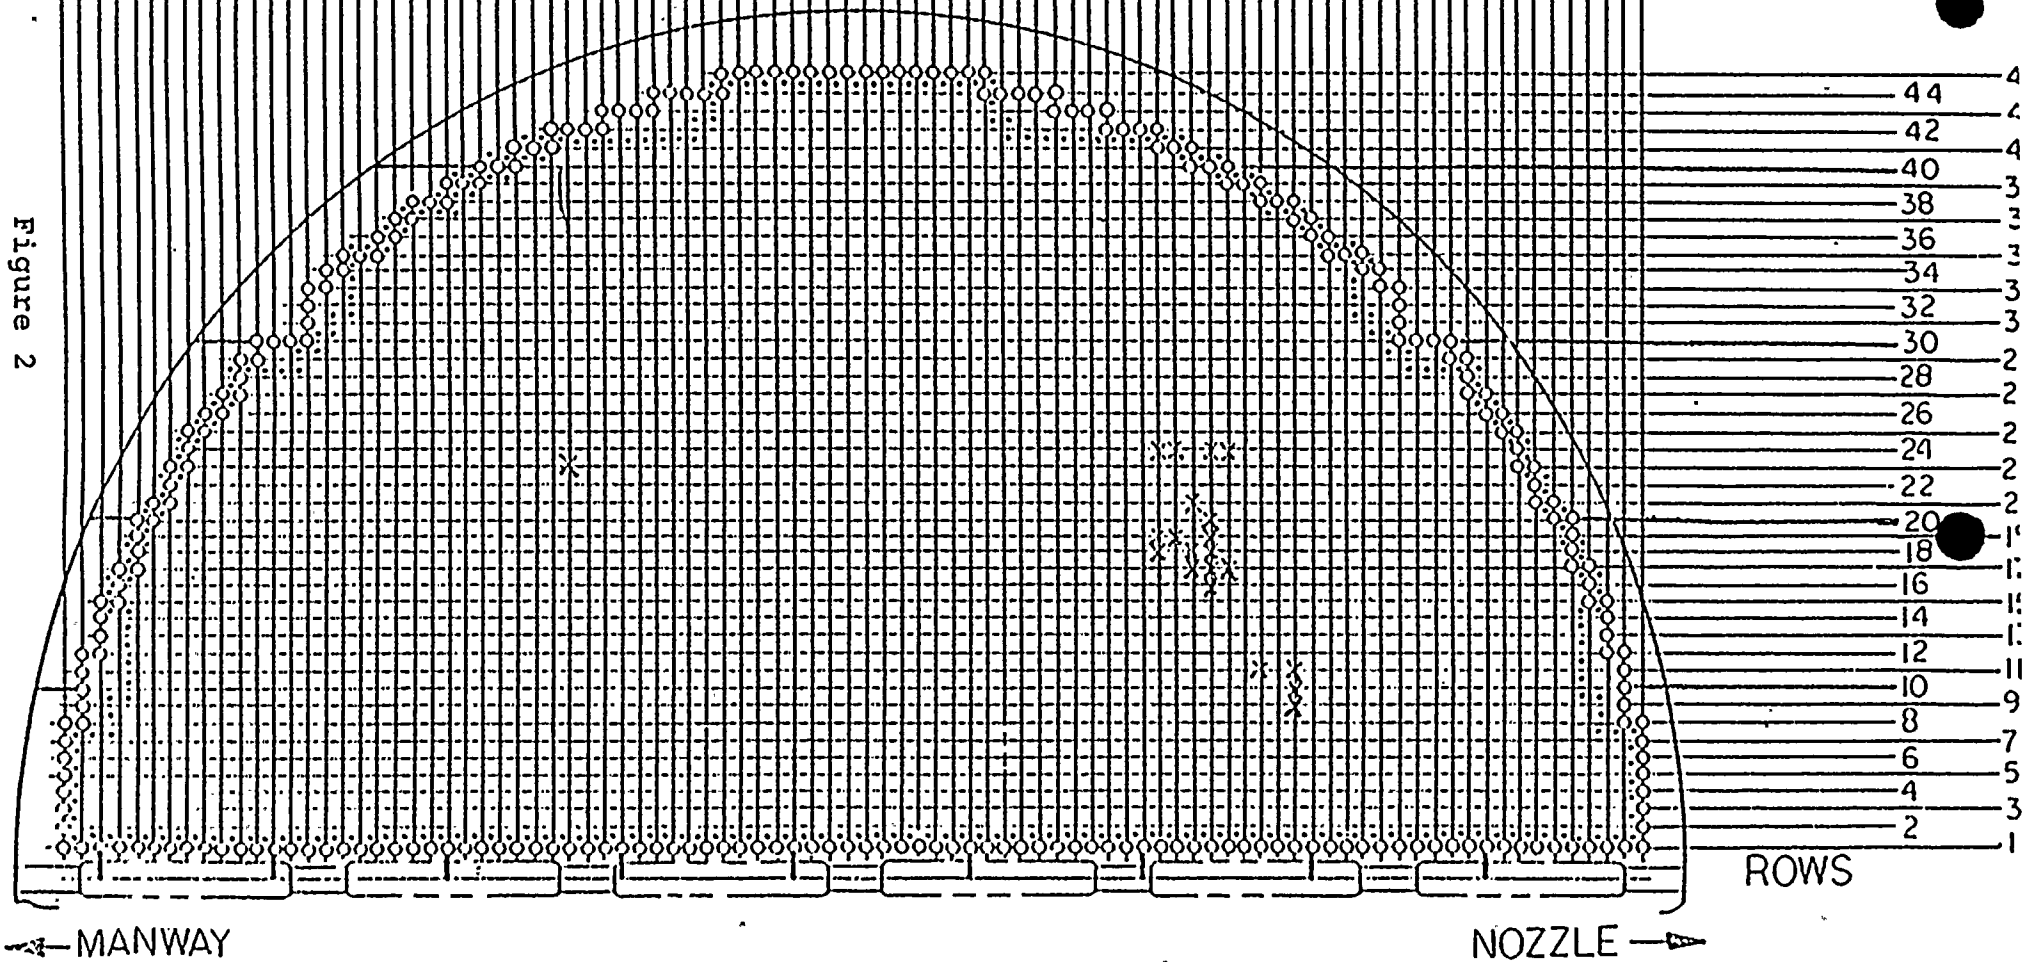
Figure 2

All of the eddy current indications were within the first few inches of tubing directly above the tube sheet with the exception of one in the U-bend area of the "B" steam generator. This indication in the "B" steam generator U-bend area was on a periphery tube and appears to be a one-of-a-kind construction-type defect of very small volume, 95% through the tube wall. The other indications with the exception of two, are postulated to be due to wastage, based on growth rates. The excepted two

# "B" INLET EDDY CURRENT INDICATION
