Subject: NSAL-18-1 Revision 0, "Thermal Sleeve Flange Wear Leads to Stuck Control Rod"

Nuclear Safety

Advisory Letter

Subject: Thermal Sleeve Flange Wear Leads to Stuck Control Rod	Number: NSAL-18-1
Basic Component: Thermal Sleeve in CRDM Reactor Head Penetration	Date: July 9, 2018
Substantial Safety Hazard or Failure to Comply Pursuant to 10 CFR 21.21(a)	Yes No N/A
Transfer of Information Pursuant to 10 CFR 21.21(b)	Yes
Advisory Information Pursuant to 10 CFR 21.21(d)(2)	Yes

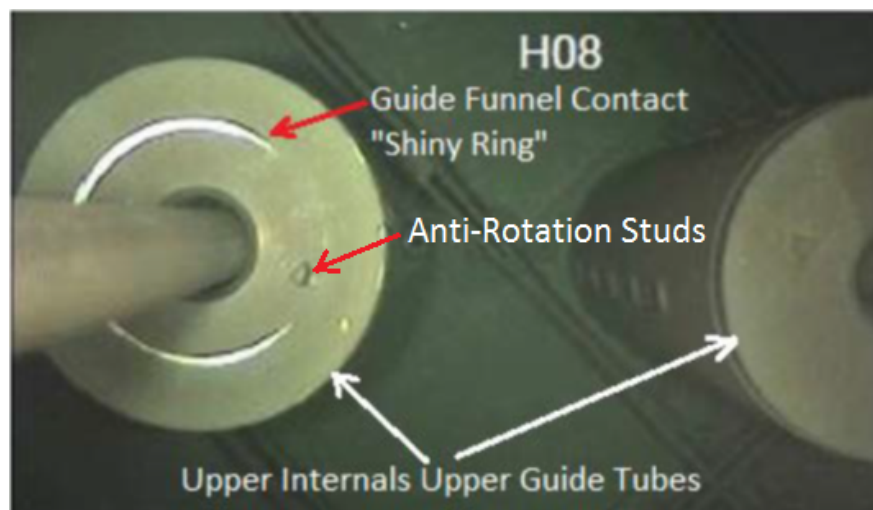
Figure 4: “Shiny Ring” Evidence of Guide Funnel Contact Wear on the UGT at Belleville Unit 2

For plants with 17x17 and 16x16 guide tubes, actual contact of the guide funnel with the UGT top housing plate will likely only occur after the flange has completely separated from the thermal sleeve. In December 2017, a 4-loop 1300 MW EdF plant in France, Belleville Unit 2, experienced complete wear-through and separation of one of the thermal sleeve flanges at a rodded location (Core Location H-8). Figure 4, taken from Belleville Unit 2, illustrates the wear marking (“shiny ring”) that may be visible on the UGT top housing plate after the reactor vessel head is removed, if a plant has been operating with a failed thermal sleeve.

Figure 4 also shows the anti-rotation stud design used on the EdF guide tubes. Westinghouse NSSS plants have an anti-rotation stud/nut configuration on the top housing plate which results in the stud protruding slightly higher and the nut extending more into the diameter of the wear ring. This difference in configuration may result in slightly different wear markings on the stud and nut as compared to what is shown in Figure 4. While signs of contact between the guide funnel and the anti-rotation stud/nut may be visible before flange separation occurs, this wear pattern indicates that significant thermal sleeve flange wear has occurred.

- For plants with 17x17 and 16x16 guide tubes, look for the “shiny ring” shown in Figure 4.
- During the next under-head inspection (i.e., the volumetric inspections required by ASME Section XI Code Case N-729-4 [5] and 10 CFR 50.55a), and at subsequent under-head inspections:
