LR-N18-0080

Salem Generating Station Unit 1  
Renewed Facility Operating License No. DPR-70  
NRC Docket No. 50-272

Subject: Notification of Deviation from Electric Power Research Institute (EPRI),  
"Materials Reliability Program: Pressurized Water Reactor Internals  
Inspection and Evaluation Guidelines (MRP-227-A)"

Deviation of MRP-227-A Needed Examinations

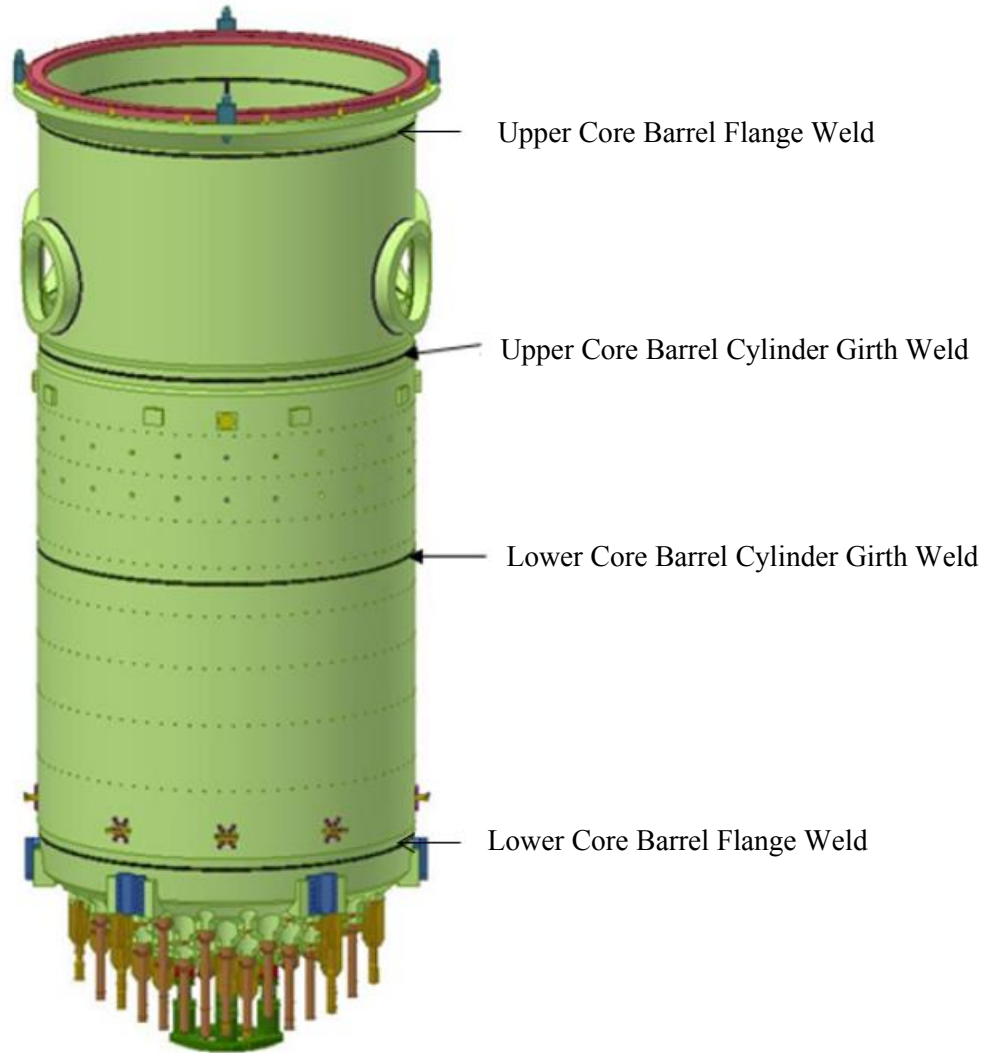
Attachment 1

## **2.1 Lower Core Barrel Cylinder Girth Weld and Lower Core Barrel Flange Weld**

Westinghouse Core Barrel and Welds

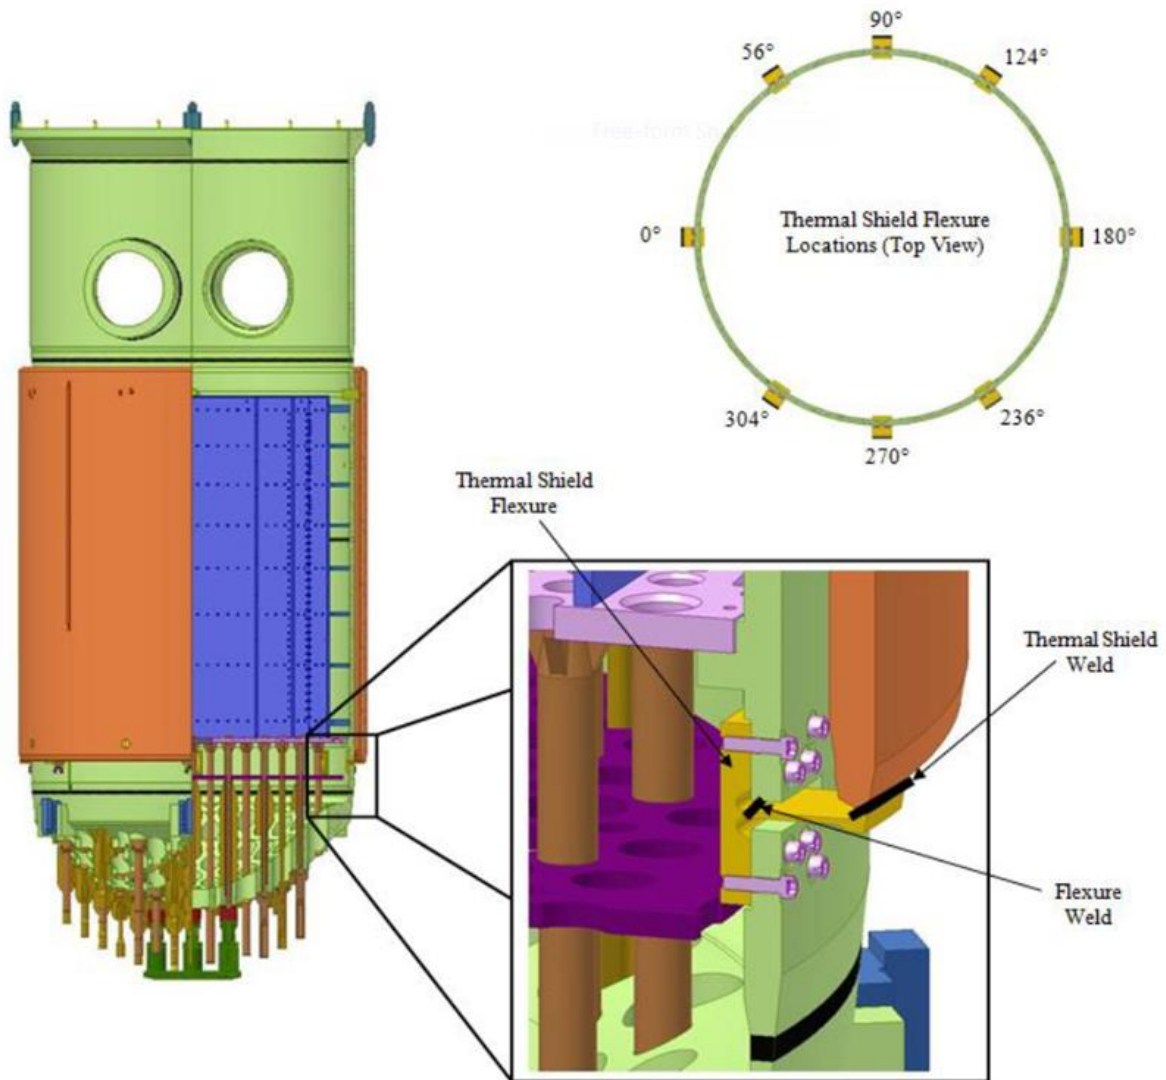
Attachment 2

The MRP-227-A examination requirement for the thermal shield assembly: thermal shield flexures is a visual (VT-3) examination no later than two refueling outages from the beginning of the license renewal period and subsequent examinations on a ten year interval. This examination is intended to identify cracking (fatigue) or loss of material (wear) that results in excessive wear, fracture, or complete separation of the thermal shield flexures. Operating experience summaries from Westinghouse designed plants that have completed MRP-227-A examinations of the thermal shield flexures are available in Materials Reliability Program biennial reports [4.4] [4.5] [4.6]. In summary, 12 plants similar to Salem Unit 1 have completed thermal shield flexures inspections with no recordable indications identified. These Westinghouse designed plants are Beaver Valley Unit 1, D.C Cook Unit 1, Ginna, H.B. Robinson, Indian Point 2, Point Beach Unit 1, Point Beach Unit 2, Prairie Island Unit 1, Prairie Island Unit 2, Surry Unit 1, Turkey Point Unit 3, Turkey Point Unit 4. All of the inspection findings at these sites allowed for a ten year re-inspection interval. These inspections were conducted after these plants had operated between a minimum of 29.1 effective full-power years (EFPY) and a maximum of 35.5 EFPY with an average of 32.2 EFPY. Salem Unit 1 will accumulate approximately 29.5 EFPY at the time of refueling outage 1R26, and 30.9 EFPY at refueling outage 1R27 [4.15] both of which are within the range of EFPY for the inspections in these other plants. Therefore there is reasonable assurance deferring the thermal shield flexures inspections until 1R27 is acceptable.

Westinghouse Thermal Shield Flexures
