**NRC DISTRIBUTION FOR PART 50 DOCKET MATERIAL  
(TEMPORARY FORM)**

March 21, 1975

ABNORMAL OCCURRENCE NO. 251-75-4  
OCCURRENCE DATE: MARCH 12, 1975  
TURKEY POINT UNIT NO. 4  
LATERAL RESTRAINTS FOR SPENT  
FUEL RACKS BROKEN

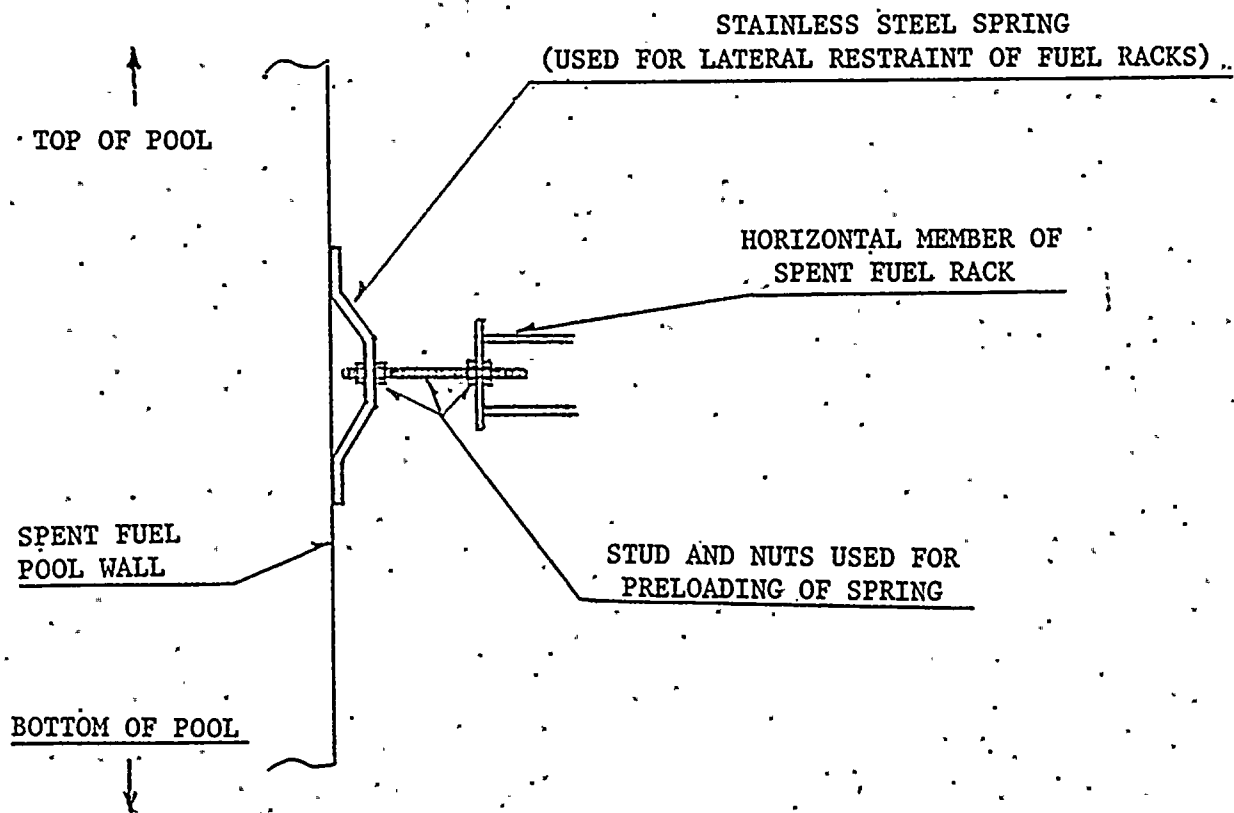
SKETCH NO. 1

During the spent fuel pool cleaning on March 6, 1975, it was found that one of the 116 stainless steel seismic restraint springs (see Sketches No. 1 and 2) on the spent fuel racks had broken into two pieces and was lying on the pool floor. The remaining springs were all noted to be in place. However, a more careful examination of each of the remaining 115 springs was completed on March 12, 1975 and revealed that 5 additional springs were similarly broken, but were held in place by the nuts used to fasten the spring to the stud used for preloading the spring (see Sketch No. 1).

SPRING INSTALLATION  
IN TURKEY POINT SPENT FUEL POOL

The broken springs will be replaced with new springs of the same functional design. A supplement to this report will be issued in the event that additional corrective action is required as a result of the continuing investigation.

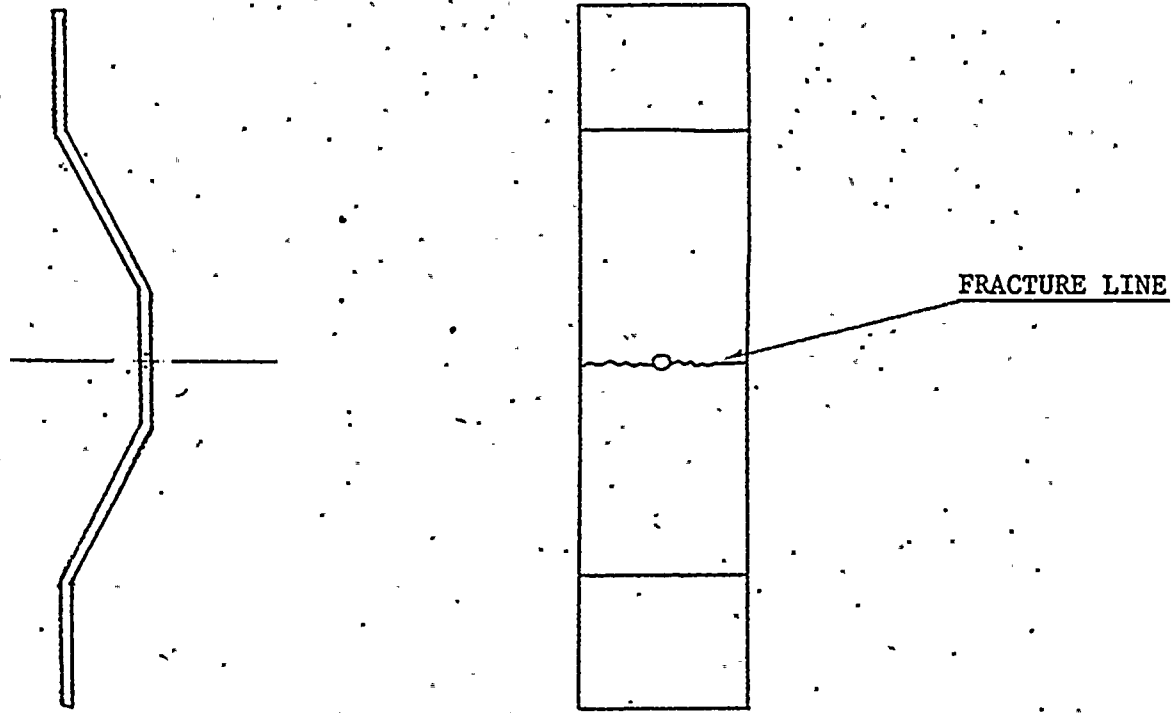
SKETCH NO. 2

The investigation to date has not conclusively determined the cause of the broken springs. One of the broken springs has been sent to a laboratory for metallurgical analysis, but the results are not yet available.

STAINLESS STEEL SPRING USED FOR  
LATERAL RESTRAINT OF SPENT FUEL RACKS AT  
TURKEY POINT PLANT
