PLANT NAME: TURKEY POINT - UNIT 4

February 1, 1978
L-78-40

Re: Turkey Point Unit 4
Docket No. 50-251
Request for Amendment to
Operating License DPR-41
Additional Information

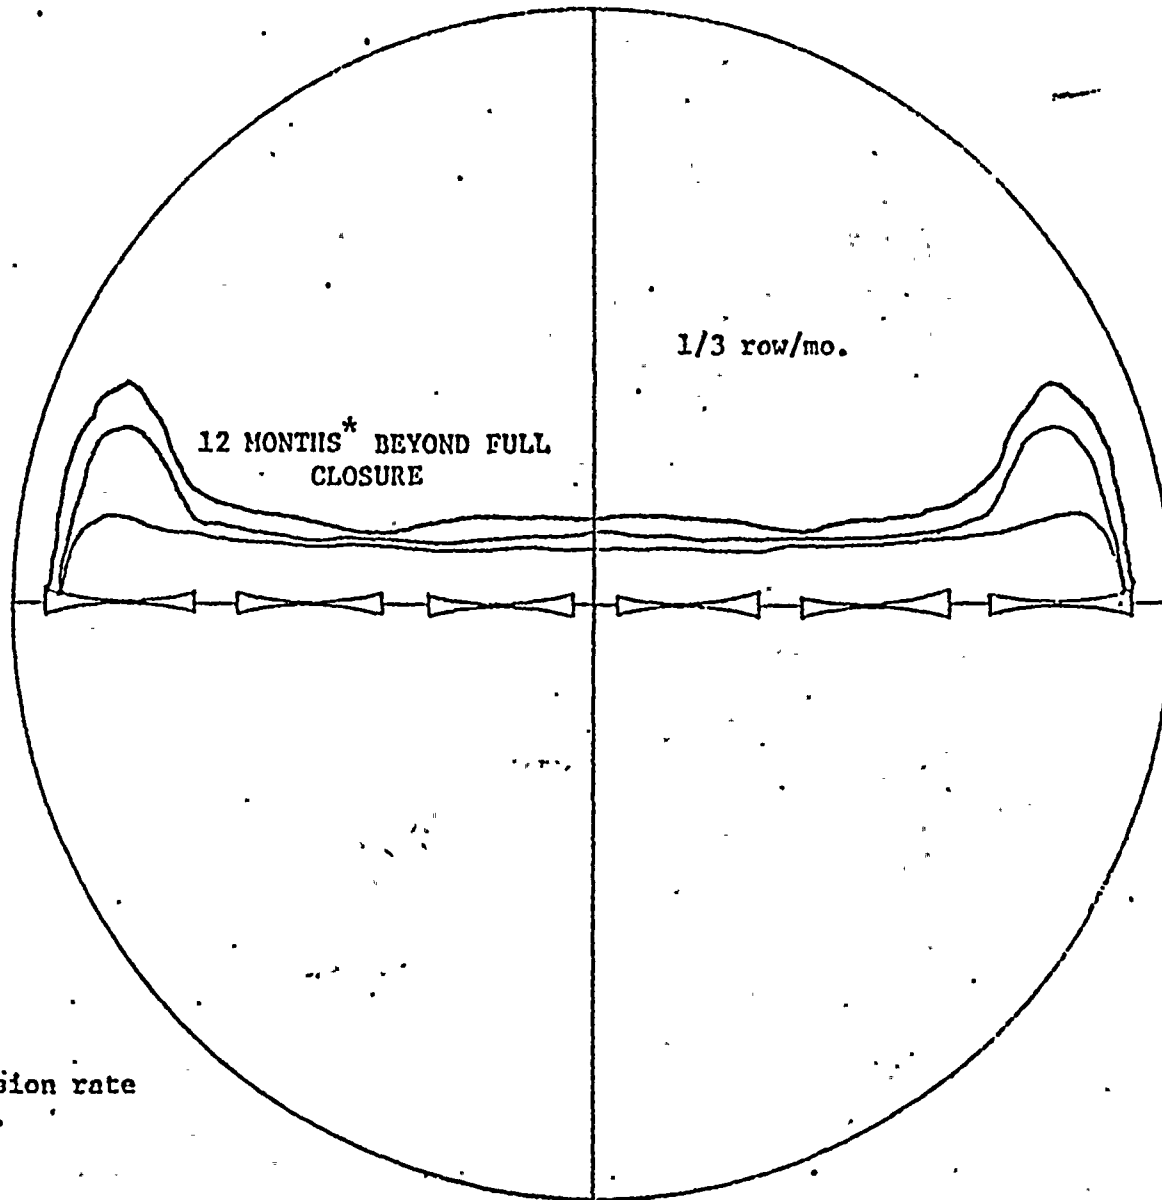
Figure 2

- a) Upon re-inspection of the Surry 1 and Surry 2 sites, only a small number of tubes in the tube lane region developed severe restrictions (i.e., tubes restricting .540" probe) between inspections (less than twenty-five at Surry 2 and less than 5 at Surry 1).
- b) Of all the tubes at both Surry 1 and Surry 2 that restrict .650" probes at both the previous and current outage, 70% still passed the 0.610" probe and more than 94% passed the 0.540" probe at the second outage.
- c) The re-inspection programs have indicated that the strain contour used to develop growth is a conservative representation of critical strain. The critical strain is closer to 17% than the 14% previously used. A re-evaluation of growth plots (Figure 2), considering the

progression of the 17% contour rather than the 14% contour, yields a reduction of the growth rates to .25 rows/month along the tube lane and .5 rows/month at the outside columns. Thus, for the Turkey Point 4 plugging pattern of 2 rows out along the tube lane and 4 rows out at the outside columns, this new rate allows for 8 months of operation, or an additional 2 months beyond the current operating period, for all three steam generators.

$\approx 2/3$ row/mo. (maximum)

1/3 row/mo.

Note that only this one area of the plate (near the 3 and 9 o'clock wedge) must be examined separately with regard to growth of strain contours. In all other regions, 1/3 row/mo. is a conservative growth rate.

"Growth" of 14% Hoop Strain Contour

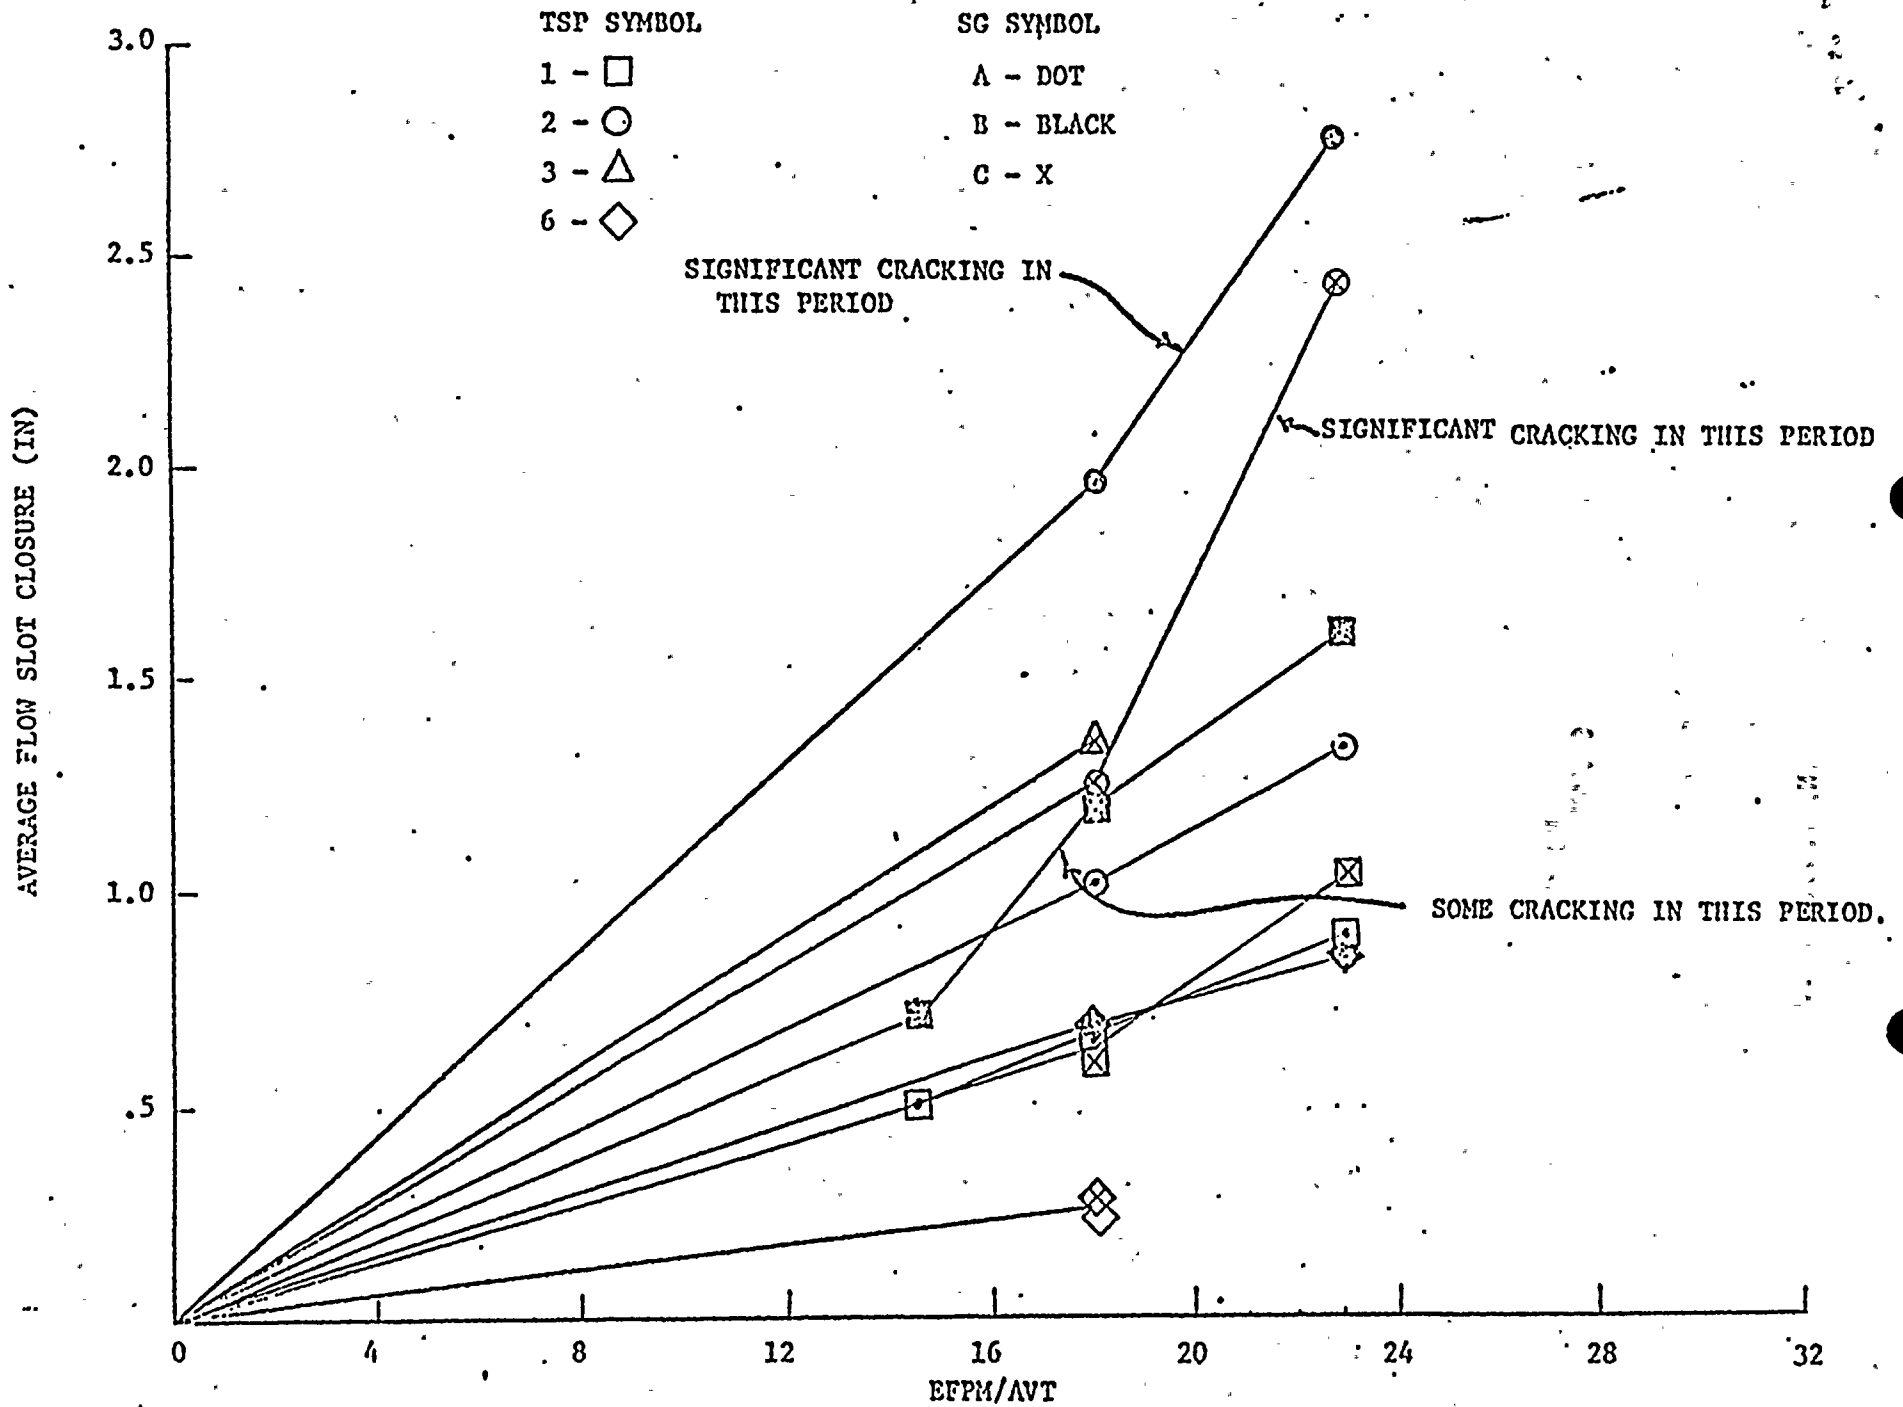
In all previous evaluations of tube inspection results, the most severe rate of plate expansion (among the steam generators of a given plant) was used for all steam generators. This is very conservative, and in the case of Turkey Point 4, severely penalized two of the three steam generators. Figure 1 shows the flow slot closure history for all three steam generators. The rate of closure used to develop the current stress pattern was .12 in/mo based on the second tube support plate in steam generator B. From this figure it can be seen that no plate in steam generators A and C has a closure rate exceeding .08 in/mo. Based on this, and the direct relationship previously developed between growth of critical strain and closure rate, the plugging patterns used for steam generators A and C support safe operation for:

$$\frac{.12}{.08}(6) = 9 \text{ months}$$
