ANALYSIS PROVIDING ADDITIONAL INFO. CONCERNING PREVIOUSLY SUBMITTED  
REQUEST FOR AMEND. TO OPERATING LICENSE WHICH WOULD REQUIRE THAT  
THE UNIT 4 STEAM GENERATORS BE INSPECTED DURING THE NEXT REFUELING  
OUTAGE OR SOONER IF OPERATING EXPERIENCE SHOWED THAT A

PLANT NAME: TURKEY POINT - UNIT 4

Re: Turkey Point Unit 4  
Docket No. 50-251  
Request for Amendment to  
Operating License DPR-41  
Additional Information

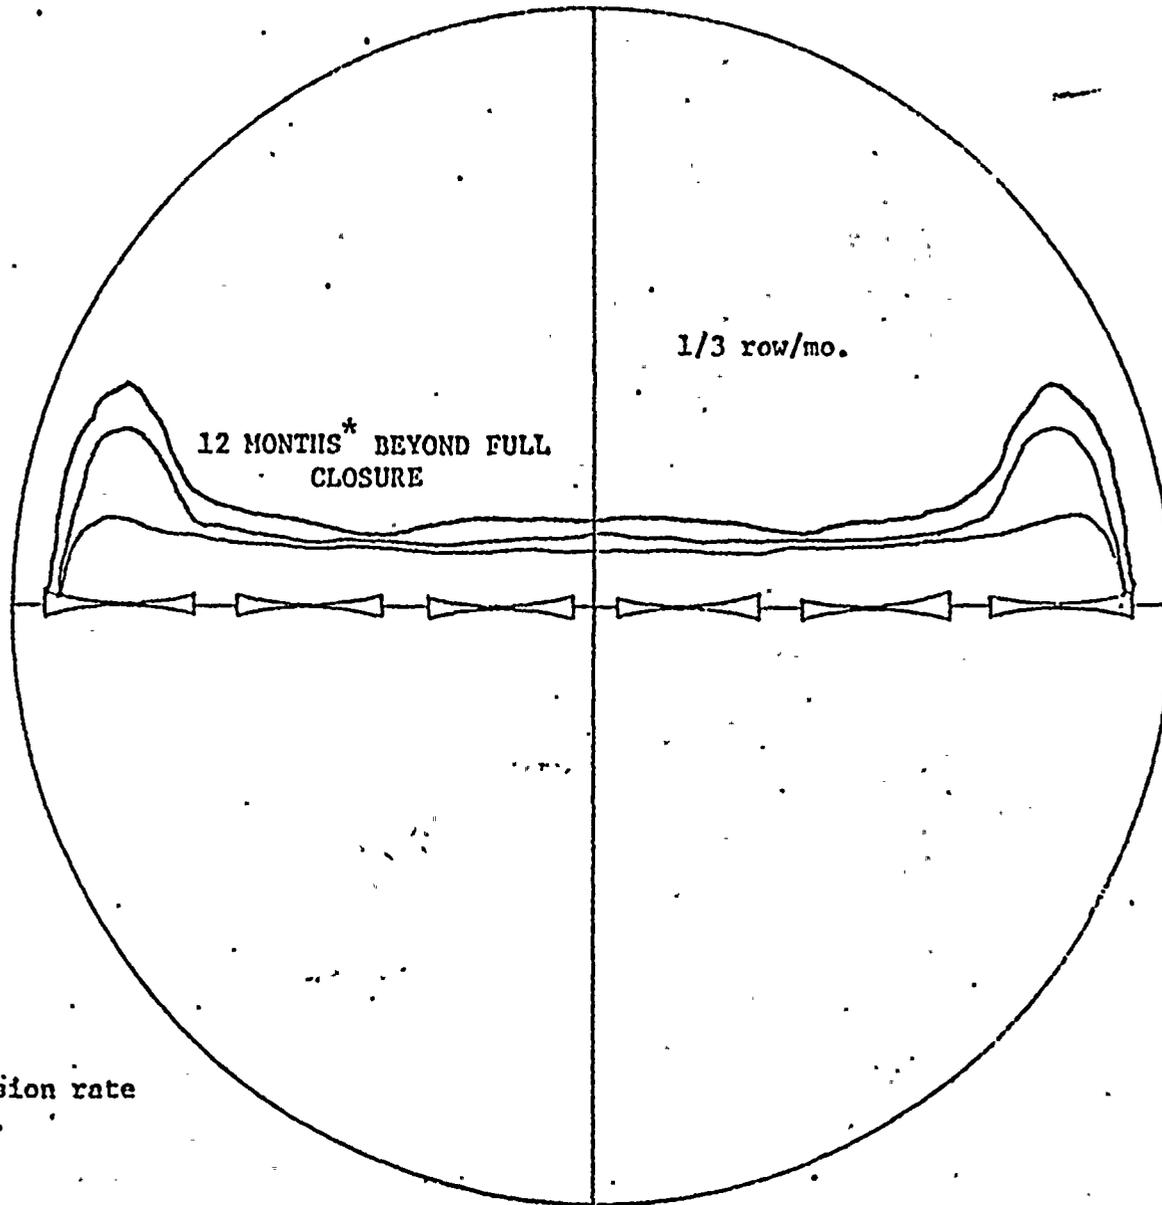
Figure 2

progression of the 17% contour rather than the 14% contour, yields a reduction of the growth rates to .25 rows/month along the tube lane and .5 rows/month at the outside columns. Thus, for the Turkey Point 4 plugging pattern of 2 rows out along the tube lane and 4 rows out at the outside columns, this new rate allows for 8 months of operation, or an additional 2 months beyond the current operating period, for all three steam generators.

$\approx 2/3$  row/mo. (maximum)

1/3 row/mo.

Note that only this one area of the plate (near the 3 and 9 o'clock wedge) must be examined separately with regard to growth of strain contours. In all other regions, 1/3 row/mo. is a conservative growth rate.

"Growth" of 14% Hoop Strain Contour

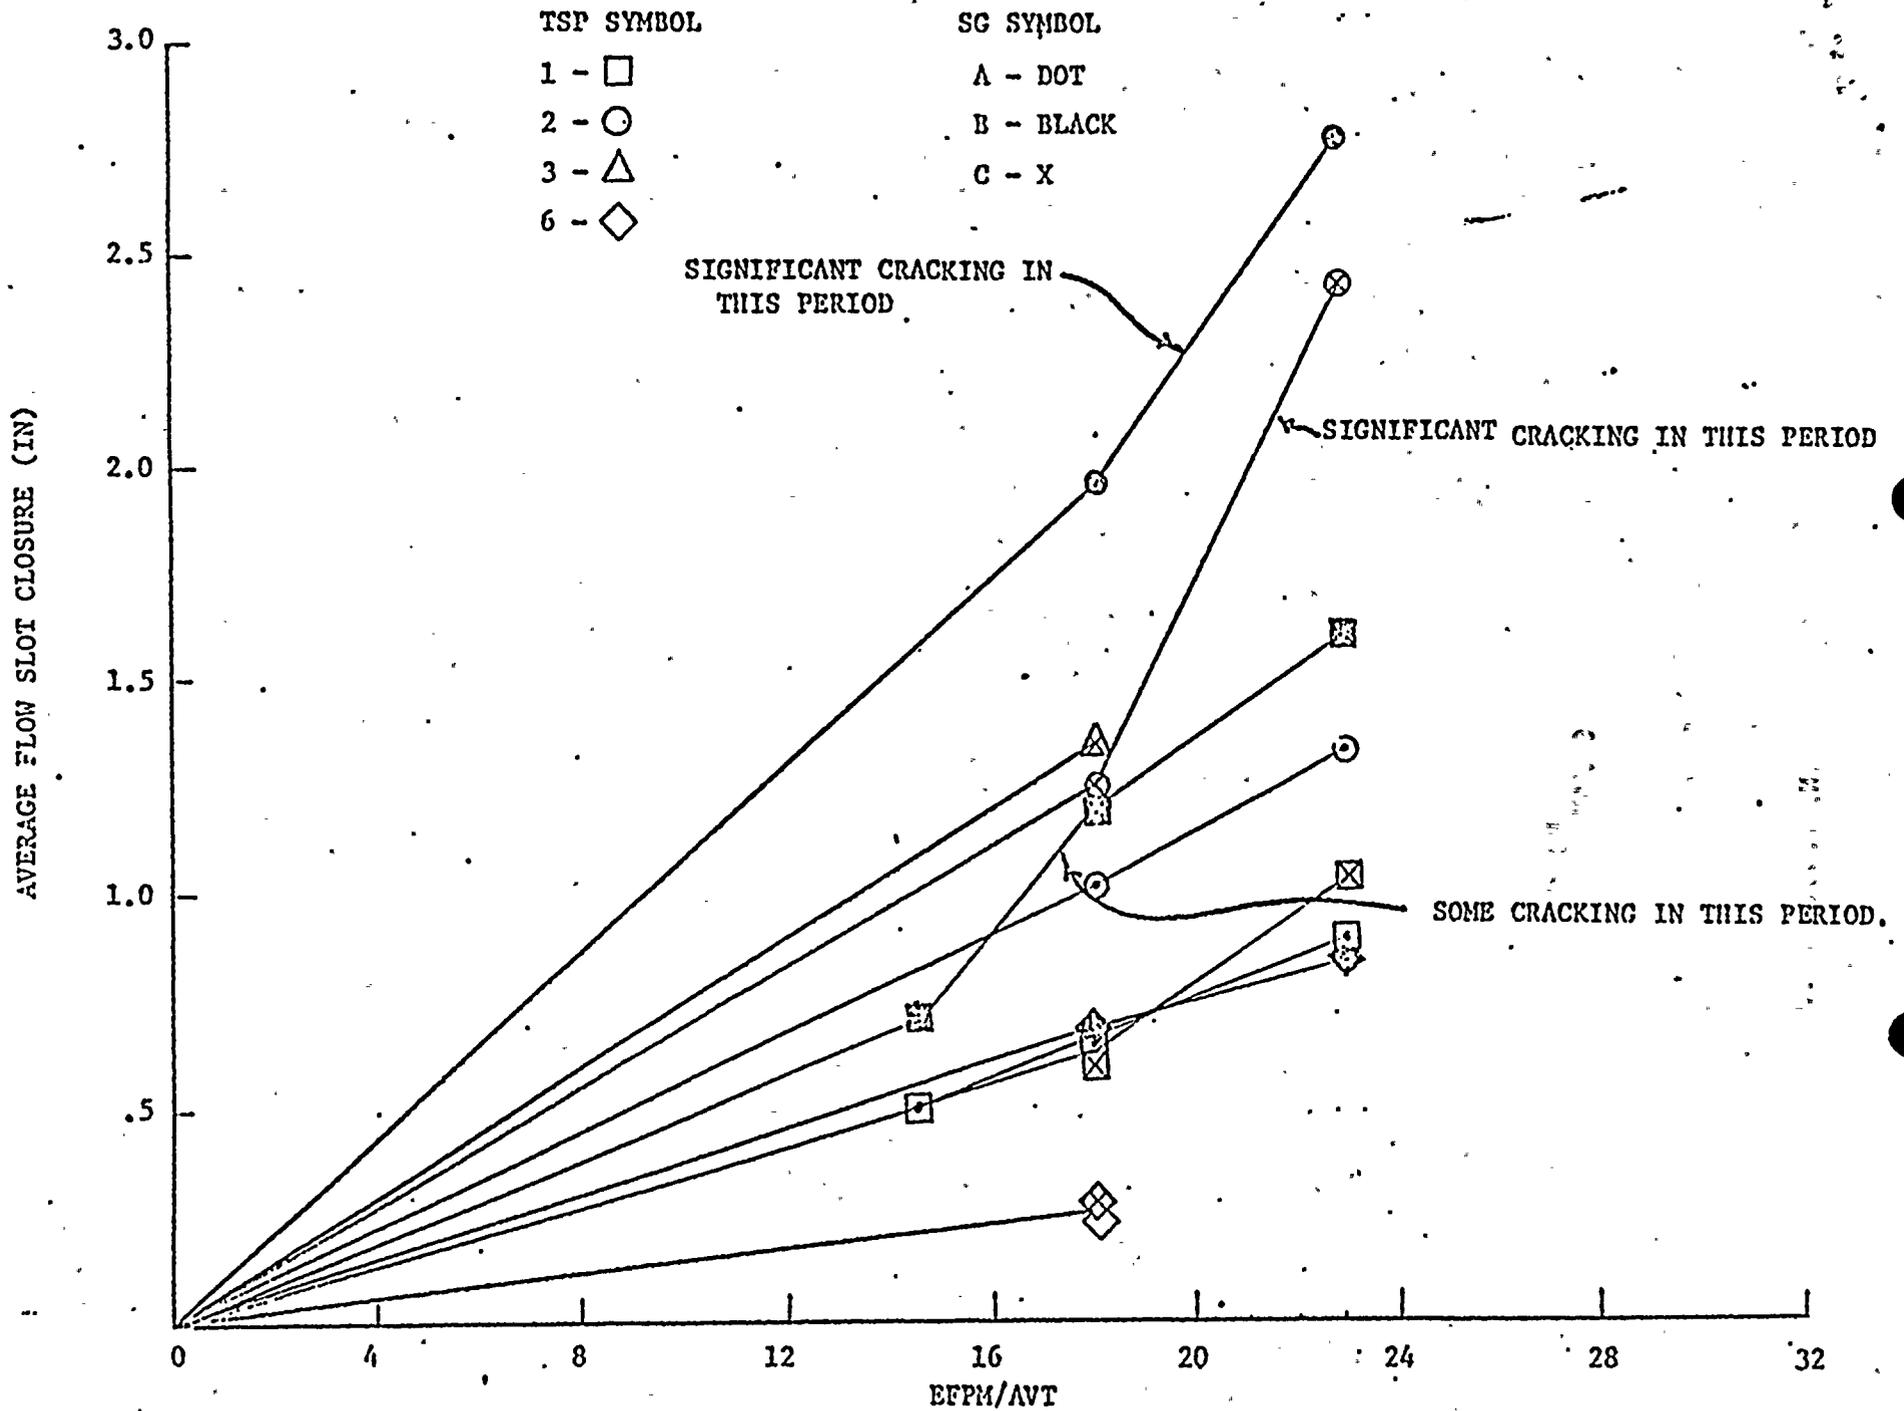
In all previous evaluations of tube inspection results, the most severe rate of plate expansion (among the steam generators of a given plant) was used for all steam generators. This is very conservative, and in the case of Turkey Point 4, severely penalized two of the three steam generators. Figure 1 shows the flow slot closure history for all three steam generators. The rate of closure used to develop the current stress pattern was .12 in/mo based on the second tube support plate in steam generator B. From this figure it can be seen that no plate in steam generators A and C has a closure rate exceeding .08 in/mo. Based on this, and the direct relationship previously developed between growth of critical strain and closure rate, the plugging patterns used for steam generators A and C support safe operation for:

$$\frac{.12}{.08}(6) = 9 \text{ months}$$
