Re: Florida Power & Light Company (FPL)
Docket Nos. 50-250, 50-251, and 50-335
Request for Additional Information

Your letter of March 16, 1978 requested additional information regarding the FPL system disturbance which occurred on May 16, 1977. Our responses to your additional questions are attached.

SUBJECT: OFF-PEAK TRANSIENT STABILITY STUDY FOR 1977

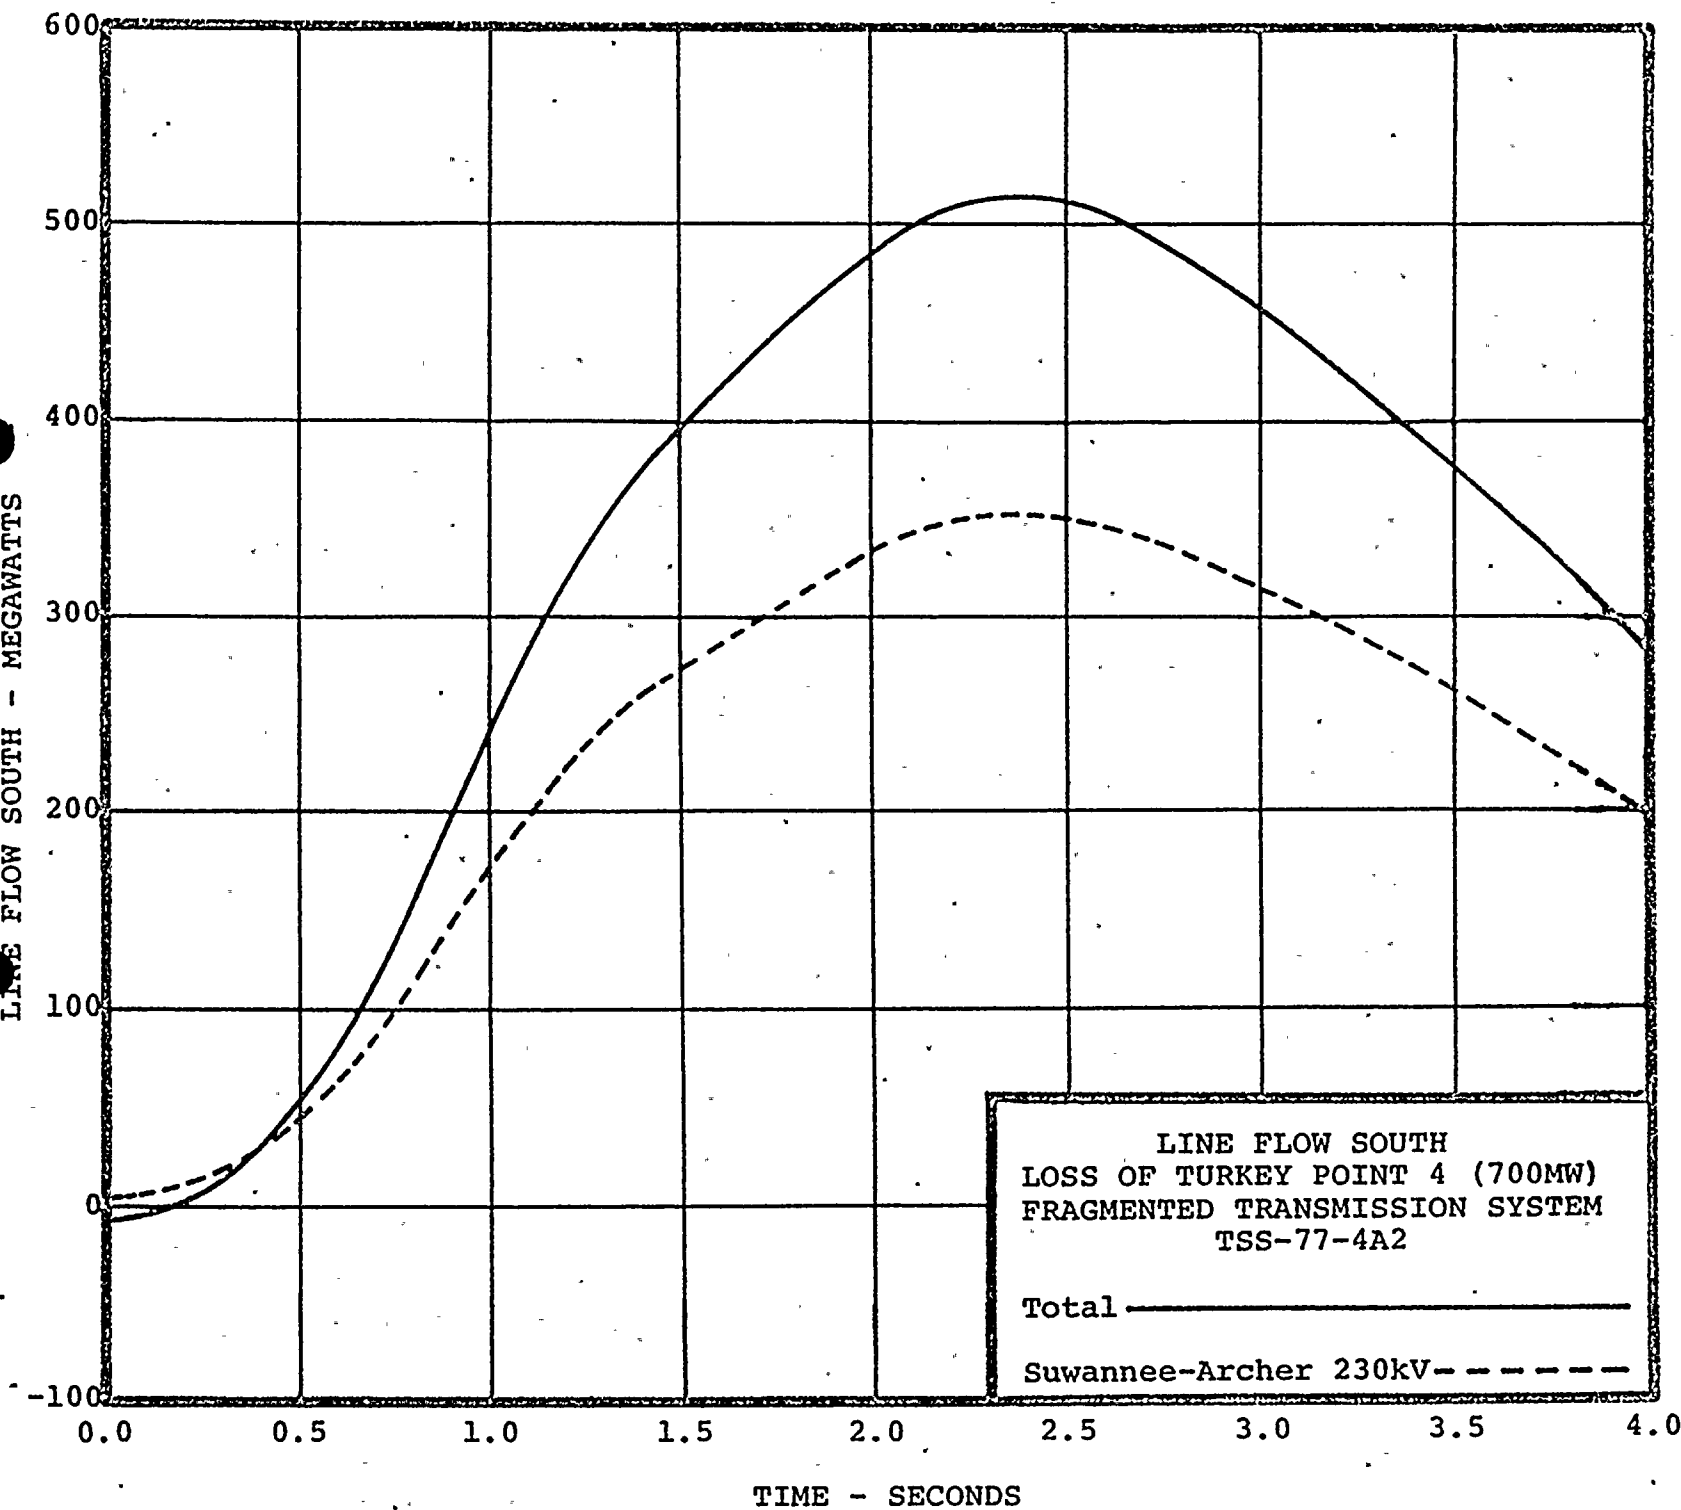
FIGURE 4A2-3

Tie lines were exporting approximately 3 MW of power when the unit outage occurred (see Figure 4A2-3). These tie lines were composed of the following circuits:

Net power flow over these tie lines reversed at $T = 0.2$ second, increasing to a peak of 515 MW at $T = 2.4$ seconds to the south. No transmission line relays operated during the course of the study.

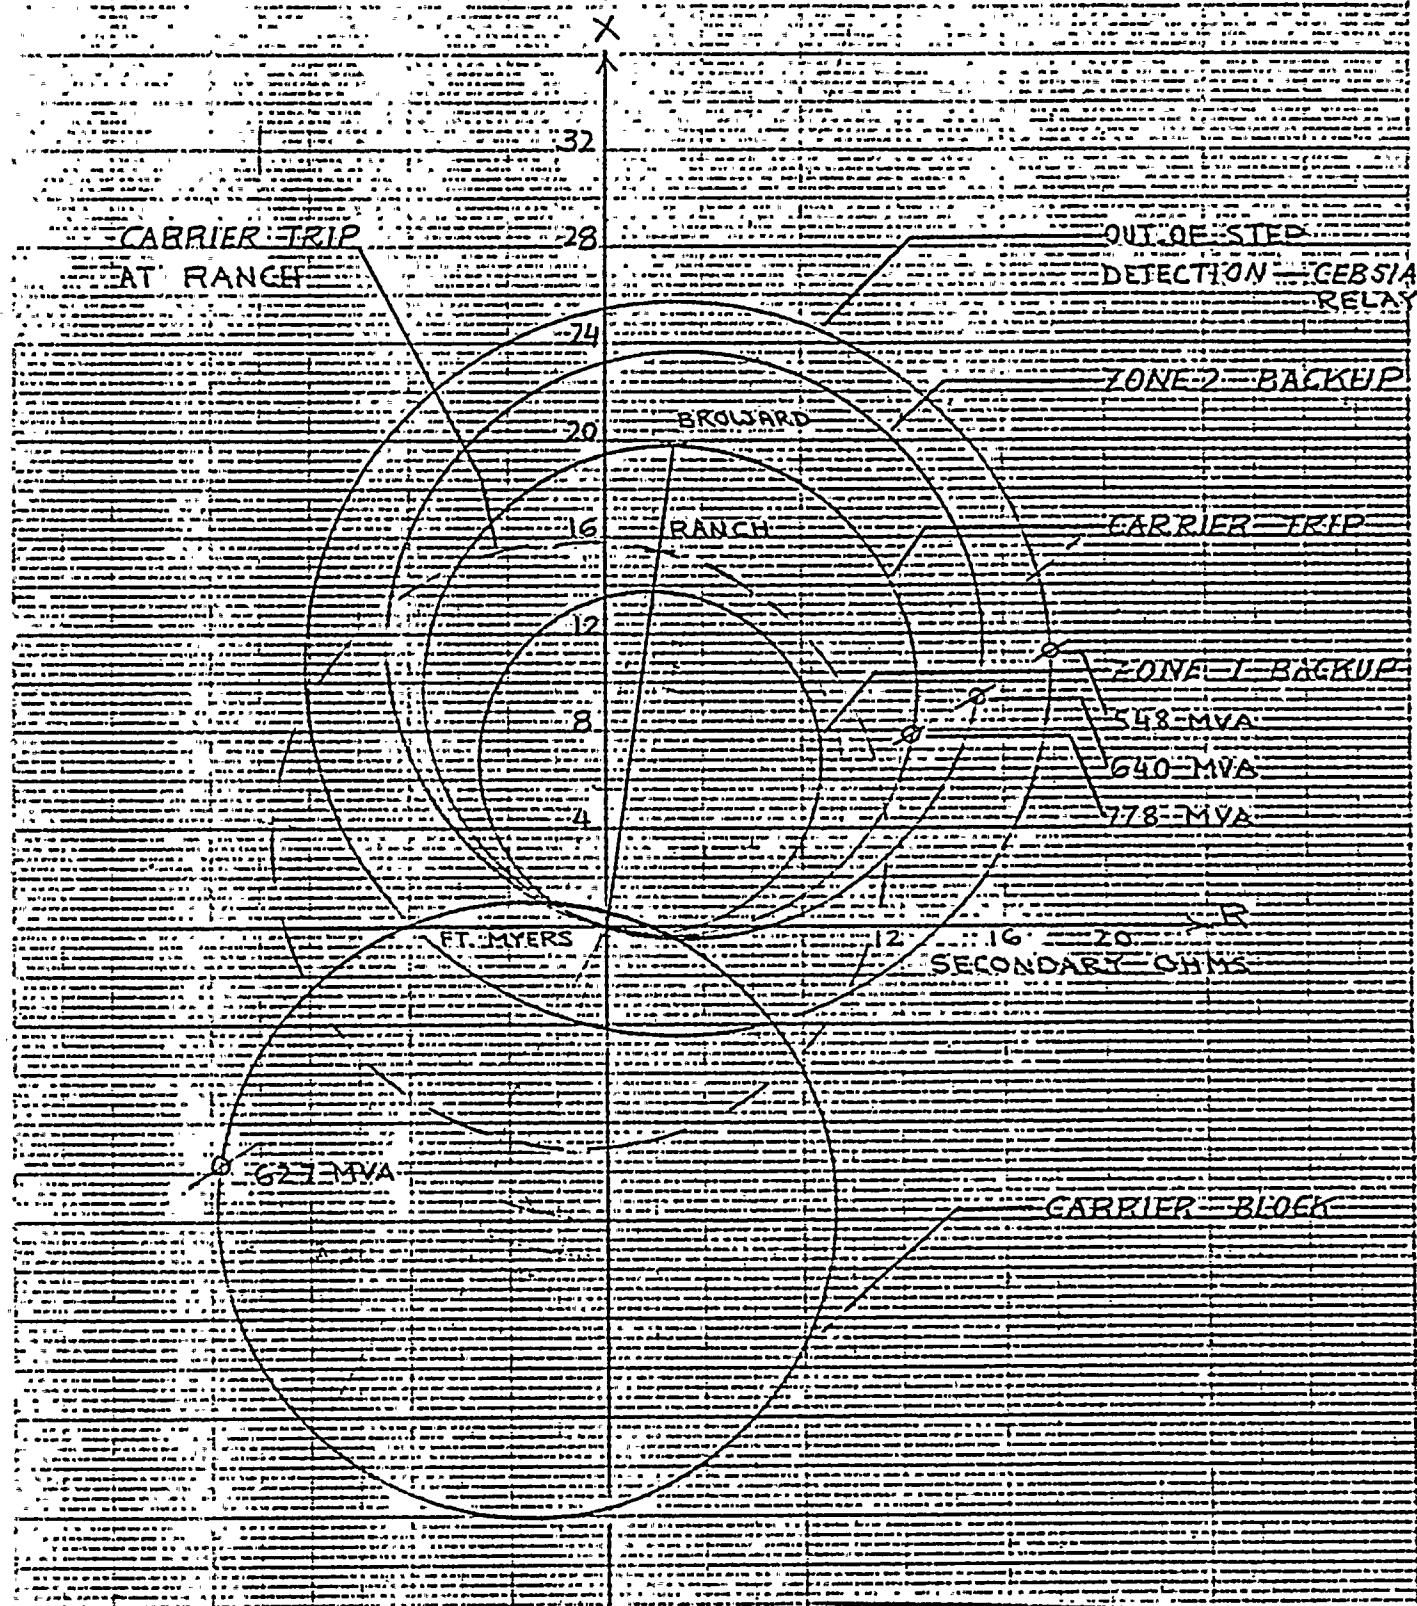
CHARACTERISTICS FOR PHASE RELAYS
 LINE FT MYERS - RANCH 240 KV
 TERMINAL FT MYERS
 BASED ON SETTINGS DATED 12-10-76
 DRAWN BY A.S.

- 9) The line loading of the Fort Myers-Ranch line was well under the tripping value.

Setting sheets are attached (Appendix D) with a plot of the relay characteristic in terms of R & X and a plot in terms of watts and vars.
