Subject: License SUA-1341, Docket No. 40-8502 (Electronic Submittal Only)
Willow Creek Project
August 6, 2018
Pump Station 8 Release
Christensen Ranch

Uranium One USA, Inc. - Willow Creek Project
Spill Report Summary
Pump Station 8 (Recovery) Fluid Releases

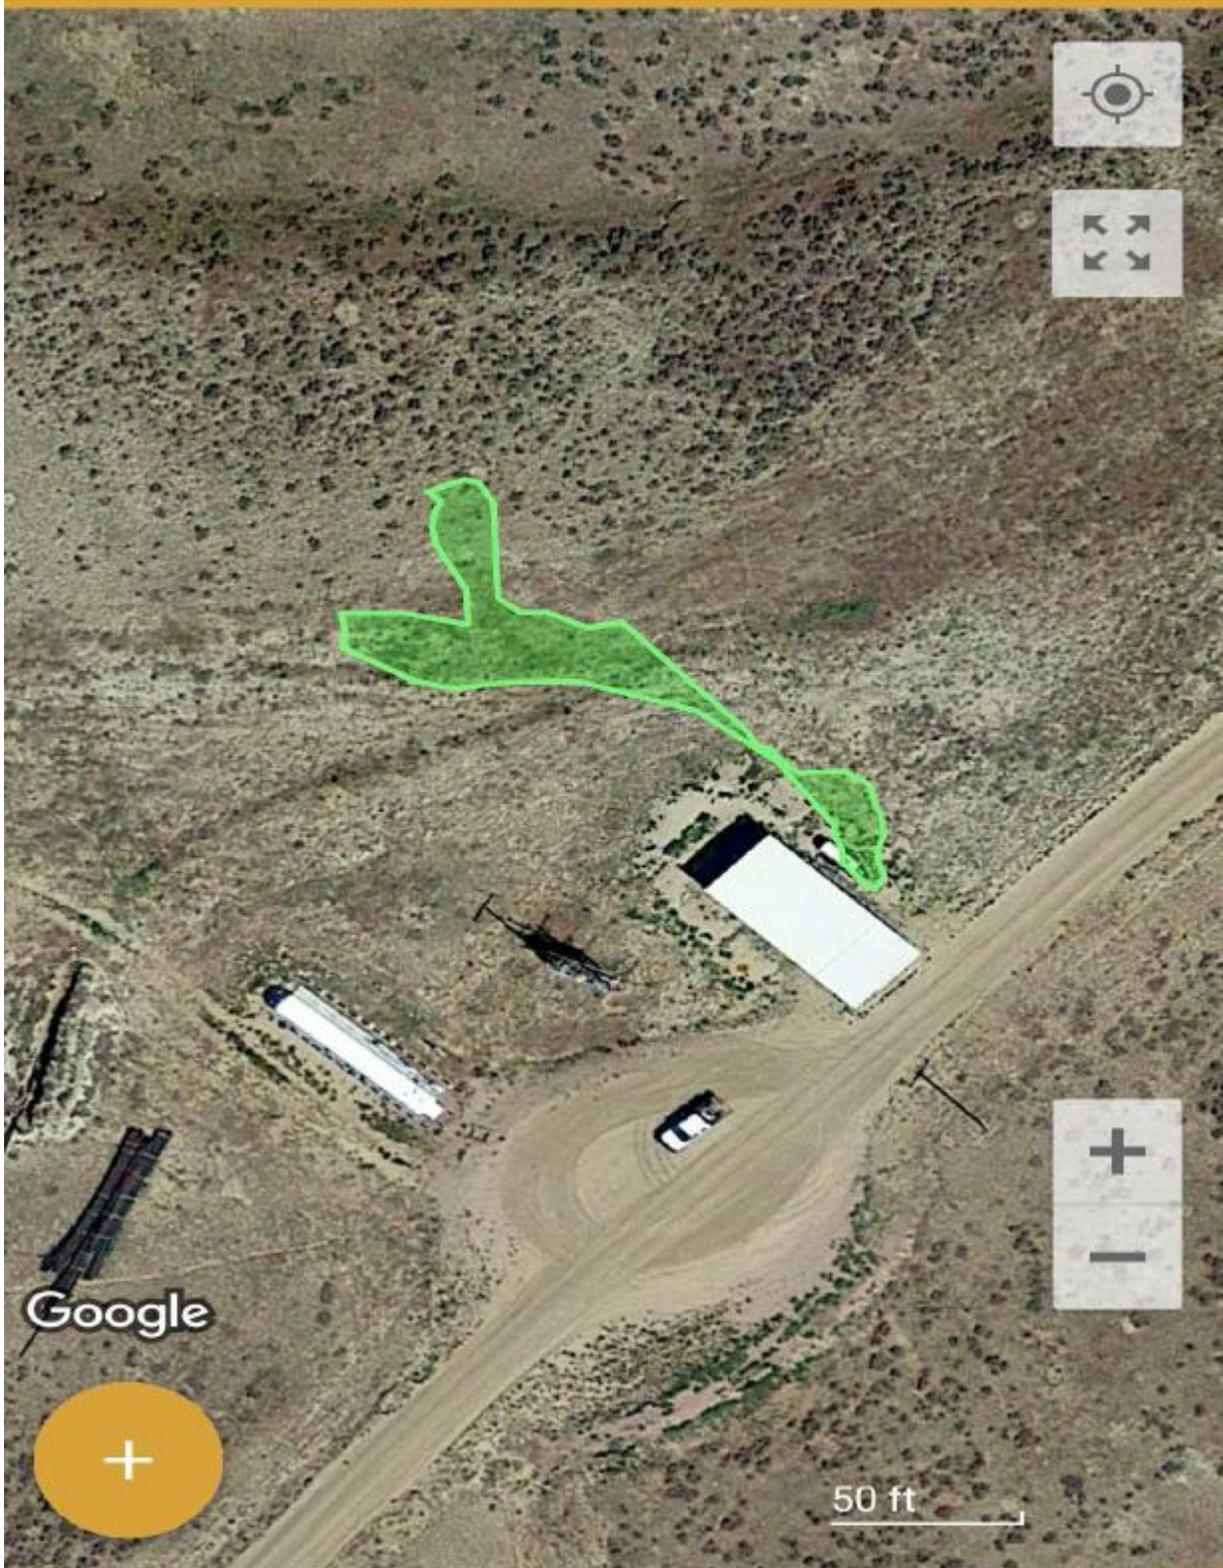
Attachement: Google Earth Photo of Pump Station 8 spill area.

The release followed the existing grade, approximately 100 foot to the south of an ephemeral draw located near Pump Station 8. The approximate surface area of the impacted was 2,803 square feet and flowed . No wildlife or livestock were impacted, nor did the spill reach surface water or the subsidiary to any waterways. No significant erosion resulted from the release.
