SHEARON HARRIS NUCLEAR POWER PLANT
FAULT INVESTIGATION

PROGRESS REPORT

EBASCO SERVICES INCORPORATED

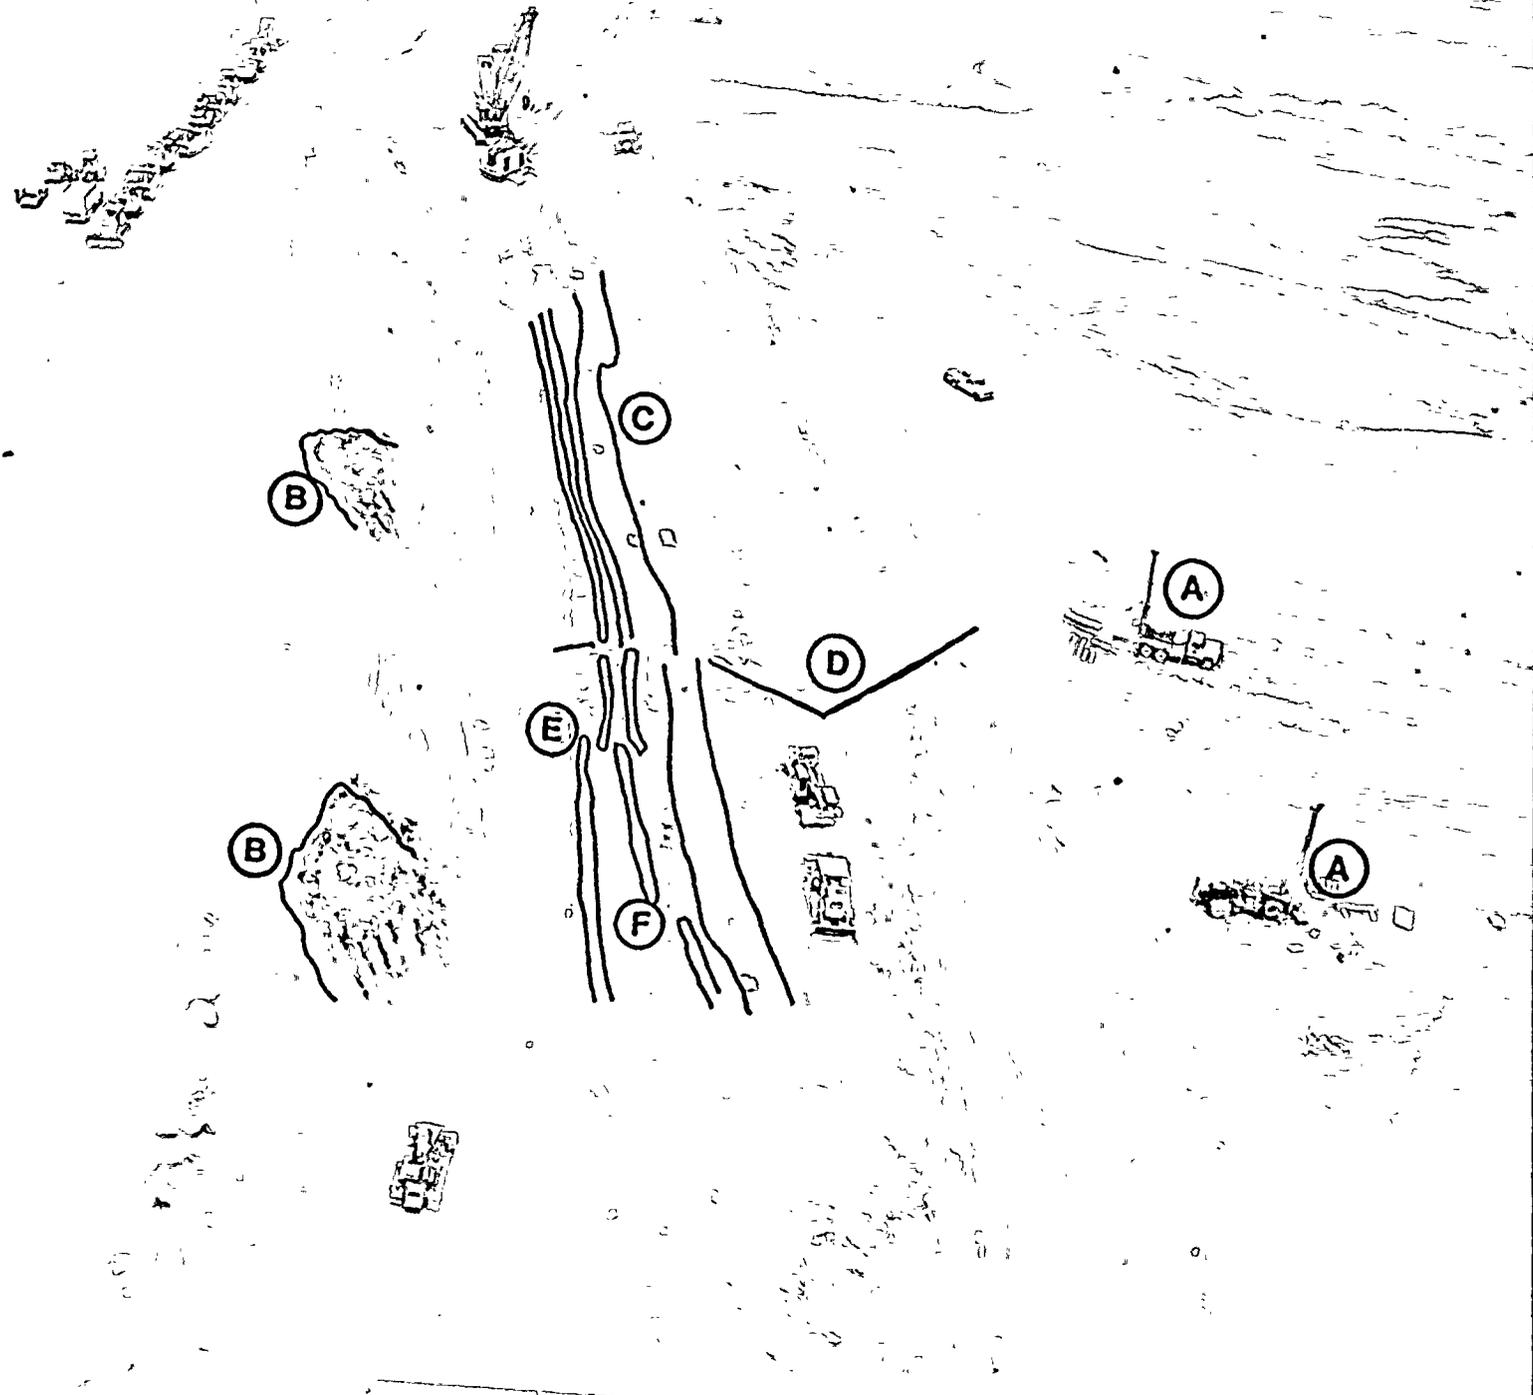
PHOTO E
CS4459

View northward along East Dike 2 at the intersection with the fault. The total exposure of dike is some 800 feet in length. Line segments (B) represent bedding plane slope failures on dip slopes which are common at higher elevations on clays which are found in association with the diabase dikes. These clays are concentrated near the dikes and are not found below the saprolite zone in areas several hundred feet removed from dike exposures. The two drill rigs at points (A) are coring to explore the vertical component of offset along the fault. Line segments (C) show the limits of the diabase dike. Line segments (D) represent the fault. Point location (E) represents apparent offset of the dikes not seen at lower elevations. Note the lack of offset of the dike to the right in this exposure. Point (F) similarly represents apparent but not real offset of one of the smaller dike segments. A cleaned and close-up view of this particular location is seen in Photo Q.

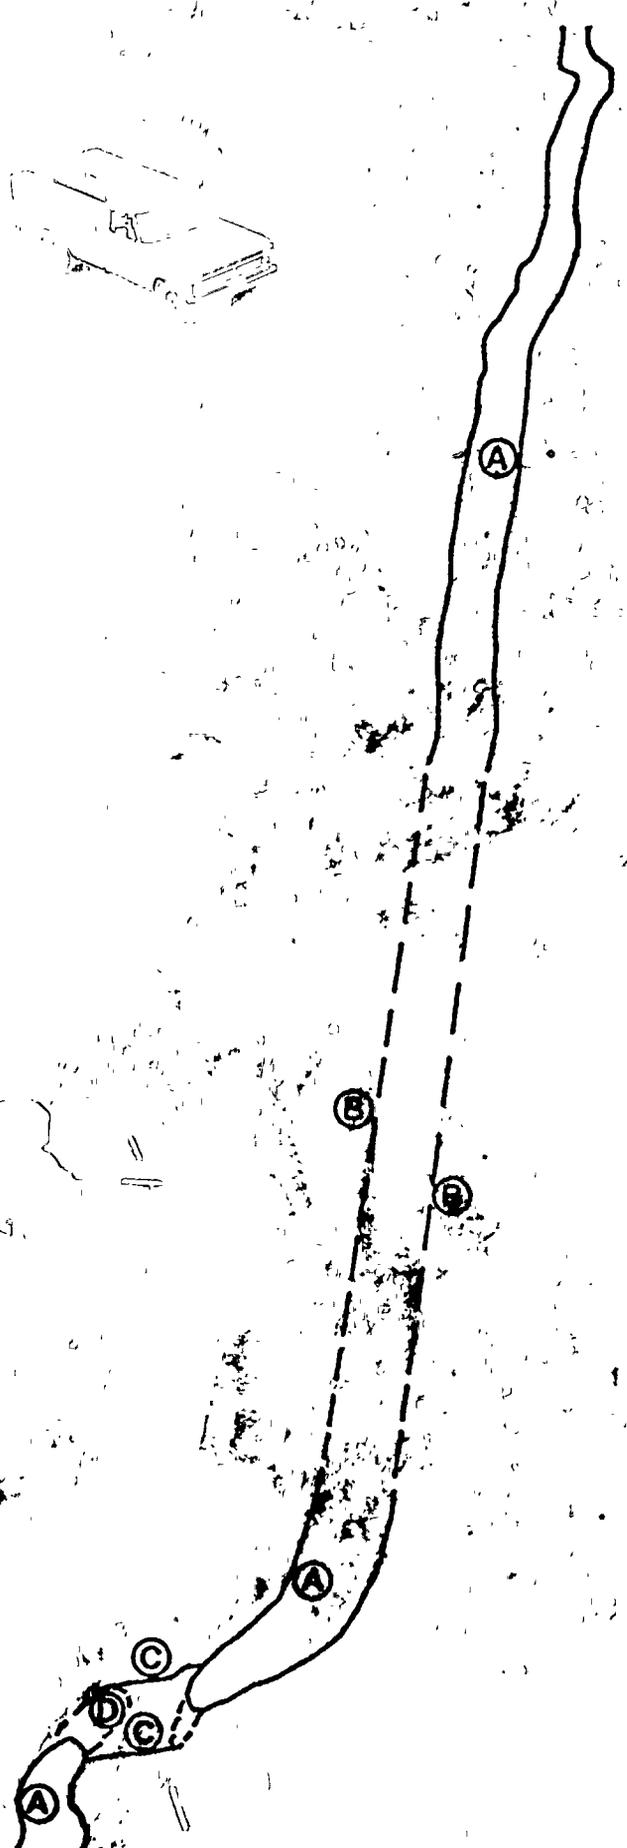
PHOTO M
CS4-508

View north along West Dike 3S, at reference elevation 239 north or the intersection with the fault. Line segments (A) show the limits of diabase. Line segments (B) indicate the limits of diabase where covered by muck. Line segments (C) represent the limits of the zone of alteration between the two exposed segments of diabase. Line segments (D) enclose zones of highly altered material trending toward diabase composition in this weathered exposure. The straightness of West Dike 3S in this exposure indicates either that the dike is vertical or that it exhibits uniform dip at locations other than the fault zone. Work this photo with vertical Photos N, O and P.

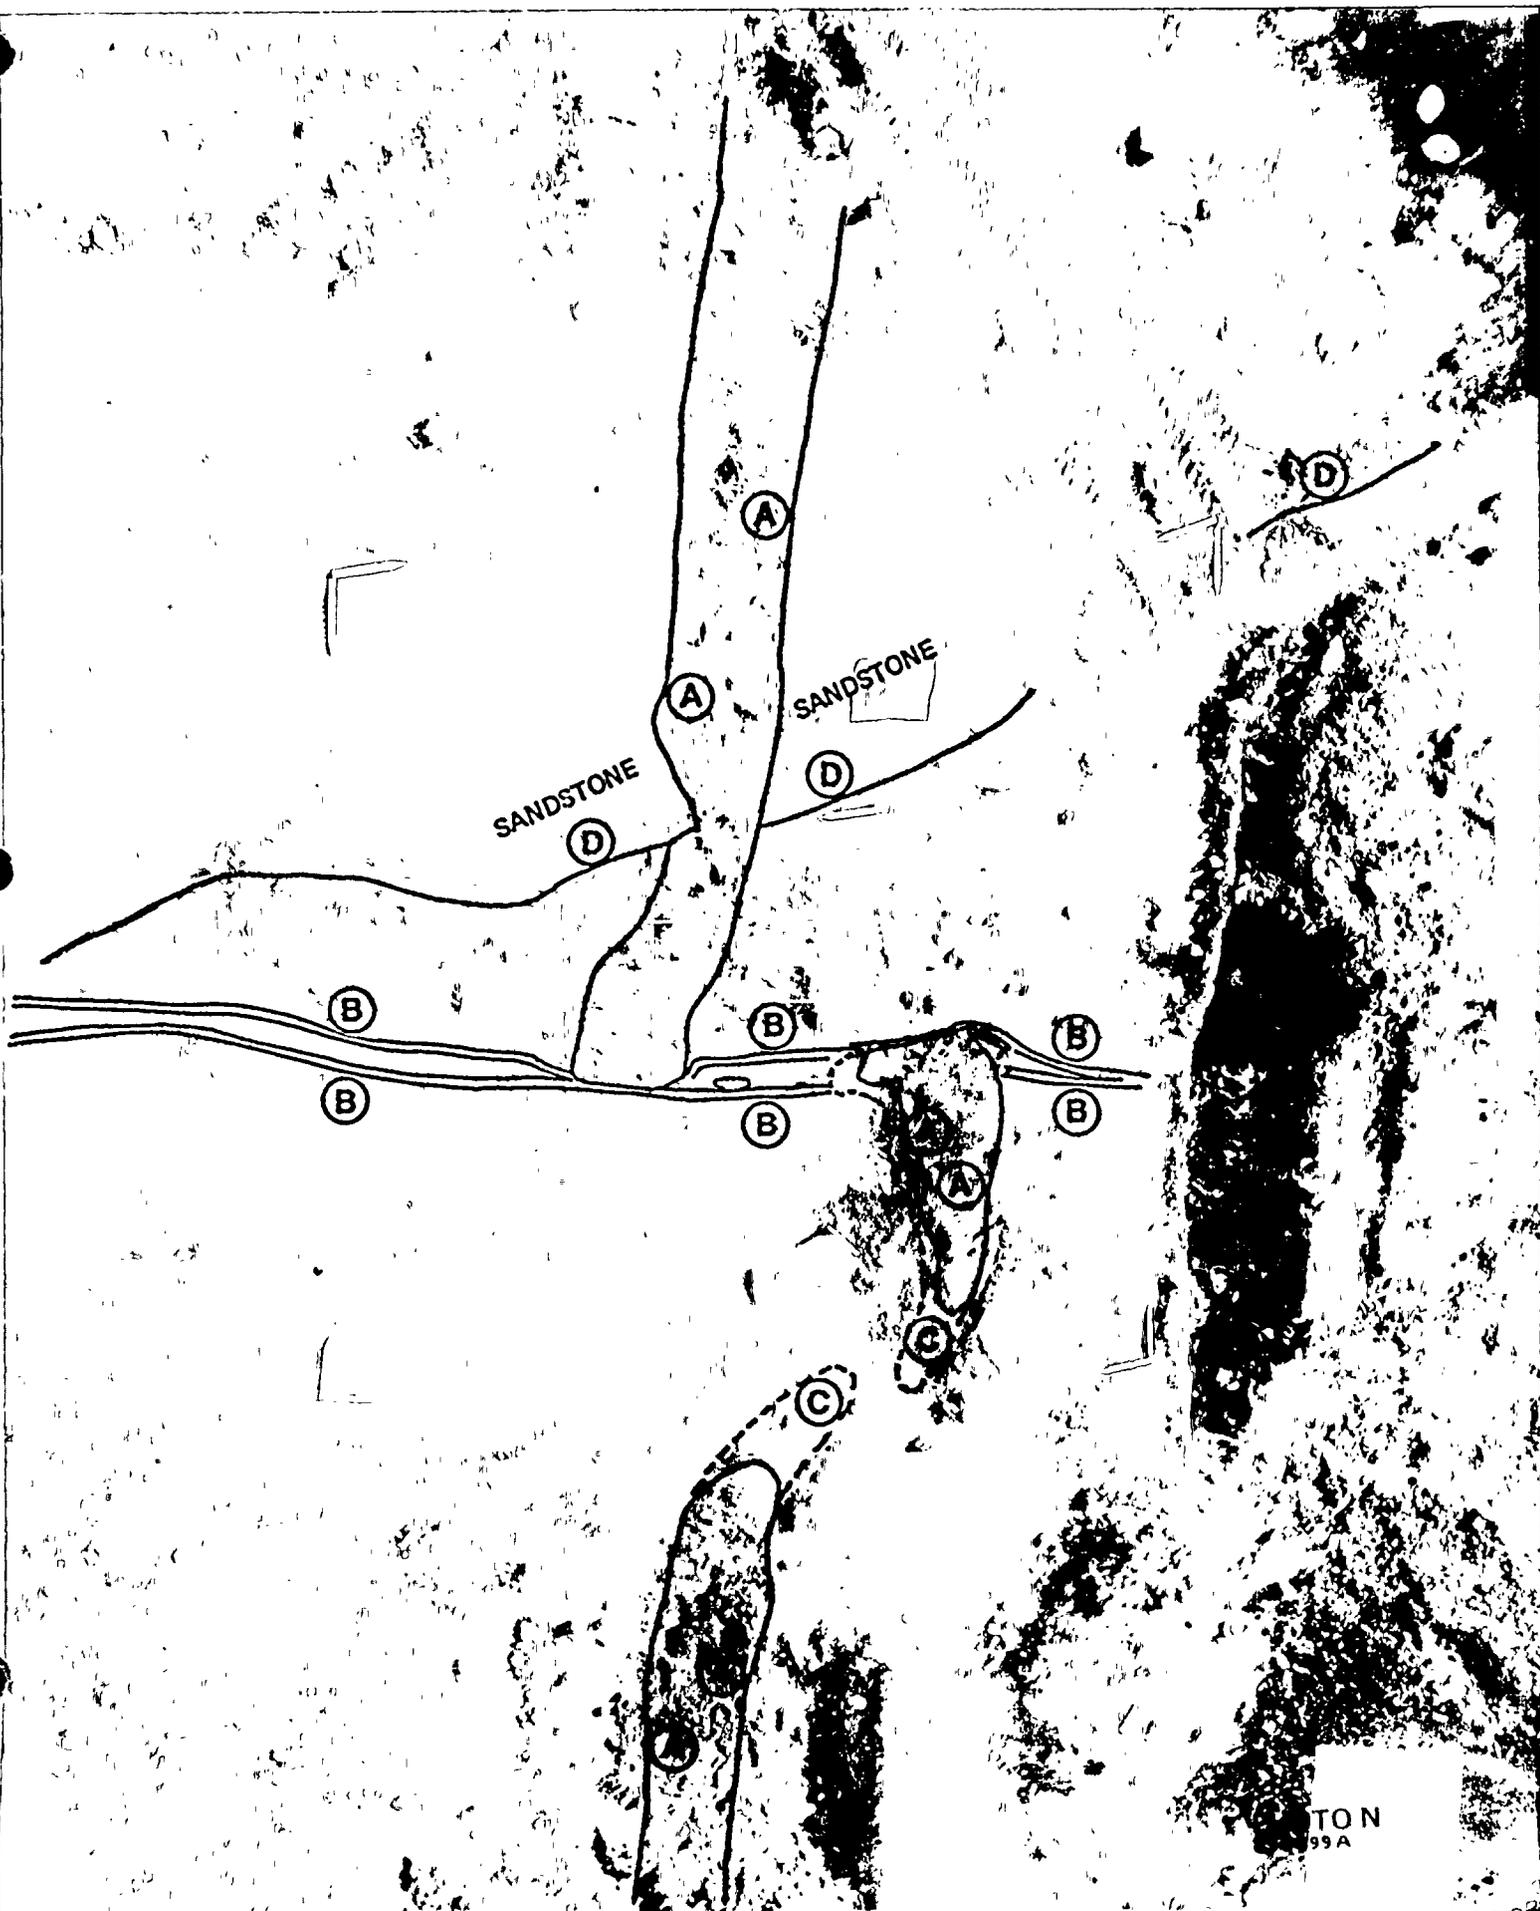
View south along West Dike 3S, at the intersection of the dike with the fault at elevation 239. Line segments (A) represent limits of diabase. Line segments (B) enclose the zone of sheared material, mainly fish-scale clays, in the fault plane. Line segment (C) outlines the zones of darkened, highly altered country rock. Line segments (D) represent a bedding plane in sandstone which crosses West Dike 3S without displacement. Note the apophyses of diabase into the sheared clays of the fault zone in the northerly dike exposure. Note the high degree of alteration on the left or east side of this exposure extending into the sheared clays of the fault. Note the distortion of the diabase of the north limb where it has intruded the broken ground of the fault plane. Compare the lack of distortion on the southern limb of the diabase with the documented observation that all distortion in sedimentary beds observed in numerous other fault outcrops occurs on the south limb as drag folding. See closer views of this exposure on Photos O and P.

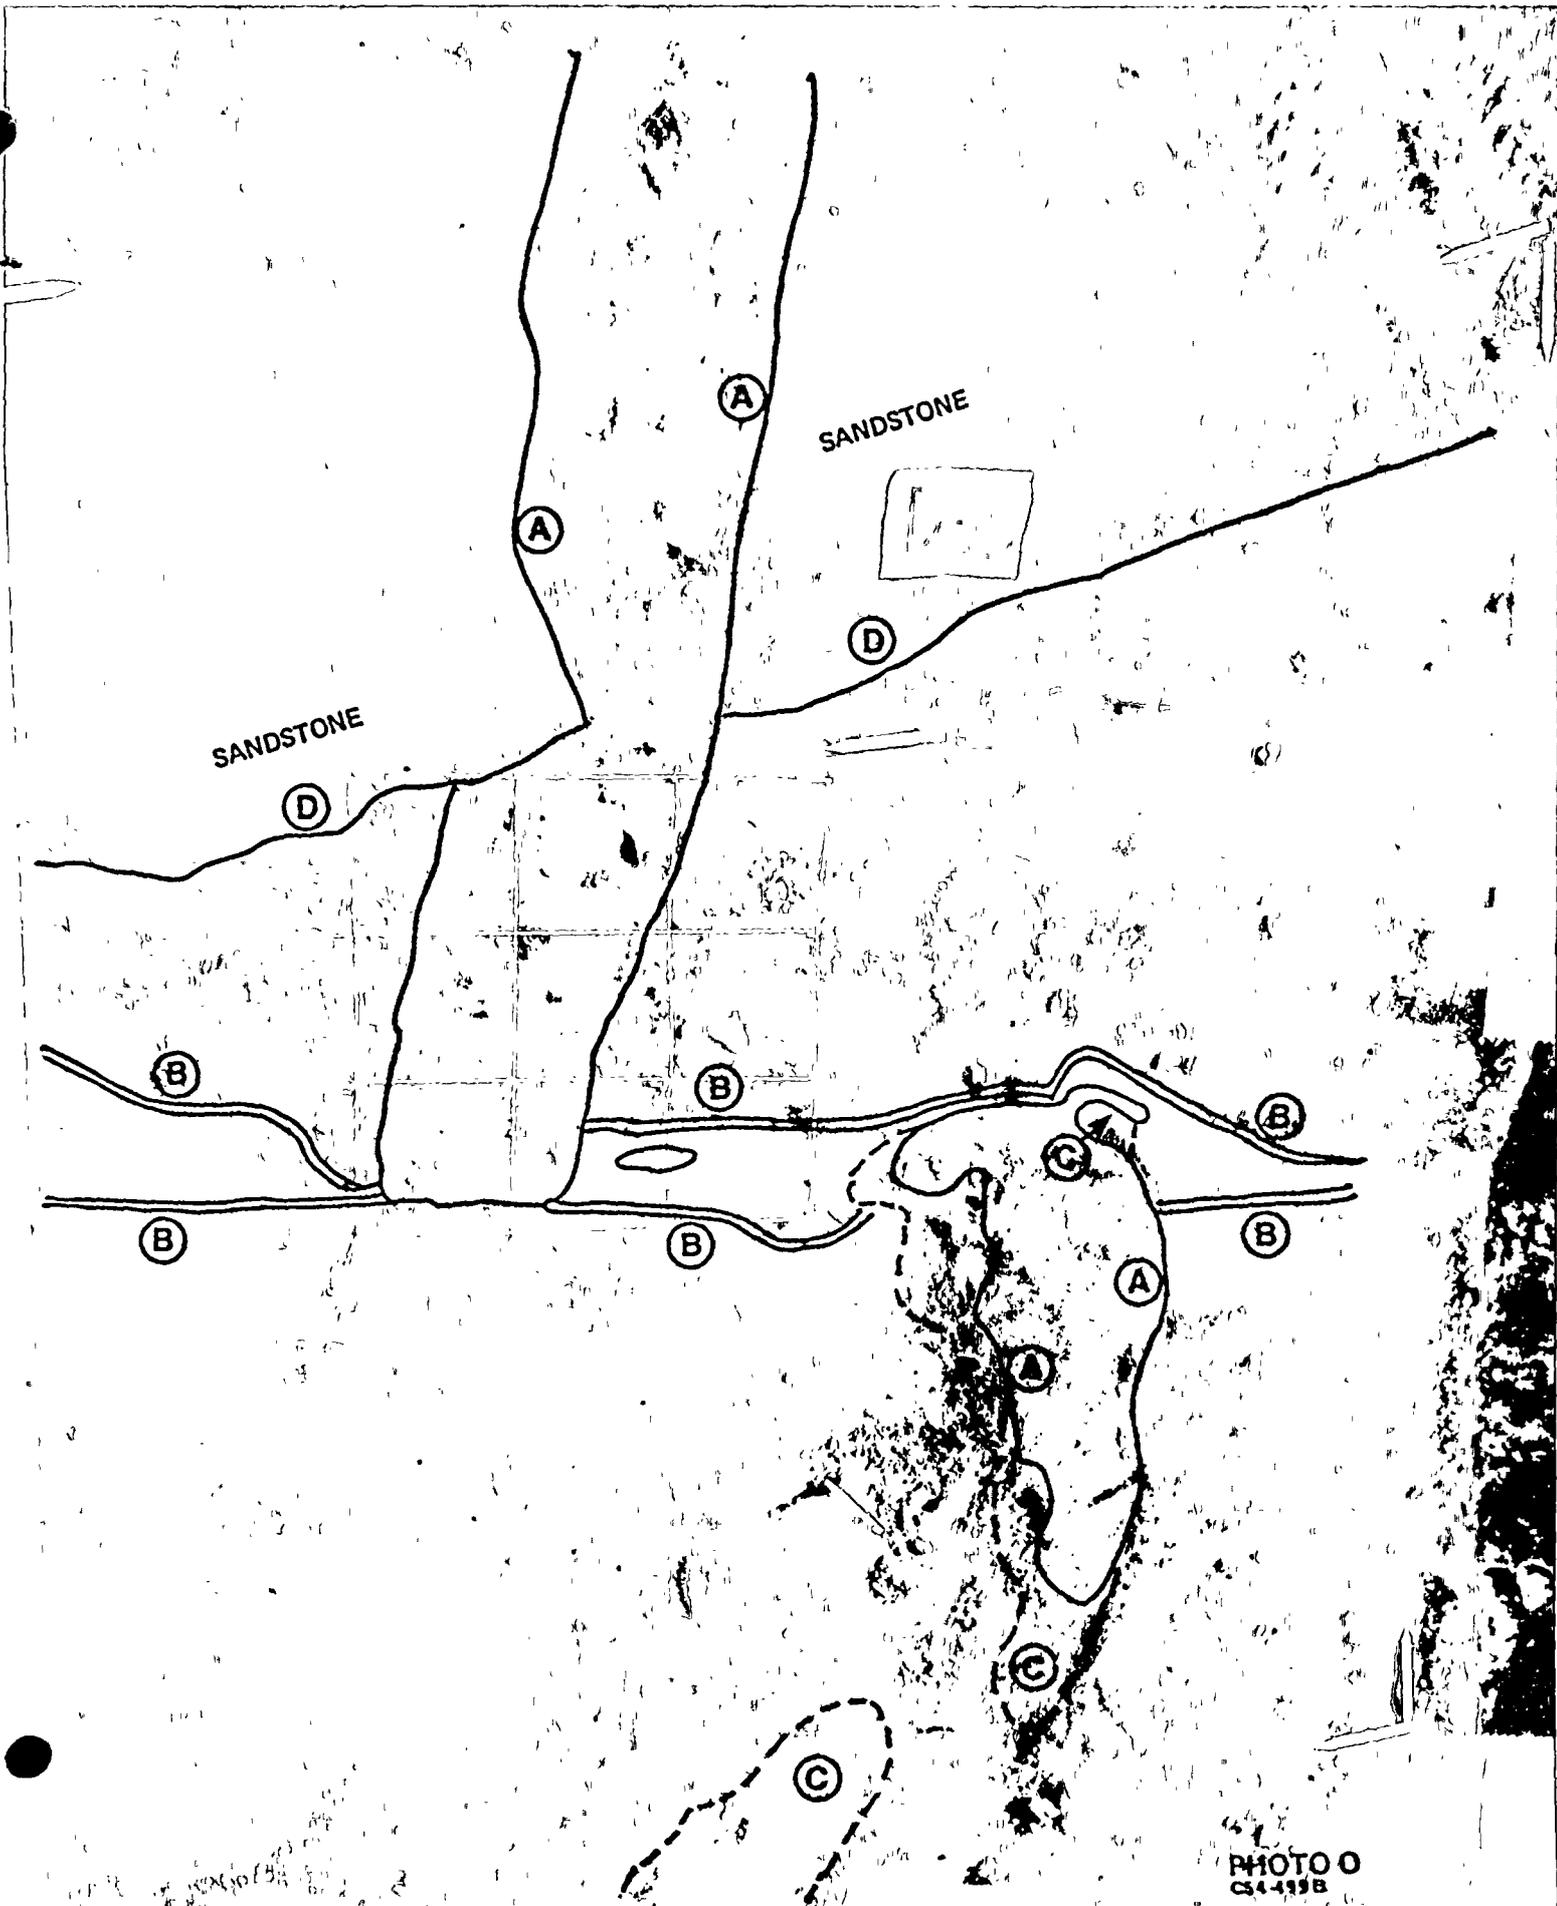
PHOTO O
CS-499B

This represents some enlargement of Photo N. The view is south along West Dike 3S, at the intersection of West Dike 3S with the fault. Line segment (A) represents limits of diabase. Line segments (B) enclose sheared fish-scale clays in the fault. Dashed line segments (C) represent zones of intensive alteration of country rock by the diabase. Line segment (D) represents a bedding plane which crosses West Dike 3S without offset. Note that the dike intrudes the fault plane and that the two limbs of the diabase overlap one another. The fault plane exhibits high angle dip to the south at this point. The apophysis of diabase at the south end of the right or west dike segment are intruded into the sheared clays of the fault. A small football shaped apophysis of diabase is seen in the sheared clay just to the west of the east limb of the dike. See following Photo P for a further enlargement of this intersection and the locations from which zeolite samples were taken.

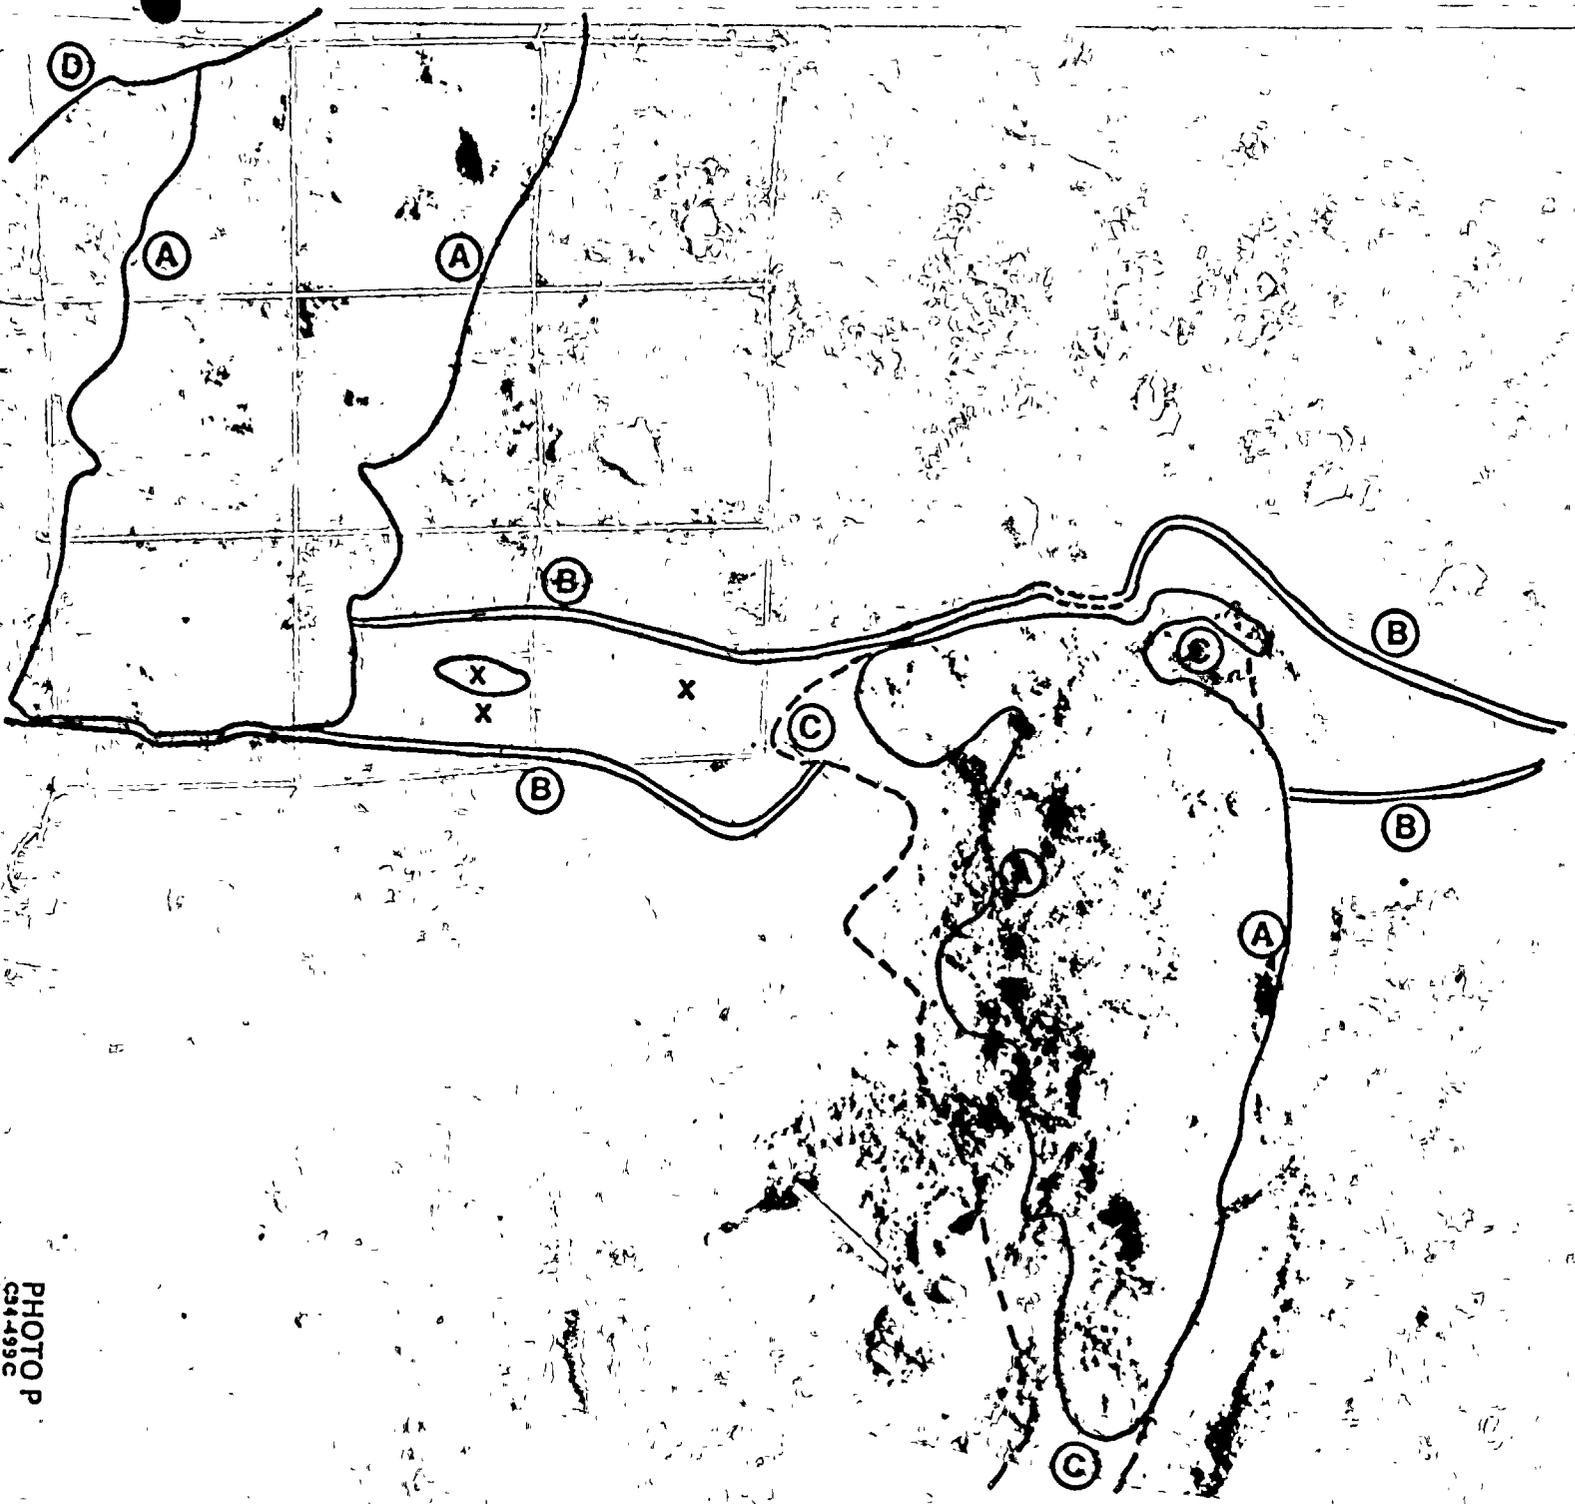
PHOTO P
CS4499C

View from overhead and northward to the left of the photo as bound. This is an enlargement of a part of Photo N. North is to the left of the photo as bound. Line segments (A) show the limits of diabase. Line segments (B) enclose sheared clay in the fault plane. Dashed line segments (C) show zones of highly altered country rock adjacent to the diabase. Line segment (D) is a bedding plane. Locations designated by (X), 3 in number, are the locations from which samples of zeolite secondary minerals were taken. One of these samples was taken from a small football shaped apothesis of diabase to the west of the east limb of the dike. The other two samples were taken from sheared clay in the fault plane.
