Three Mile Island Unit 1  
Route 441 South, P.O. Box 480  
Middletown, PA 17057  
Telephone 717-948-8000

TMI-18-088  
September 21, 2018

Subject: Response to Request for Additional Information  
TMI Fall 2017 Steam Generator Tube Inspection Report

**Response to Request for Additional Information  
TMI Fall 2017 Steam Generator Tube Inspection Report**

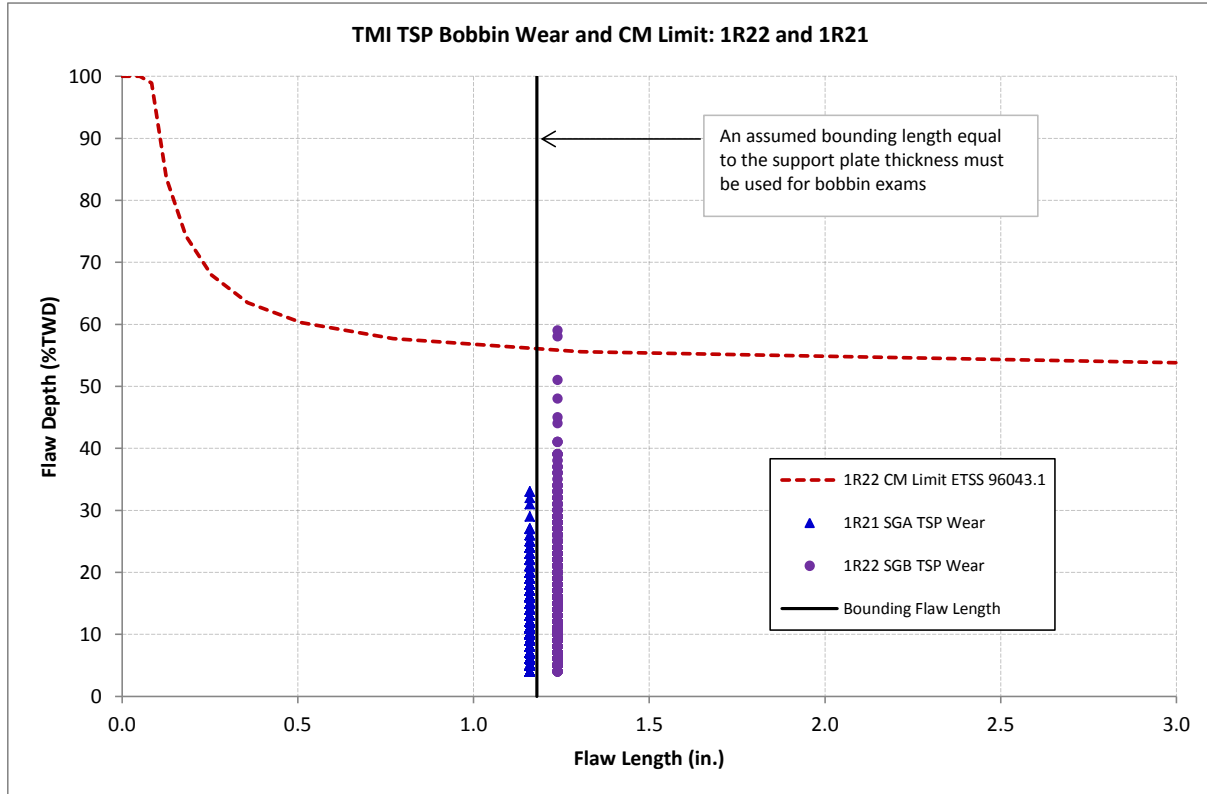
**Figure 1: TMI-1 Condition Monitoring of TSP Wear at T1R22 (SG B) and T1R21 (SG A) Based on Bobbin Sizing**

Condition Monitoring assessments have been performed on both SGs since the first inservice inspection (T1R19 in 2011). SG A, unlike SG B, has passed Condition Monitoring acceptance criteria analytically by a wide margin at all three of its inspections, including T1R21. Given that SG A has not exhibited and is not expected to exhibit the high wear behavior as SG B, there is confidence that SG A will again meet Condition Monitoring after operating for two cycles.

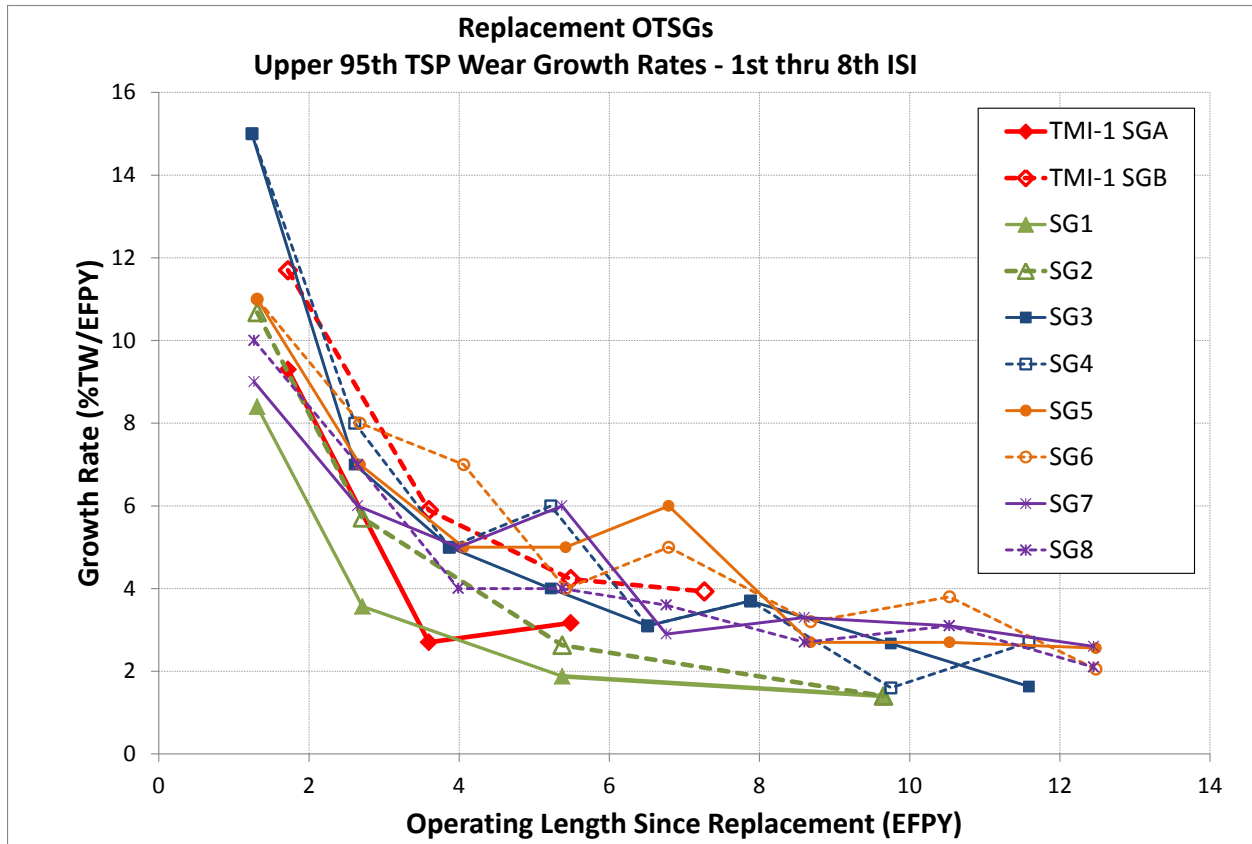
**Figure 2: Upper 95<sup>th</sup> Percentile TSP Wear Growth Rates in Replacement OTSGs**

While there are, expectedly, certain similarities in the behavior of broached tube support plate wear in both SGs, SG B has consistently exhibited distinct patterns of aggressive wear in certain locations that differ significantly from SG A. SG A lacks distinct patterns of aggressive wear. As a point of comparison, Figure 1 plots the TSP wear depths for SG A and SG B at T1R21 and T1R22, respectively, compared to the T1R22 CM limit curve. This shows the large difference in the depth distribution and margin to the CM limit between the two SGs. In addition, the wear depths and growth rates in SG A are in line with other replacement EOTSGs in the US nuclear fleet. As described above, there is sufficient qualitative and quantitative evidence to support the hypothesis that SG A is not subject to the tube support plate partial locking phenomenon that affects SG B and has been a contributing factor to the aggressive broached tube support plate wear observed. It is therefore justifiable to treat SG A differently than SG B in their Operational Assessments (OAs).

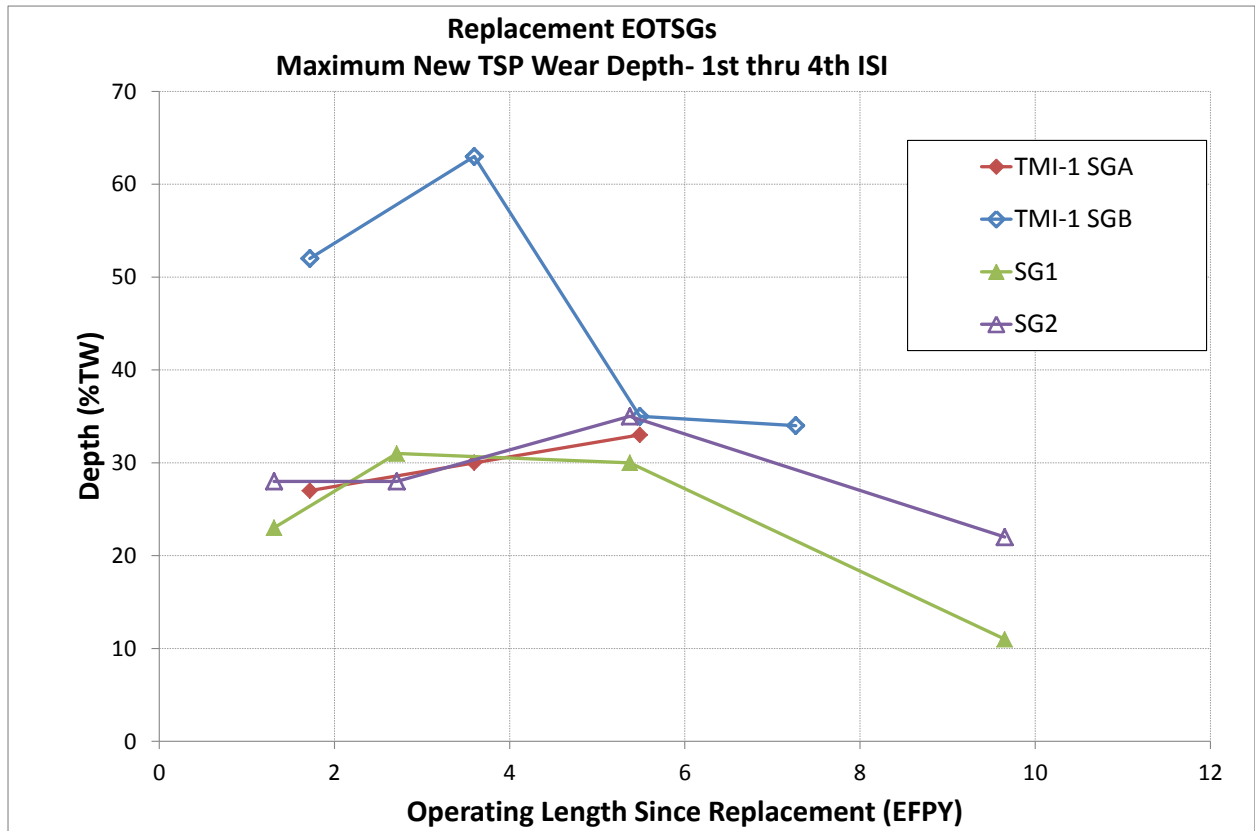
**Figure 4: Maximum Depth of New TSP Wear in EOTSGs**

Operational Assessments have been performed with proven fully-probabilistic methods on both SGs since the first in-service inspection (T1R19). Predictions from the OA models have bounded the actual inspection results with respect to wear depths and growth rates, validating the accuracy of the model and method. Additionally, conservatism is included in the model with respect to the wear growth rates assumed since measured broached tube support plate wear growth rates among all replacement EOTSGs have been observed to attenuate, rather than increase, as operating time increases, as shown in Figure 2 (Upper 95<sup>th</sup> Percentile Growth Rate) and Figure 3 (Average Growth Rate) below, providing reasonable assurance that wear rates in SG A will follow a similar trend. With respect to the expected size of new TSP wear flaws, a comparison of the maximum new TSP wear depths observed for units with AREVA designed replacement EOTSGs was made. It can be seen in Figure 4 that TMI SG A is trending similarly to SG2, which has justified operating ~4.7 EFPY until the next planned inspection.
