SUBJECT: WESTINGHOUSE ELECTRIC COMPANY – NUCLEAR REGULATORY  
COMMISSION INTEGRATED INSPECTION REPORT NUMBER 70-1151/2018-004  
AND NOTICE OF VIOLATION

Report No.: 70-1151/2018-004

Facility: Columbia Fuel Fabrication Facility

### Failure to Properly Implement Management Measures for the HF Spiking Station

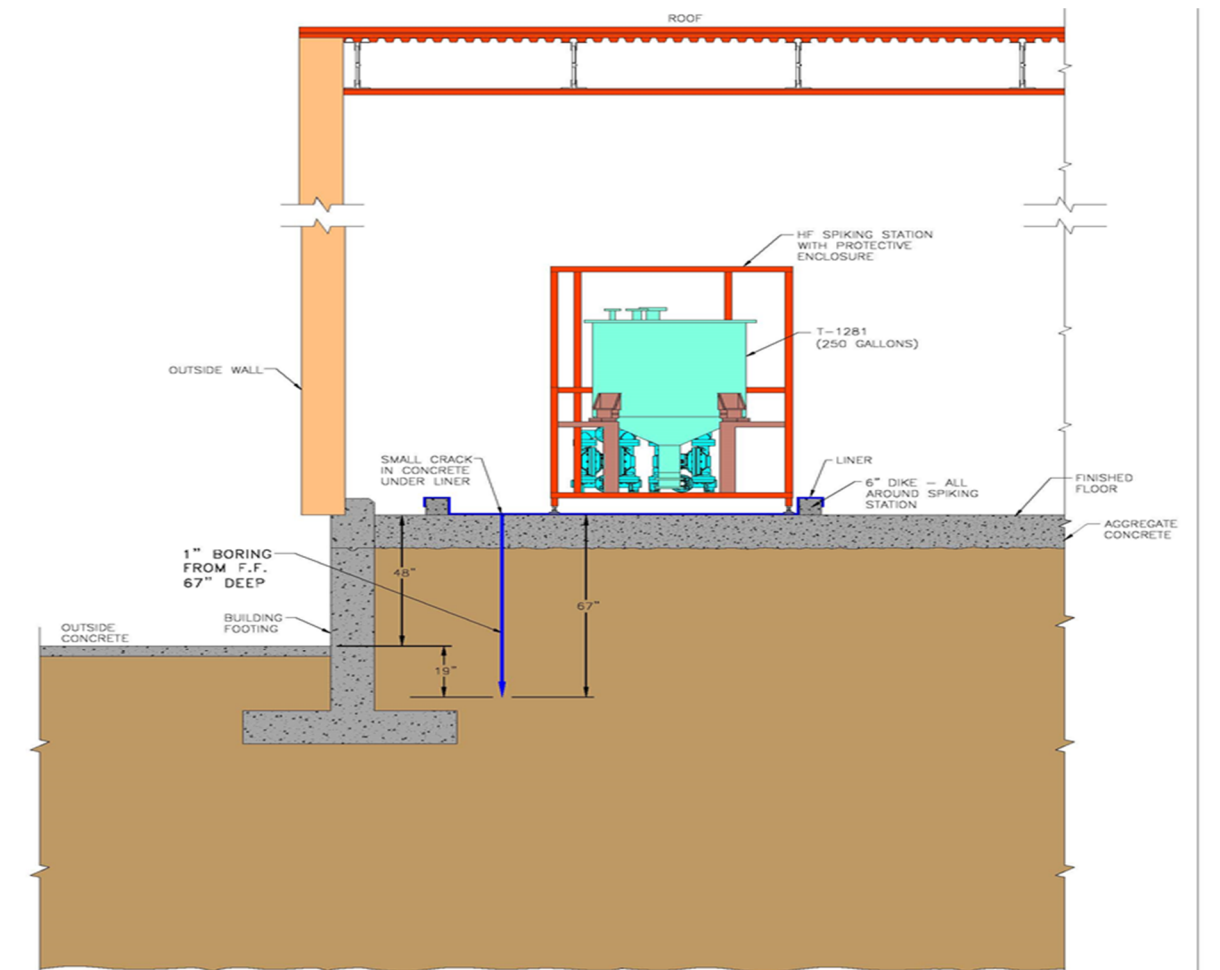
#### Cross-sectional View of HF Spiking Station

- The liner was removed so the diked area could be cleaned and inspected. Upon removal of the liner, maintenance noticed a small hole about the size of a quarter in the epoxy coating over the concrete. Prodding to investigate further resulted in a ~3 inch hole in the concrete surface.
- Maintenance was able to insert a wire down to ~30 inches into the building backfill before meeting resistance. They also noticed that the concrete was degraded around the immediate area. It should be noted that the building sits ~4 feet above the natural ground level.

*Description:* On June 16, 2018, approximately 30 gallons of UNH solution leaked into the diked area surrounding the HF spiking station. A flanged piping connection was the source of the leaking solution. After the system was shutdown, a worker identified a small amount of solution that appeared to have migrated to the outside of the dike wall. CAP 2018-11205 was written to track the issue and Spiking Station #2 was shut down. The dike liner was removed as part of corrective measures. While the polypropylene liner was removed for repair work, a small crack was noticed in the epoxy floor covering. The plan was to repair the crack but as the loose epoxy was chipped away, a hole of approximately 3 inch diameter was revealed.

ADUHFS-902 was considered degraded as indicated by cracks and degradation of the concrete dike wall. The inspectors noted that there was no policy or procedure in place to periodically inspect the area below the liner for indications of degradation of the concrete floor due to liner leaks.
