BROWNS FERRY NUCLEAR PLANT UNIT 3 - REPORTABLE DEFICIENCY -
RPV STABILIZER PLATES INSTALLED INCORRECTLY - IE CONTROL
NO. HO 1340 F2

BROWNS FERRY NUCLEAR PLANT UNIT 3

RPV STABILIZER PLATES INSTALLED INCORRECTLY

FINAL REPORT

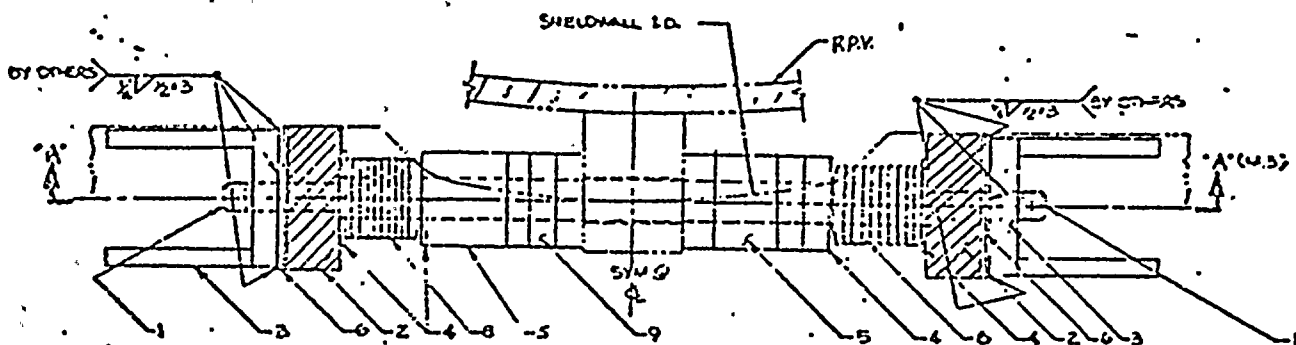
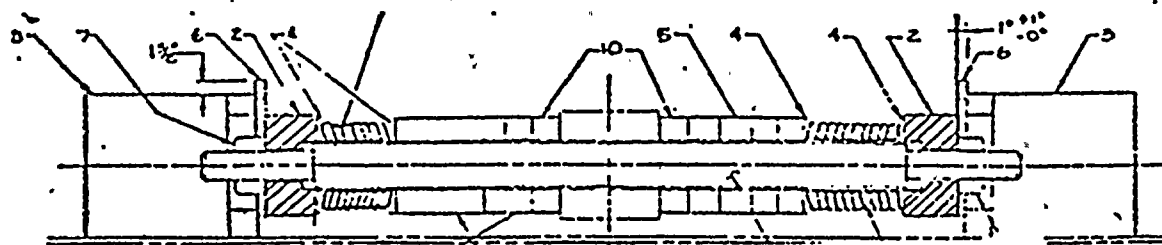
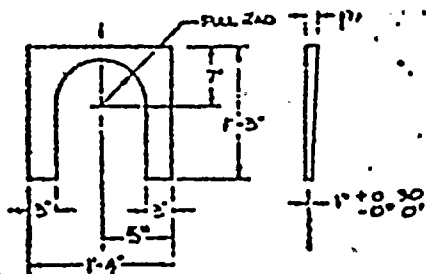
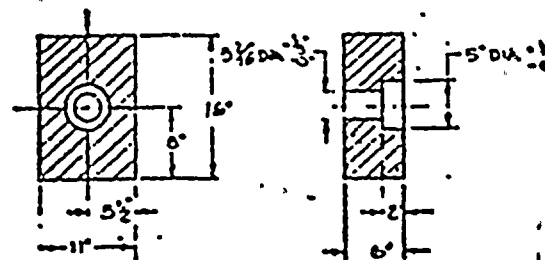
FIGURE 1

The General Electric Company released a field disposition instruction (FDI) requesting that an inspection be performed on the reactor pressure vessel (RPV) seismic stabilizers at Browns Ferry Nuclear Plant. The purpose of the inspection was to ensure the stabilizers were installed with sufficient clearances to permit relative deflections between the reactor pressure vessel and the shield wall without binding and inducing cyclic stresses in the stabilizers. When performing this inspection it was discovered that part of the stabilizer assembly had been incorrectly installed. Bearing plates at each end of the assembly had been installed 90 degrees from their intended orientation, see figure 1, attached.

The stabilizer bearing plates were originally installed rotated 90 degrees from their intended orientation.

The RPV stabilizers are the seismic restraints for the reactor pressure vessel. The bearing plates that were incorrectly installed are the bearing surfaces between the RPV stabilizer assemblies and the bumper assemblies mounted on the biological shield wall. The bearing plate of a stabilizer assembly directly reacts against a shim plate welded to the bracket. This shim plate is "U"-shaped to allow for movement of the stabilizer assembly due to thermal expansion of the RPV (see figure 1). With the bearing plate installed rotated 90 degrees from the correct orientation, the amount of bearing surface between it and the shim plate is reduced. It is possible that the thermal expansion of the RPV could move the stabilizer assembly so that one edge of the bearing plate is above the cut-out portion of the shim plate. During a seismic event this orientation could lead to the bearing plate "punching through" one side of the shim plate cut-out resulting in binding of the stabilizer assembly which could impair its operability. The RPV would not be damaged due to the stabilizer assembly binding, but the stabilizer could be damaged to the extent that replacement would be necessary.

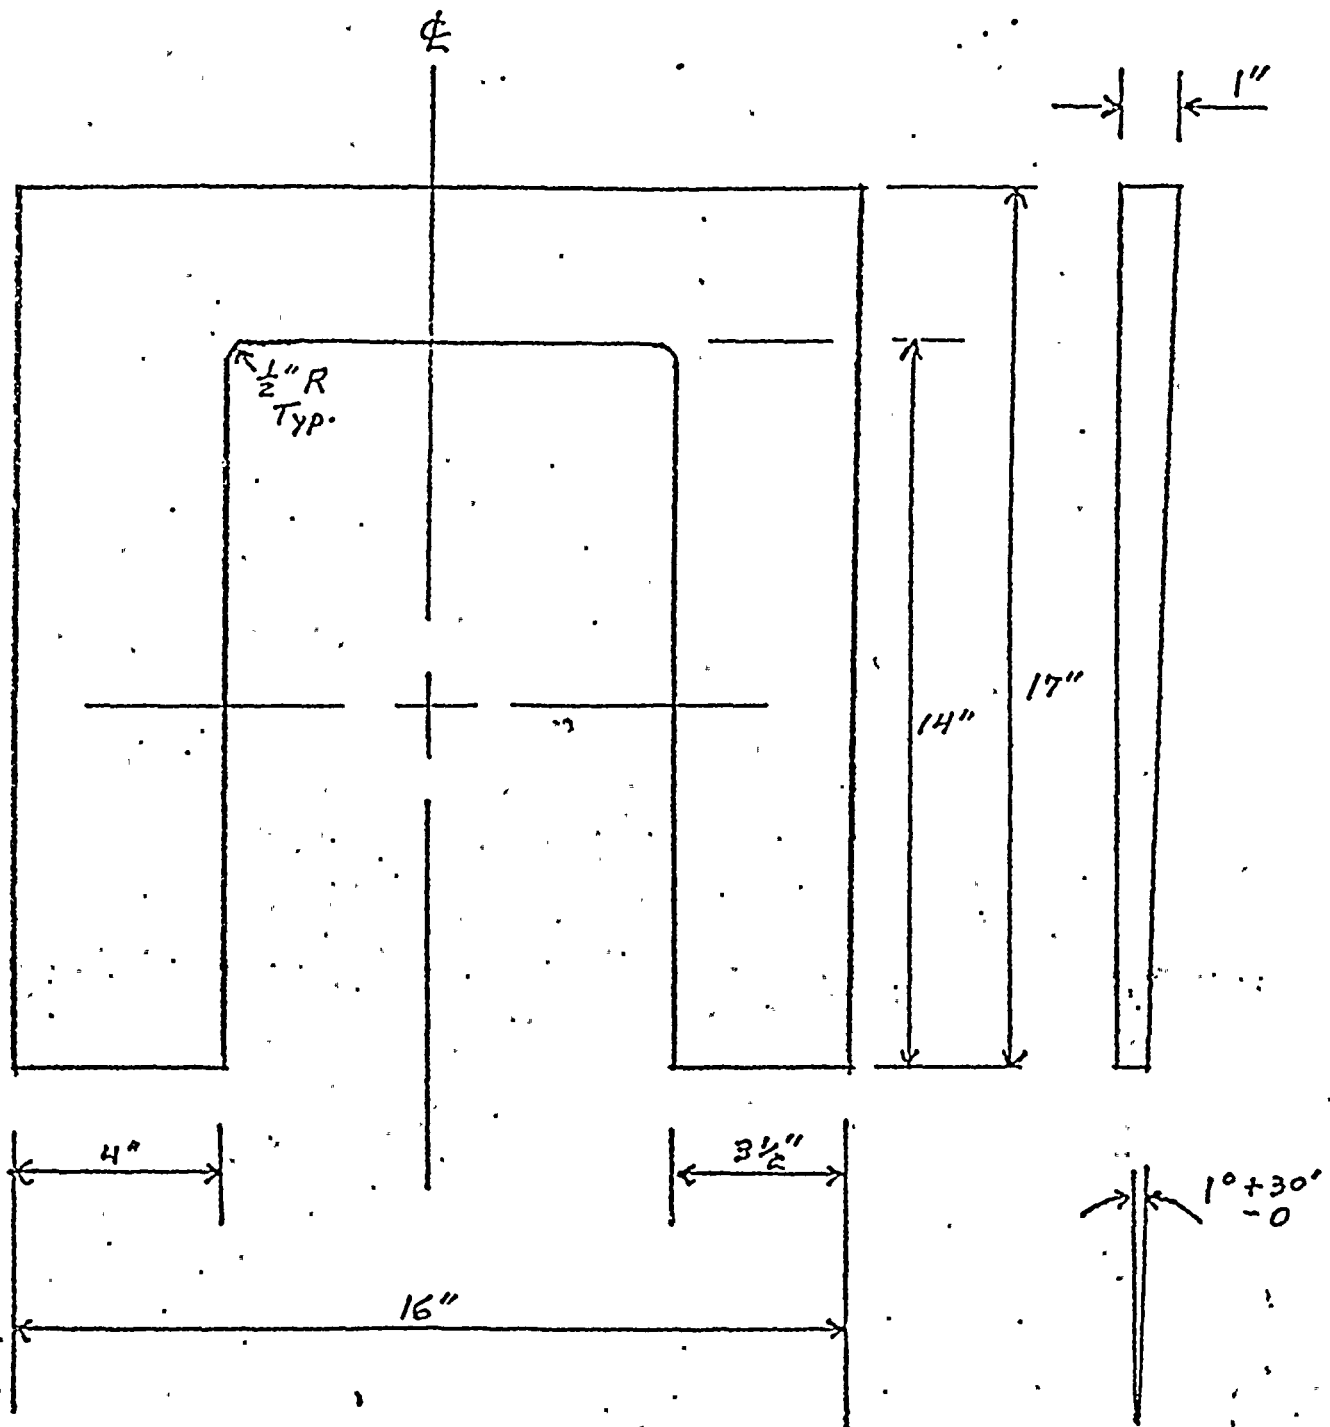
FIGURE 2

NEW SHIM PLATE

General Electric was notified of this deficiency and recommended that TVA implement one of two fixes: (1) rotate the bearing plate 90 degrees to the correct orientation, or (2) replace the shim plate on the bumper bracket with a new design of different dimensions. Since the stabilizers are fully assembled and are located in an area with limited access, rotation of the bearing plates would have been very difficult. Instead, new shim plates have been fabricated and have been installed. These new shim plates increase the amount of bearing surface area available and decrease the likelihood of a bearing plate "punching through" the shim plate cut-out (see figure 2 for new shim plate dimensions).
